Delaware River Basin

Restoration Roadmap

for American Shad, Alewife, and Blueback Herring

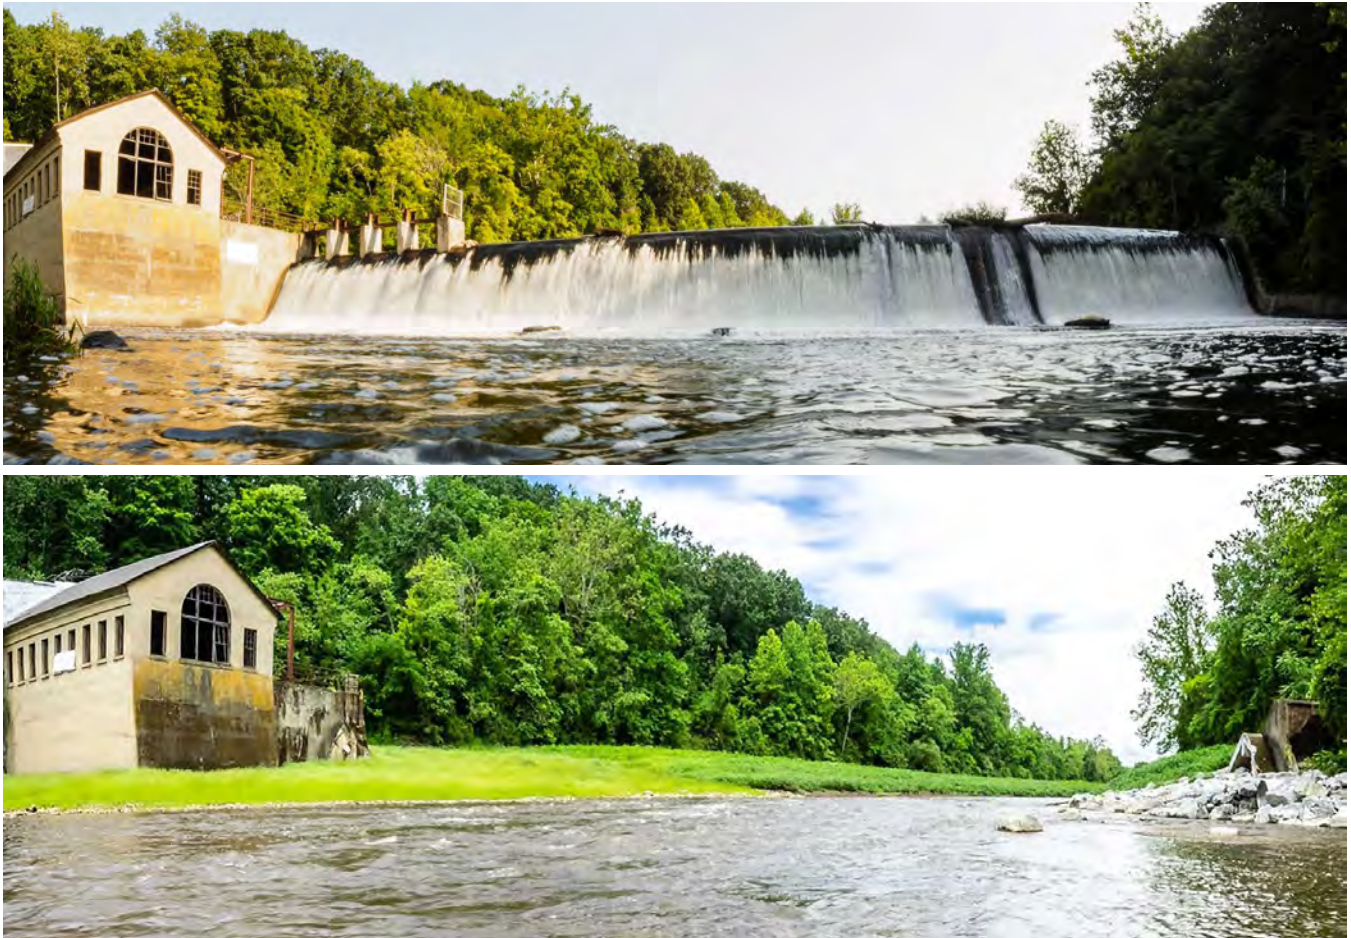
Figure ES-1. The Columbia Lake Dam on the Paulins Kill, before and after removal. Following the removal of the dam in 2018, American Shad and other migratory fish species now have access to an additional 10 miles of habitat upstream of the former dam site. Credit: Jeffrey Burian/TNC.

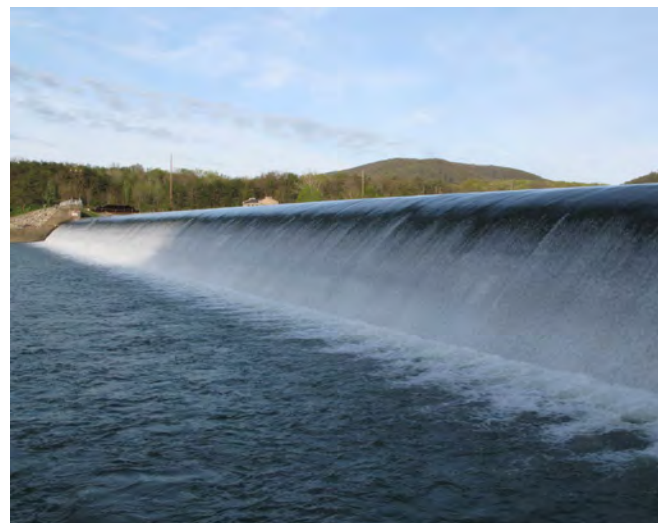
Figure 1-1. New Kernsville Dam. The Schuylkill River dam is being removed as it is a public safety risk. Credit: Flickr user Jack.

and Apse 2011). Some of the dams that restrict access to spawning habitat are obsolete and no longer serve their intended purpose; some are dangerous to human life (Figure 1-1), and others, not designed to withstand the increased flooding associated with climate change, pose risks to local communities. Over the past decade, dam removal has become more socially acceptable as local communities understand the benefits that barrier removal provides to both people and nature.

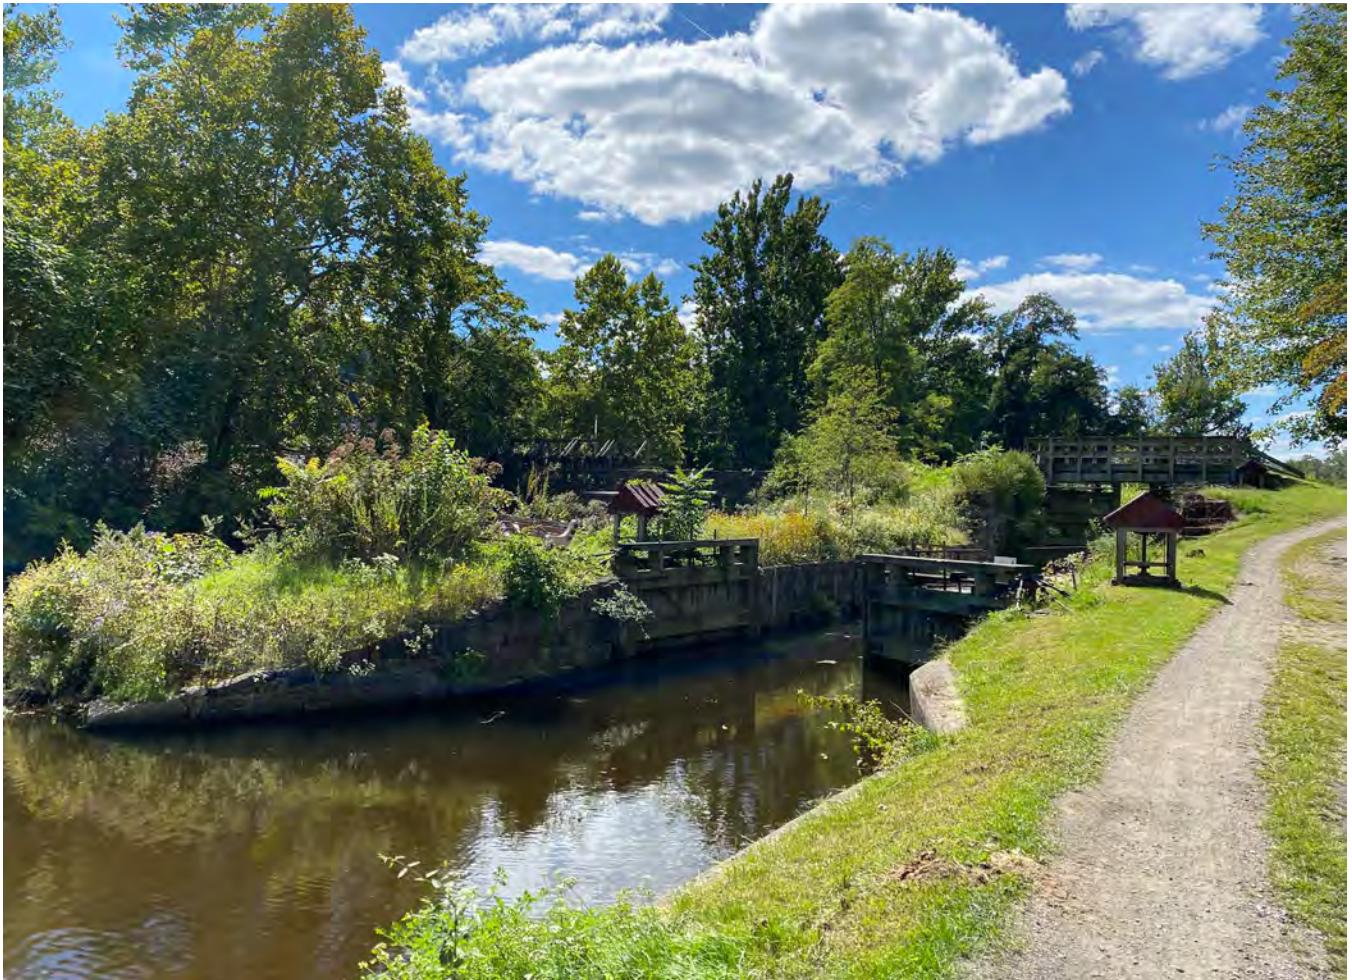
Figure 3-2. The Lehigh Canal in Easton, PA. The Chain Dam currently waters the canal, which is used as a cultural and recreational resource, and is the main reason why stakeholders have opposed removing the dam. Credit: Lyndon DeSalvo/TNC.

Locally cherished historic canals have proven a significant barrier to advancing dam removal on priority river systems and therefore restoration of alosines. Although the original use for these canal systems is long gone, many of the canal towpaths have been turned into recreation trails along water-filled canals (Figure 3-2). Dams still provide the water to these canals and solutions to removing the dam while maintaining water in the canal have proven to be difficult to overcome. Innovative solutions to balance the needs of migratory fish passage and historic and recreational interests are needed.

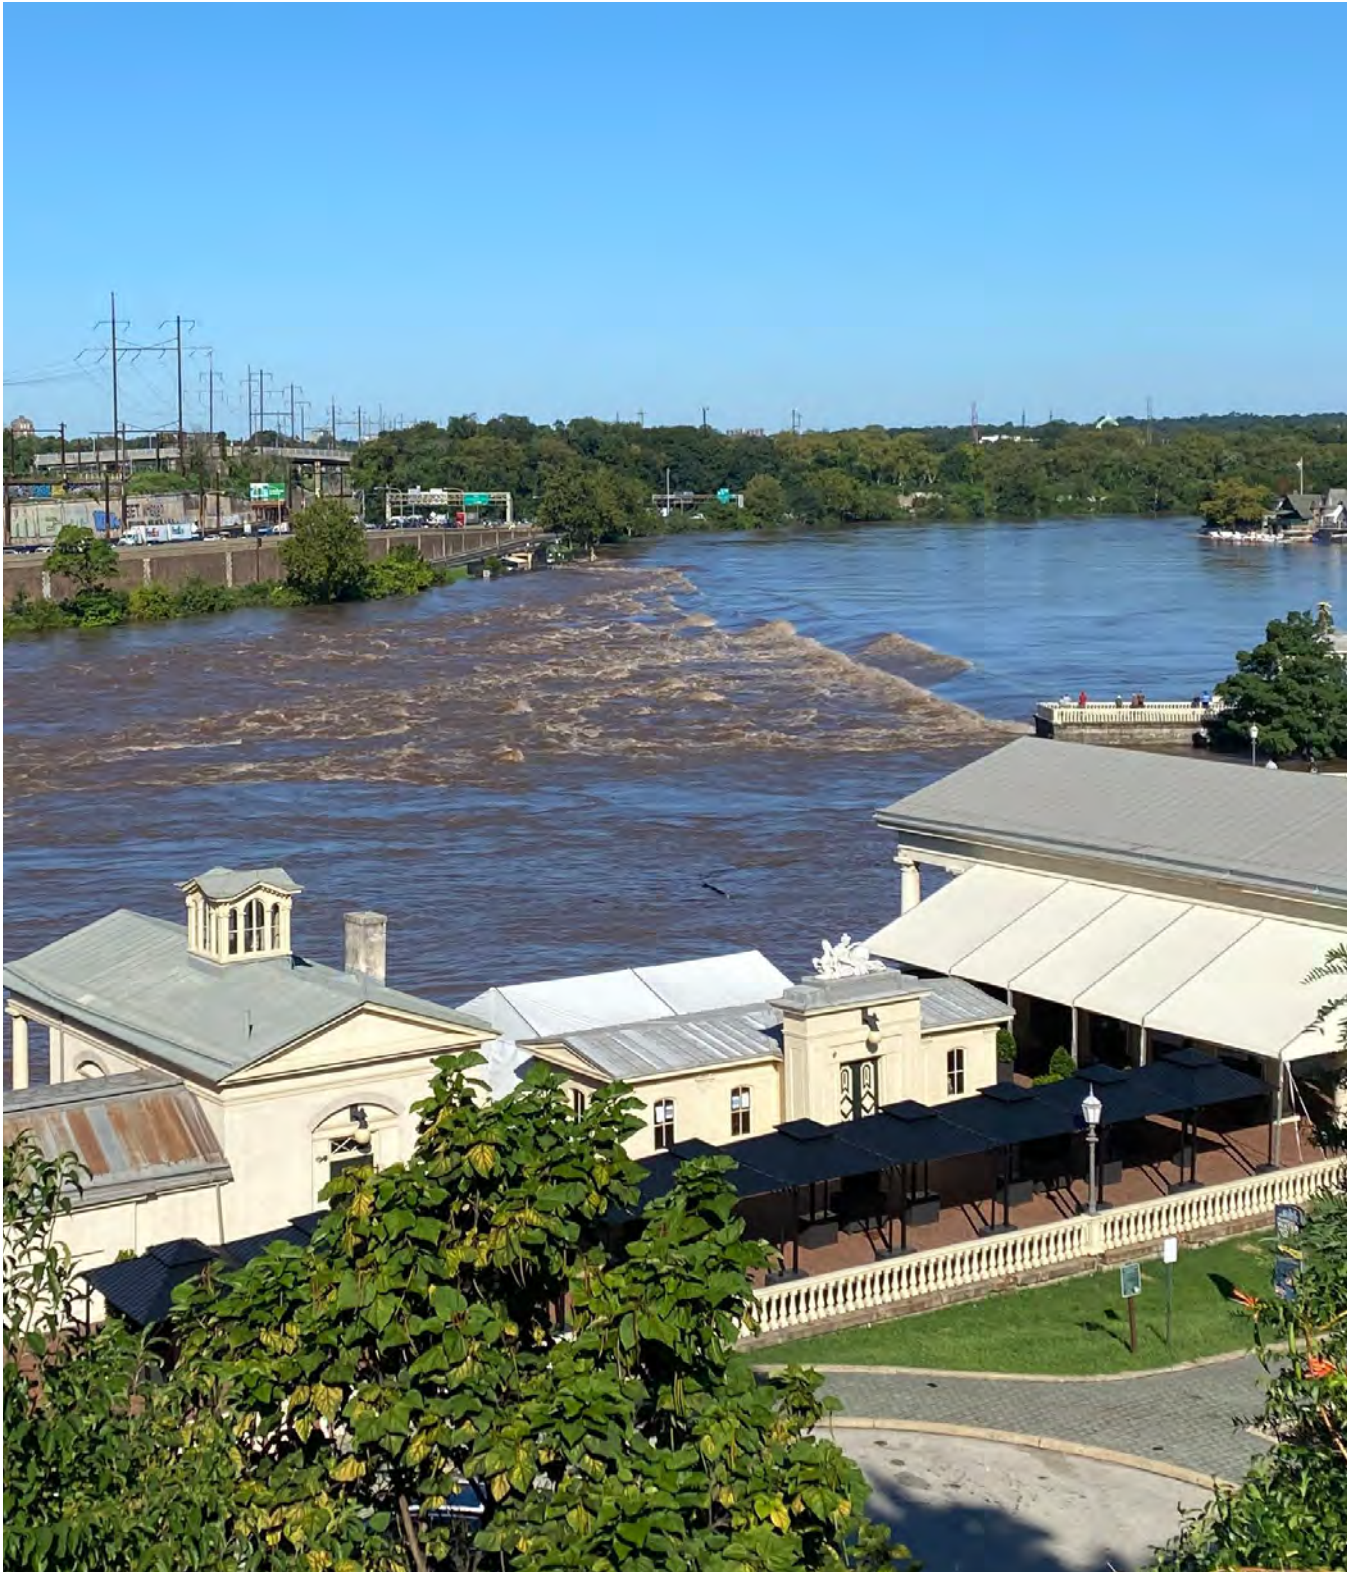
Figure 3-3. Fairmount Dam during Tropical Storm Ida, September 2021. The lower Schuylkill River severely flooded during Ida in September 2021 causing the Fairmount Dam to be completely submerged. During the storm, the fishway was damaged and may not be operational for the 2022 spawning runs. Credit: Lyndon DeSalvo/TNC.

Increasing urbanization and corresponding increases in impervious surfaces can significantly reduce the percentage of Alewife eggs and larvae that survive, and this may be especially true in smaller watersheds (Limburg and Schmidt, 1990, Uphoff 2011, Monteiro et al. 2020). For example, between 2000 and 2015, the population of the Brandywine-Christina watershed grew by 8%, with most of the growth occurring in Pennsylvania (Brandywine Conservancy 2018). This increase in impervious area combined with extreme storm events, such as Tropical Storm Ida in September 2021, has led to severe flooding particularly in the downstream urbanized section of the creek that runs through Wilmington, Del. This is not unique to the Brandywine watershed and highlights the need for a multifaceted approach to alosine restoration that includes a focus on water quality, protecting intact habitat, and restoring degraded streams (Figure 3-3).

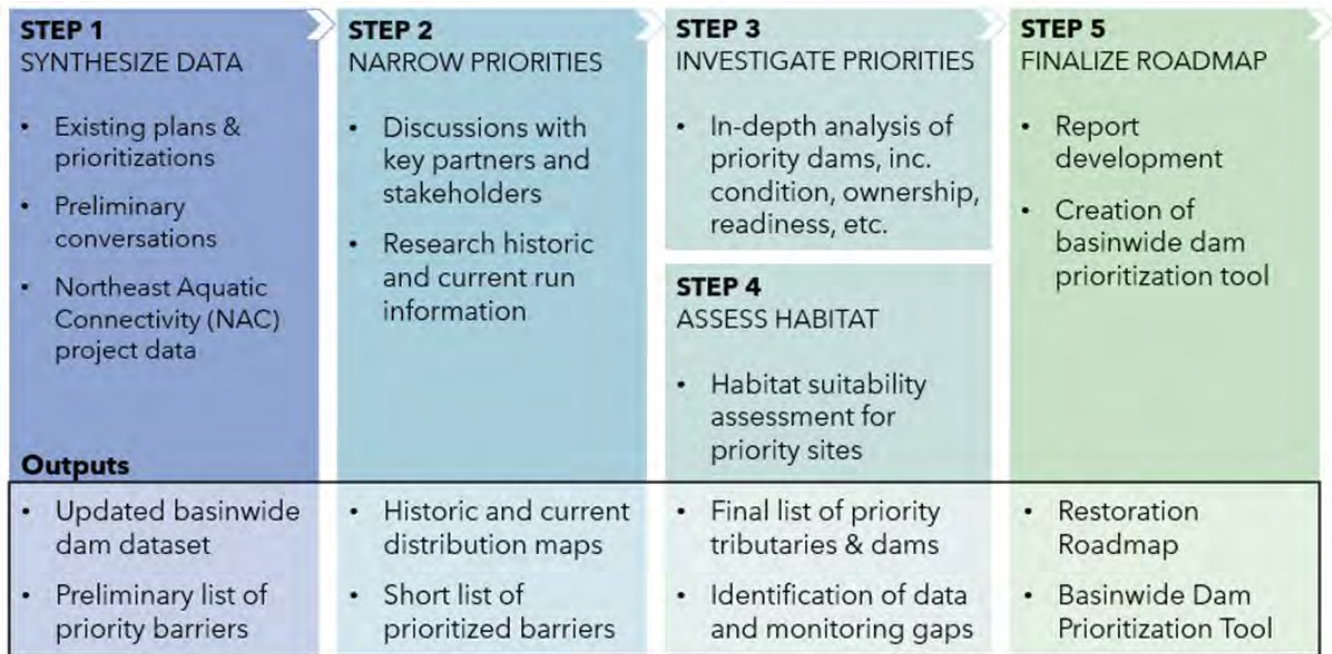
Figure 4-1. Restoration Roadmap process diagram.

During Step 2, numerous one-on-one and small group discussions were held with key partners and stakeholders to further understand on-the-ground conditions and current species distribution throughout the watershed. This included state and federal agency officials, academic fishery experts, local watershed practitioners, and community members advancing aquatic connectivity efforts. Information on historical runs was also collected from historic fisheries reports, historic narratives, and previous assessments and then mapped with current distribution to view key barriers to upstream migration. The preliminary list of priority sites was then assessed against known historical and current runs of shad and river herring in the basin to further refine priorities. Feedback was solicited

In Step 3, priority barriers were investigated in-depth to better understand on-the-ground conditions and feasibility of options for improving connectivity at these sites. This involved discussions with partners, review of previous assessments and reports, and site visits to ascertain opportunities and challenges associated with each of the structures. Special attention was paid to engineering constraints, such as the existence of nearby infrastructure, stream gages, and as possible, the extent of legacy sediment behind the dam, permitting challenges associated with cultural resources and rare species, and existing uses, such as water supply or recreation. In some instances, site visits also helped to determine that certain structures were passable by alosines in typical spring flow conditions and did not constitute a barrier to passage. For instance, two barriers within the Crosswicks Creek watershed were deemed to be passable and therefore this system was removed from the final priority list (Figure 4-2). When feasible, meetings with dam owners also occurred to understand project feasibility and readiness for barrier removal or alternative fish passage options. Through this process and the concurrent habitat suitability assessment described below, the final list of priority tributaries and associated dams was developed for inclusion in the roadmap.

The final step was to develop the Restoration Roadmap, which consolidates information gathered in the previous steps and highlights key actions needed to address priority barriers for the restoration of alosines in the Delaware River Basin. This includes recommendations on funding needs, opportunity, potential for phasing projects, and key partners and stakeholders. Alongside the report is a Delaware River Basin Fish Passage Prioritization tool developed in ArcGIS Online that uses an updated basinwide dams dataset and includes information on fishways and barrier permeability (Figure 4-3). Users can customize an ecological benefits assessment using 12 pre-set aquatic connectivity and landscape-scale metrics determined to be most relevant to shad and river herring, as well as explore the known historic and current run information for these species and the priorities identified in the Restoration Roadmap.

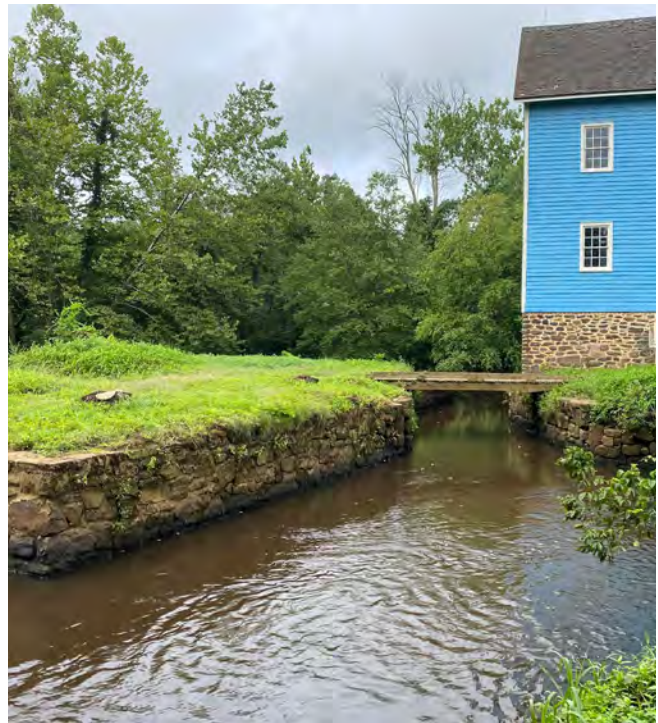
Figure 4-2. Walnford Dam on Crosswicks Creek. A side channel beside the historic gristmill was determined to allow for sufficient fish passage during a site visit. Credit: Lyndon DeSalvo/TNC.

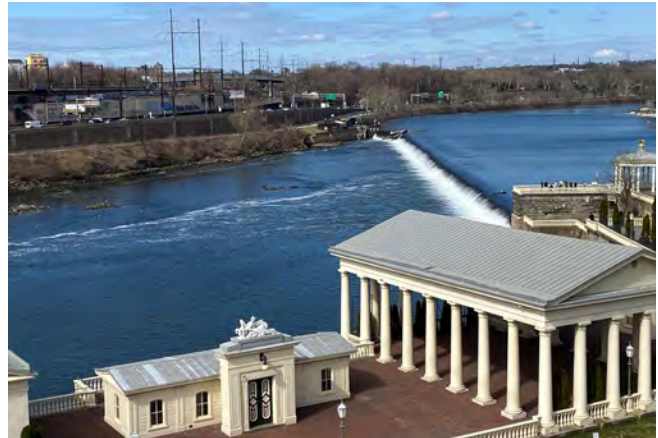
Fairmount Dam. Credit: Lyndon DeSalvo/TNC.

The Fairmount Dam fish ladder, initially installed in the 1970s, underwent major renovation in 2008 and the new vertical slot fish ladder has the capacity to pass 200,000 to 250,000 shad yearly, according to USFWS, but reaching these numbers would require a significant increase in the overall Delaware River basin shad population. Between 2009 and 2018, approximately 1,500 shad have been observed passing annually, a significant improvement over the few shad that passed prior to the renovation, but still far below expectations. The Philadelphia Water Department maintains and monitors the fishway and has noted several significant issues currently effecting alosine passage. In addition to depressed basinwide populations, lower than expected passage counts at the Fairmount fish ladder are likely due to issues with the attraction flow, turbulence between pools and at the observation window, and observed predation at the entrance and within the fishway. As of December 2021, the fish ladder was still inoperable due to damages caused by flooding during Tropical Storm Ida and may not be operable for the 2022 season.

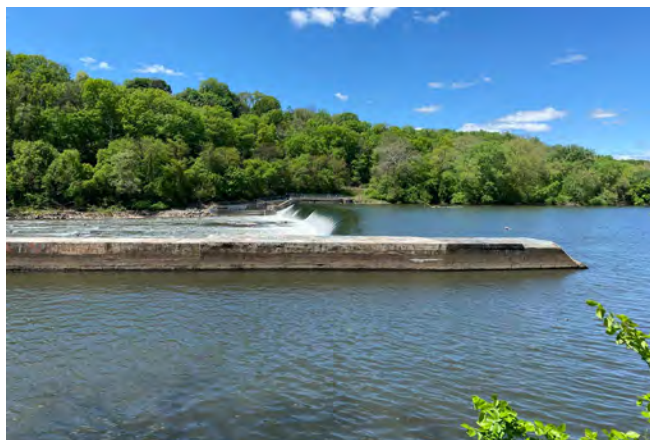
Flat Rock Dam. Credit: Lyndon DeSalvo/TNC.

When PFBC documented American Shad at the Flat Rock Dam in 2002, it was the first time the species had been observed above Fairmount Dam since its construction in 1820. As a result, a vertical slot fishway with observation window was added on the west side of the dam, though monitoring has never occurred here. Due to its historic inclusion in the Schuylkill River Project, PA DEP's Bureau of Abandoned Mine Reclamation (BAMR) is the owner of the dam; however, BAMR is currently only able to provide minimal maintenance and repairs to the fishway. Due to this and challenges caused by the placement and design of the fishway, it is largely considered to be ineffective at passing American Shad and river herring.

FLAT ROCK DAM (Dam #2) was originally completed in 1818 by the Schuylkill Navigation Company to water a two-mile section of the Schuylkill canal system in Manayunk, now a neighborhood in Philadelphia. The Philadelphia Water Department, which owns the canal and locks,

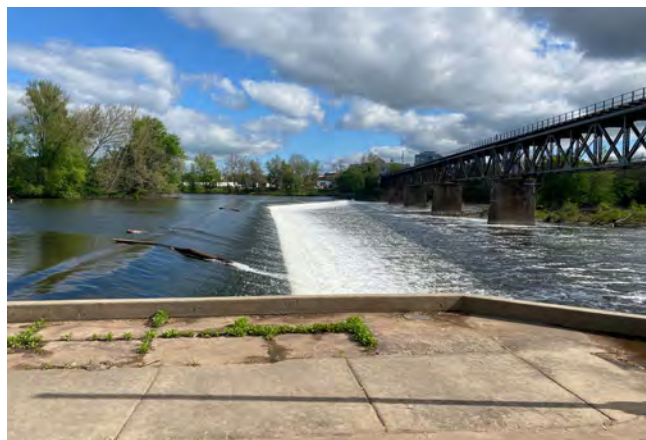
Norristown (Swede St) Dam. Credit: Lyndon DeSalvo/TNC.

subsidiary of Exelon—took ownership of the dam to support its generating station on Barbadoes Island, located just upstream. Sections of the dam were rebuilt in the 1980s and 1990s following a breach and, in 1993, PECO transferred ownership of the dam to Montgomery County following the decommissioning of the Barbadoes Generating Station. Dam removal was considered by PECO at the time of ownership, but Montgomery County residents were adamant about preserving upstream recreation in the five-mile impoundment at the time. A Denil-style fishway with observation window was added to the south side of the dam in 2008, but monitoring has never occurred here, and any maintenance is likely intermittent. The expansive 900-foot-wide dam is known to create a problem for fish to find and utilize the fishway and a USFWS engineer noted debris buildup and technical issues with the fishway during a 2017 site visit.

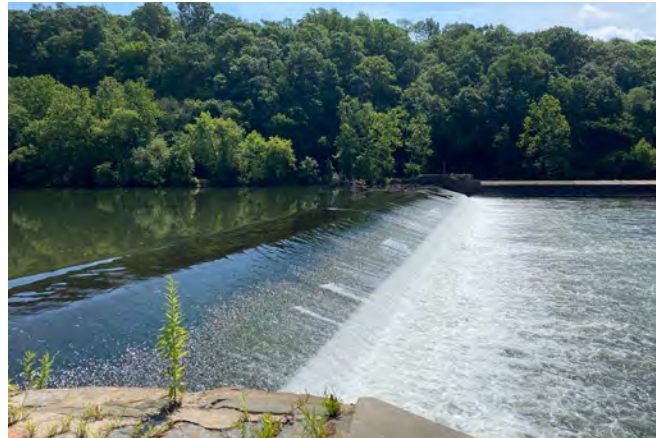
Black Rock Dam. Credit: Lyndon DeSalvo/TNC.

BLACK ROCK DAM (Dam #4) was originally constructed in 1822 to water a section of the Schuylkill Navigation Canal between locks #60 and #61. The present dam was built in 1840, replacing the original, and still retains its rock-filled timber crib structure underneath a concrete cap that was added in the 1960s. In recent decades, the dam also supplied a water source to the Cromby Generating Station, a recently retired coal-fired power plant located upstream within the 2.9-mile-long impoundment. In the last few years, ownership of the generating station and the dam has transferred from Exelon to a developer that may not require the dam for water supply purposes. The restored section of canal is a popular recreational area with private residences located along its length. In 2017, a family of four boating down the Schuylkill were trapped in the turbulent waters at the bottom of the dam and required rescue.

A Denil-type fishway was added to the dam in 2008 with an observation window and video monitoring that allowed for fish passage counts from 2011 to

2016, which included a total of 11 American Shad and no documented river herring during this period. PFBC also noted that American Shad were present during June electrofishing in the next downstream pool below the dam.

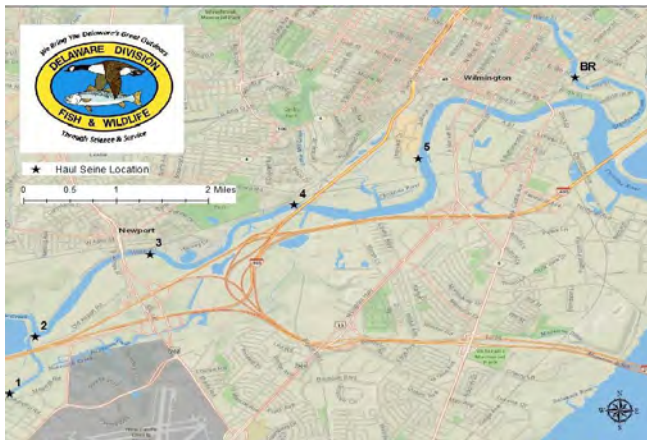
Figure 4-7. Christina River haul seine site locations. Credit: DNREC.

DNREC performs annual sampling using a deep haul seine at five locations in the Christina River and one location in Brandywine Creek each summer to determine a juvenile abundance index (JAI) for shad and river herring in the Christina watershed (Figure 4-7; Park 2020). The four species targeted during

DNREC performs annual sampling using a deep haul seine at five locations in the Christina River and one location in Brandywine Creek each summer to determine a juvenile abundance index (JAI) for shad and river herring in the Christina watershed (Figure 4-7). The four species targeted during this effort include American Shad, Hickory Shad, Alewife, and Blueback Herring. Site 2 is located at the confluence of the Christina River and White Clay Creek and is often the most productive (Park and Stangl 2020). Unfortunately, electrofishing for

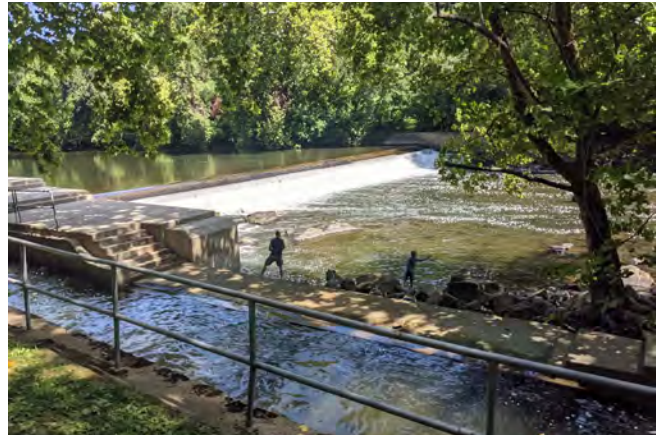
Broom Street Dam. Credit: Brandywine Shad 2020.

BROOM STREET DAM (Dam #2) is owned by the City of Wilmington and is critical to the city's water supply, as the dam maintains a sufficient water level in the creek to support raw water intake upstream and via the adjacent mill race. Though not historic, the dam is located within the Brandywine Park and Kentmere Park Historic District and the original structure and raceway date back to 1762. An antique fish ladder was added to the dam in the 1960s to support anadromous fish restoration efforts, but it is ineffective, and the concrete dam currently is a complete barrier to migration. Following the removal of Dam #1 in 2019, the area below Dam #2 was sampled in the summer of 2020 using a seine and 160 juvenile and 8 adult American Shad were collected, demonstrating multiple life stages were utilizing the newly available habitat (Hale 2020). Due to its current use the dam is not being considered for removal. Brandywine Shad 2020 and partners are currently assessing alternative fish passage options—including a rock ramp or bypass—having received a 2021 NFWF grant to develop engineering and design.

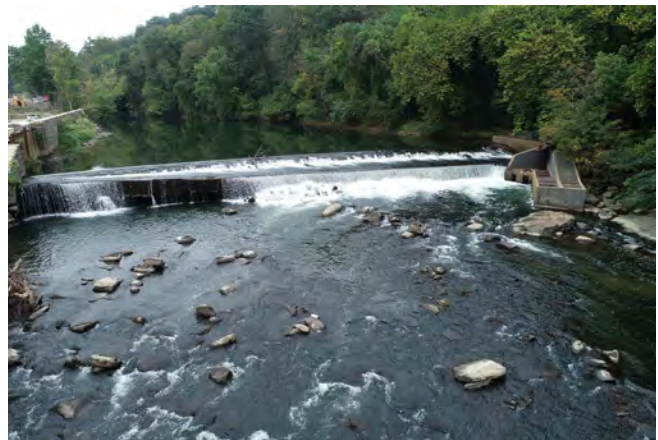
Alapocas Run Dam. Credit: Brandywine Shad 2020.

ALAPOCAS RUN DAM (Dam #4) is owned by the Delaware Department of Natural Resources and Environmental Control (DNREC) and is adjacent to Alapocas Run Park and Bancroft Mills. The concrete dam was historically used for water supply, but currently has no known use and there is a cavity in the center of the structure. Brandywine Shad 2020 received funding from NFWF in 2021 to remove the dam, which is estimated at a cost of approximately \$400,000, and has already filed the required state and federal permits.

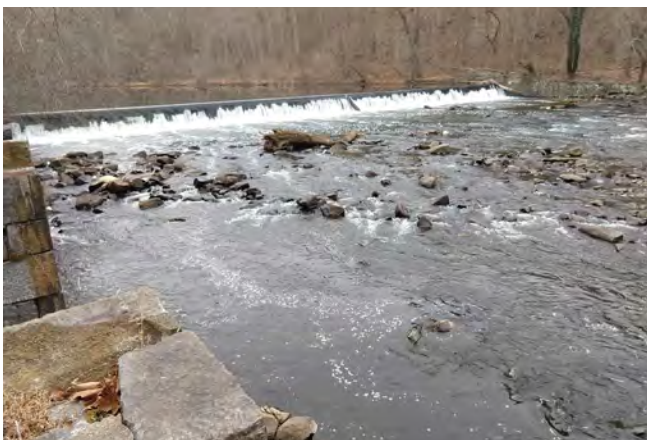
Lower Hagley Dam. Credit: Brandywine Shad 2020.

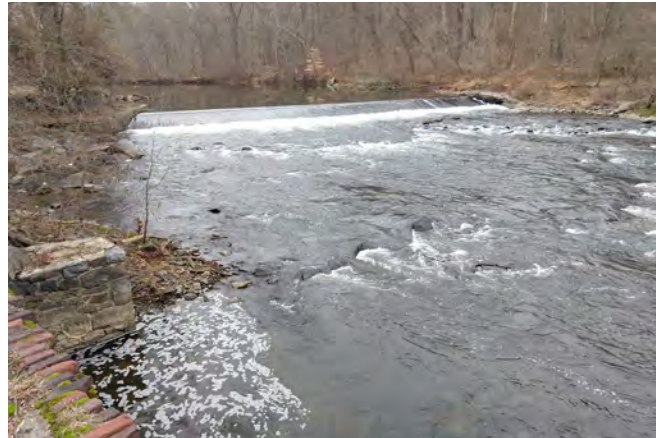
ELEUTHERIAN DAM (Dam #10) is a historic dam owned by the Hagley Museum and located within the Eleutherian Mills Historic District, recognized as a National Historic Landmark Area. The original dam was likely built around 1800 and was critical to the du Pont family's production of gun powder throughout the nineteenth and early twentieth centuries. The structure has a timber spillway and was reconstructed within the past 15 years by Duffield Associates at a cost of \$1,000,000 to the museum. There is a millrace on the western side of the creek and a channel on the eastern side and flow through these structures is supported by the dam.

Eleutherian Dam. Credit: Brandywine Shad 2020.

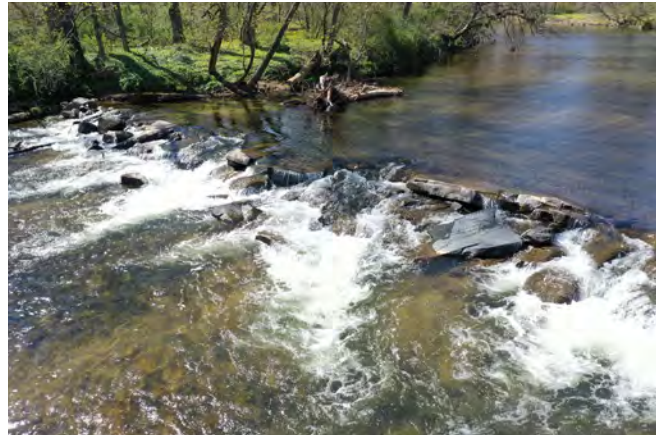
RED MILL DAM (Dam #2) is currently the first barrier on the White Clay Creek given that the former Byrnes Mill Dam (Dam #1) was notched in 2014 to allow migratory fish passage. A dam has likely existed at this location for nearly 300 years as the dam was originally constructed to provide water to a raceway for Red Mill (a former gristmill) situated 60 feet upstream that is listed in the National Register of Historic Places. The current structure is a rockfill dam that is failing at several points and leading to severe downstream bank erosion and areas of upstream sediment deposition (Narvaez et al. 2010). The University of Delaware's Water Resources Agency received NFWF funding in 2019 to remove the dam, which is currently in process and should be completed by 2022. However, since the removal of Dam #1 on the White Clay, alosines have yet to be confirmed below the Red Mill Dam despite several monitoring efforts and it is suspected that sediment build up in the lower section of the creek near Dam #1 may be prohibiting passage upstream to the site.

Red Mill Dam. Credit: Jason Fischel.

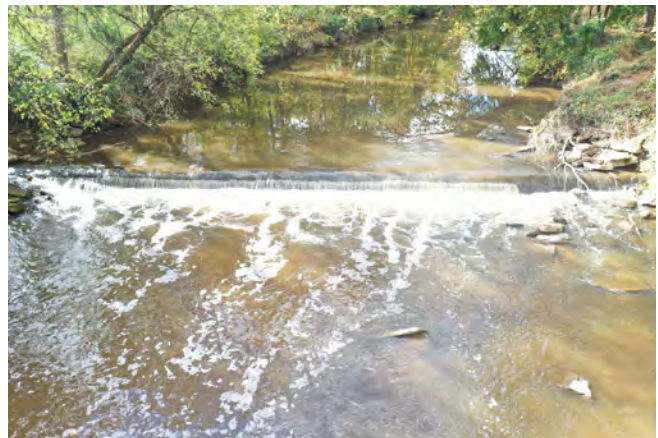
Karpinski Park Dam. Credit: Jason Fischel.

KARPINSKI PARK DAM (Dam #3) is formed by a City of Newark sanitary sewer line that is approximately 18 to 20 inches in diameter and encased in concrete. The sewer main has eroded on the downstream side and the City is considering alternative replacement options, such as a sewer siphon or reburying the sewer below the streambed, that would remove the in-stream barrier to fish passage. The dam is easily accessible as it is located immediately adjacent to City of Newark parkland on both banks.

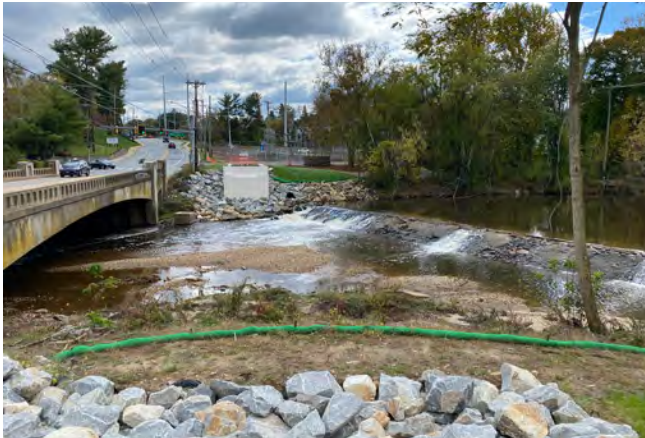
Paper Mill Dam. Credit: Jason Fischel.

PAPER MILL DAM (Dam #4) is a concrete structure formerly associated with the National Vulcanized Fibre (NVF) company. Although the dam no longer serves its original purpose, it does function as a hydraulic control for a USGS gage station (White Clay Creek at Newark - 01478650) and is used to verify minimum flow requirements from the upstream Newark Intake Dam (Dam #5) as SUEZ North America has first rights of withdrawal at river mile 0.6 where they employ an inflatable dam. The dam is in poor condition and is anticipated for removal in 2022 following the placement of an adjacent pedestrian bridge and the re-gaging of the stream by USGS. New Castle Conservation District is managing the restoration project and has received funding from NFWF and the City of Newark.

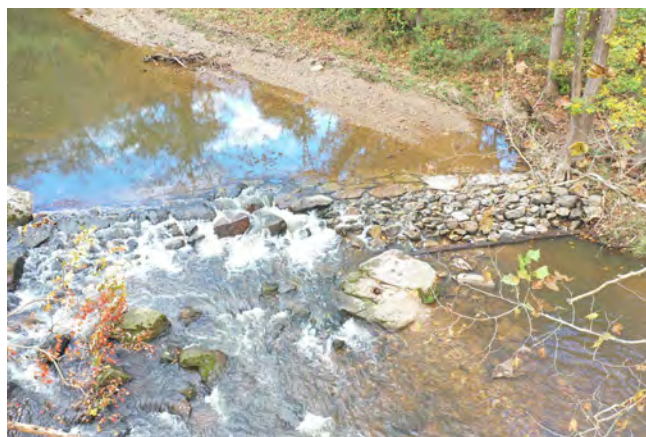
WHITE CLAY CREEK PRESERVE DAM (Dam #8) is the most upstream barrier on the White Clay before it splits into its Middle and West branches and is located within the White Clay Creek Preserve in Pennsylvania. The land that now forms the preserve and contiguous White Clay Creek State Park in Delaware was donated by the DuPont Company in 1984, which originally acquired the land to dam the White Clay Creek and form a reservoir—an idea that never came to fruition. The rockfill dam at this site is breached on its southern side but may still present a challenge to fish passage. Pennsylvania DCNR, which owns the dam, has indicated its intentions to remove the structure and included this in a list of 14 dams across the state that are part of a design/build contract.

White Clay Creek Preserve Dam. Credit: Jason Fischel.

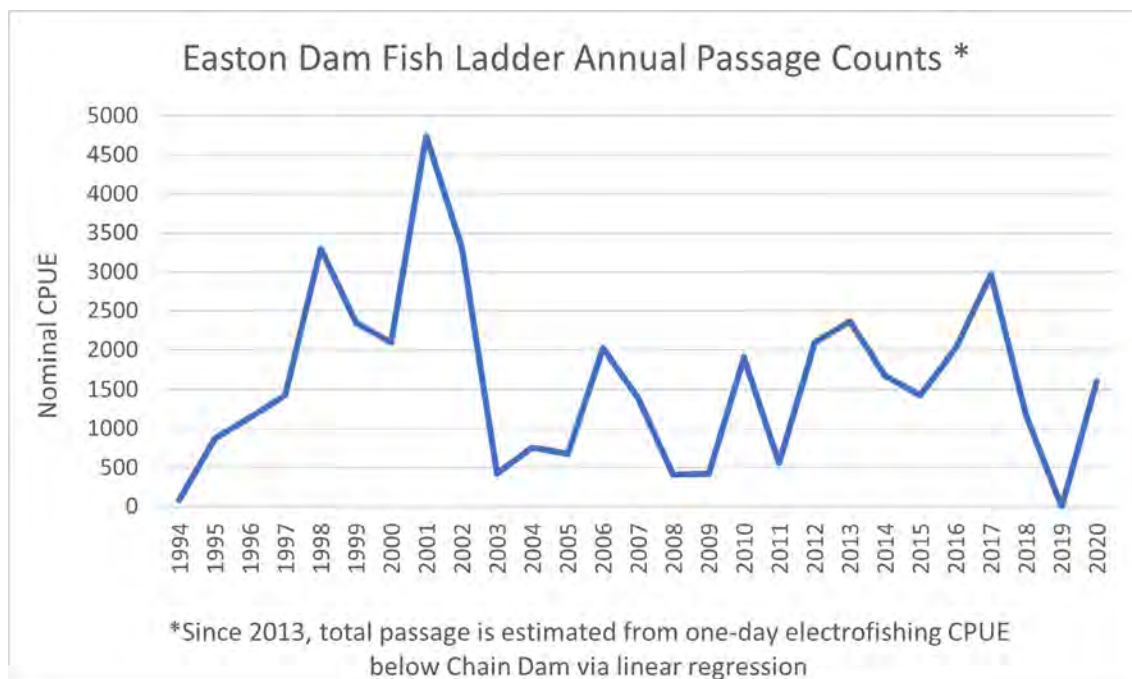
Figure 4-12. Easton Dam Fish Ladder Annual Passage Counts and Estimates. Since 2013, total passage at Easton is estimated from one-day electrofishing CPUE below Chain Dam via linear regression. Data source: PFBC.

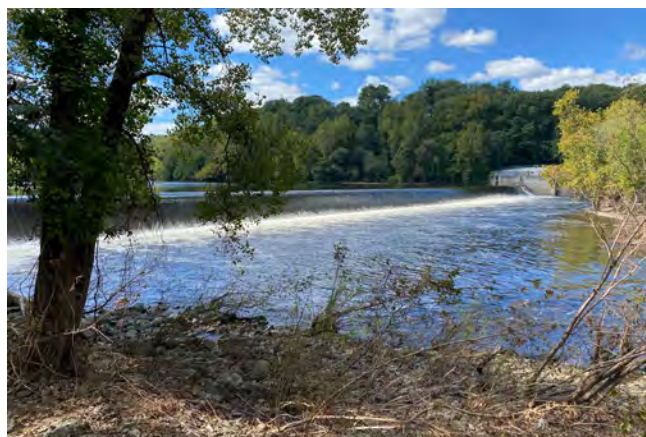
CHAIN DAM (Dam #2)—also referred to as the Glendon Dam—is located three miles upstream of the Easton Dam and was constructed around the same time to water the most downstream segment of the Lehigh Canal system. In 1965, an ice floe along the Lehigh River caused the original Chain Dam to breach and it was eventually reconstructed in 1974. The former dam was located approximately 160' upstream of the current structure and its remnants have not been fully removed from the riverbed. Today, the dam still waters over two miles of a fully restored section of the Lehigh Canal, included in the National Historic Register, and cultural offerings within the City of Easton's Hugh Moore Park, including the National Canal Museum and mule-powered boat rides along the canal, celebrate this history. While the dam is officially owned by PADEP, the agency has a binding agreement with the City of Easton and would need the city's buy-in as well as legislative support to entertain removal.

The vertical slot technical fishway was added to the dam in 1994 and is located on the north side of the river. PFBC fish passage counts from 1995 to 2012 at Easton and Chain Dams demonstrated approximately a 25% passage efficiency at Chain, with an average of 500 shad passing annually over the 15-year period. Today, the fishway is no longer monitored though DCNR staff are responsible for maintenance and operation of the fishway. Located just downstream of the dam, Palmer Pool is known to support American Shad spawning while significant sediment builds up just upstream contributes to poor water quality and proliferation of aquatic invasives, such as Eurasian watermilfoil. The 2013 feasibility study determined that full dam removal was the only viable option to significantly improve fish passage at Easton Dam; however, the City of Easton did not support removal at the time. Current efforts are underway to develop an Operations & Maintenance Plan and improve the functioning of the technical fishway.

Chain Dam. Credit: Lyndon DeSalvo/TNC.

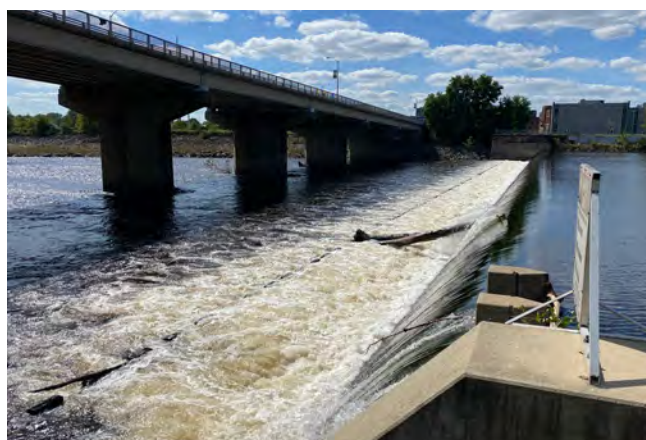
Hamilton Street Dam. Credit: Lyndon DeSalvo/TNC.

HAMILTON STREET DAM (Dam #3) is in Allentown, Pa. and was originally constructed circa 1830 to feed a section of the Lehigh Coal and Navigation Canal. In 1984, the dam was reconstructed following a breach caused by ice floes in 1977 and a vertical slot fishway was added to the eastern side, beside the canal entrance. Ownership of the dam transferred to the City of Allentown at this time, though the municipality only recently realized it owned the structure and, as of 2020, has just begun to set aside annual funds towards maintenance. The impoundment created by the dam extends approximately 3.5 miles upstream and the Lehigh County Authority does have drinking water intakes located here, though the primary water source for the City of Allentown is the Little Lehigh Creek and two springs, with the Lehigh River serving

While American Shad have been recorded upstream of the Hamilton Street fishway, it is not consistently maintained and passes fish in relatively small numbers. The fishway does not have an observation window for monitoring purposes and no fish passage counts have been recorded here. During a 2021 site visit, the fishway was found to be dewatered and in relatively poor condition.

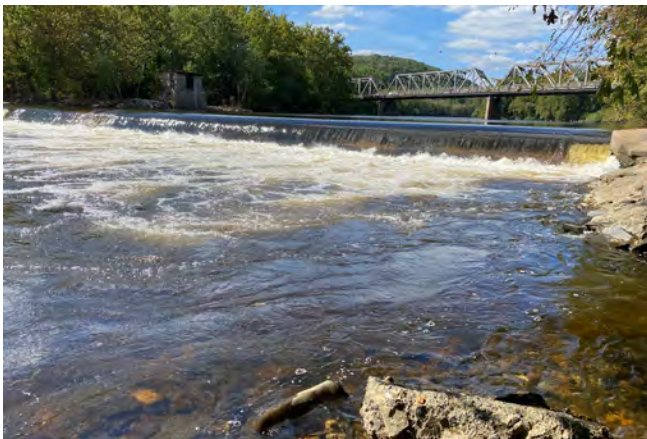
Northampton Dam. Credit: Lyndon DeSalvo/TNC.

NORTHAMPTON DAM (Dam #4), also referred to as the Cementon Dam, was constructed in 1927 and creates an impoundment extending approximately one mile upstream. The section of river above Cementon is greatly impacted by abandoned mine drainage due to inputs from several tributaries—including Sandy Run, Buck Mountain Creek, Black Creek, and Nesquehoning Creek—some of which are still devoid of fish. The adjacent Lafarge Holcim cement manufacturing plant currently relies on the dam for its water supply and determined that groundwater alone would not be capable of providing sufficient water for its daily operations. The Northampton Borough Municipal Authority (NMBA) Water Treatment Plant is also located upstream of the dam and may rely on the impoundment for its intake.

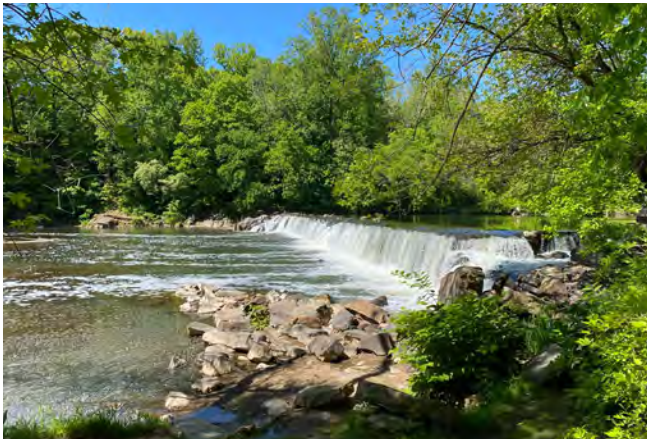
Hulmeville Park Dam. Credit: Lyndon DeSalvo/TNC.

HULMEVILLE PARK DAM (Dam #1) is a rockfill dam constructed at a natural pinch point in the Neshaminy that utilizes natural rock outcroppings on its southern portion. A dam has likely existed in this section of river for over 300 years as the Hulmeville, Pa. website mentions a plaster-mill that was built prior to 1725 near the current Hulmeville Rd/Route 513 bridge just downstream that prevented the historic shad run. PFBC and local fishermen have documented American Shad and River Herring at the base of the dam, which does not allow for fish passage, and in the lower tidal section of the Neshaminy, considered a nursery for Alosines. The neighboring Neshaminy Shore Picnic Park utilizes the upstream impoundment for recreational boating.

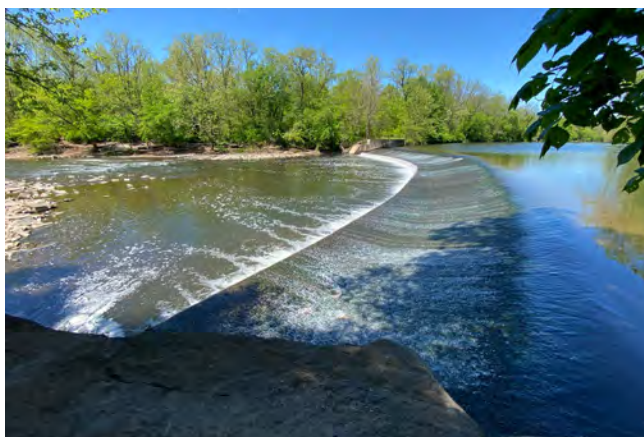
SPRING GARDEN DAM (Dam #3) is an arch-shaped, concrete dam located within Tyler State Park that does not currently allow for fish passage. The dam was likely originally connected to the Spring Garden Mill located just downstream near the Route 332 bridge, though it has since been rebuilt. Currently, the impoundment formed by the dam supports recreational boating in Tyler State Park; however, PA DCNR, the owner of the dam, considers it a liability due to unauthorized swimming at the location and is currently seeking funds for removal.

Spring Garden Dam. Credit: Lyndon DeSalvo/TNC.

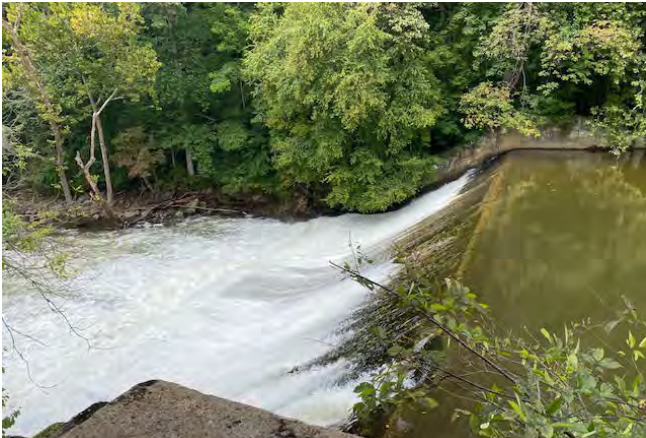
Warren Mill Dam. Credit: Musconetcong Watershed Association.

WARREN MILL DAM (Dam #4), also known as the Warren Glen Dam, is the lowest remaining barrier to migratory fish passage on the Musconetcong River following the removal of three downstream dams in the last decade. Built in 1916, the 37.5-foot High Hazard Class I Dam is vulnerable to a “Sunny Day” breach with four known leaks and poses a significant hazard to downstream residents and property. The dam is co-owned by International Process Plants and Equipment (IPPE) and the New Jersey Division of Fish and Wildlife, with both owners supportive of removal efforts. The major challenge to removal is the estimated cost at \$20 million due in large part to the sediment impounded behind the dam, which may exceed 300,000 cubic yards (USACE 2019).

The Musconetcong Watershed Association, NJDEP, USFWS, and others are currently in the process of completing necessary design and engineering studies to move the project forward. With the Warren Mill Dam removed, the NJ Field Office of the US Fish & Wildlife Service indicates that a total of 8 stream miles and 100 acres of migratory fish habitat will have been restored in the Lower Musconetcong River watershed, and resiliency to extreme weather events will improve for downstream residents and employers by eliminating the risk of flooding and property damage from failure of a High Hazard dam (MWA 2021).

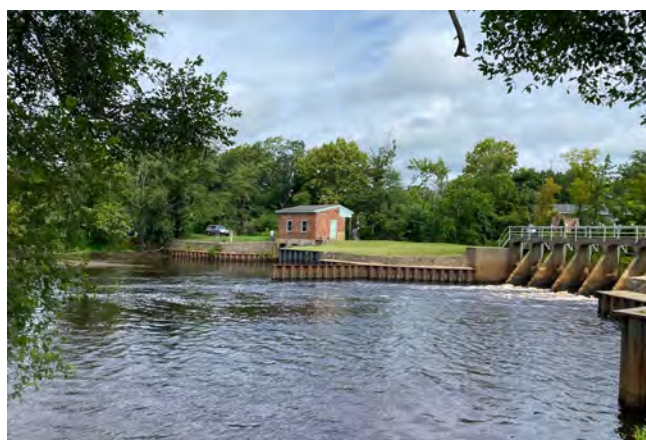
Mill Dam. Credit: Lyndon DeSalvo/TNC.

MILL DAM (North Branch Dam #1) is the first downstream barrier on the North Branch Rancocas Creek and currently does not allow fish passage. In the 1990s, USFWS and USACE specifically looked at the possibility of dam removal or added fish passage at the Mill Dam, which is owned by the

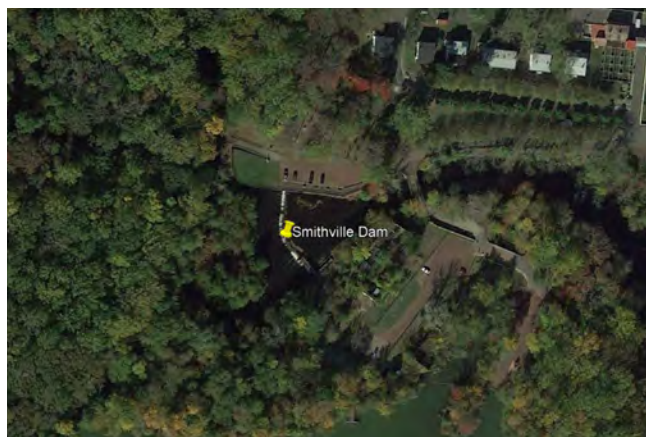
Smithville Dam. Credit: Google Earth.

SMITHVILLE DAM (North Branch Dam #2) is a 10-foot-high structure with timber cribbing that is owned by Burlington County and classified as a High-Hazard dam. The original structure was built around 1780, with significant repairs made since, the most recent in 1980. The dam is located within the Historic Smithville Park and Mansion property and is listed with local significance in the National Register of Historic Places (Ref #77000856). In a 2004 report by the Interagency Waterway Infrastructure Improvement Task Force, the Smithville Dam was listed as the only major flood control structure on the North Branch of the Rancocas. The dam currently has a steppass fish ladder; however, passage efficiency is unknown and requires further study.

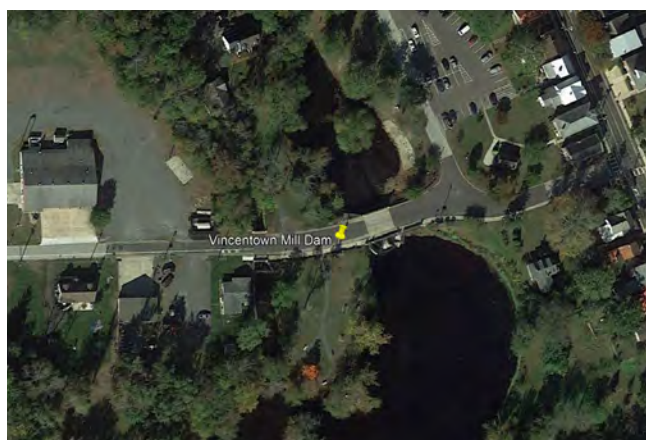
Vincentown Mill Dam. Credit: Google Earth.

VINCENTOWN MILL DAM (South Branch Dam #1) is the first downstream barrier on the South Branch Rancocas Creek and owned by the Township of Southampton. Originally built in 1891, the dam was replaced in 2005 following damage during a July 2004 storm event that caused severe flooding and dam failures in several local watersheds. The High-Hazard dam was reconstructed to include a steppass fish ladder; however, passage efficiency is unknown and requires further study. The structure is located within the Vincentown Historic District and is listed with local significance in the National Register of Historic Places (Ref #87002107).

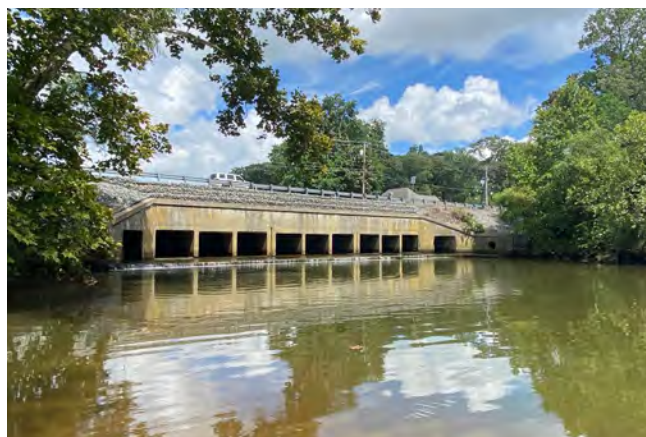
Sunset Lake Dam. Credit: Lyndon DeSalvo/TNC.

SUNSET LAKE DAM (Dam #1) and the associated raceway were repaired in 2015 following severe damage during a 2012 storm that breached the dam and drained the 94-acre lake. A dam has likely existed at this site since approximately 1815, when the Cumberland Nail & Ironworks built a mill on this site and the impounded lake quickly became a popular recreational spot, with the Tumbling Dam Amusement Park established here in the 1890s. Today, Sunset Lake is still popular for recreation, including boating and largemouth bass fishing, and dam removal is extremely unlikely especially considering the recent reconstruction. In 1997, PSE&G added an Alaskan steep pass fish ladder to the dam, and this has historically been very successful in passing Alewife and Blueback Herring (ASFMC 2017). It is recommended that passage

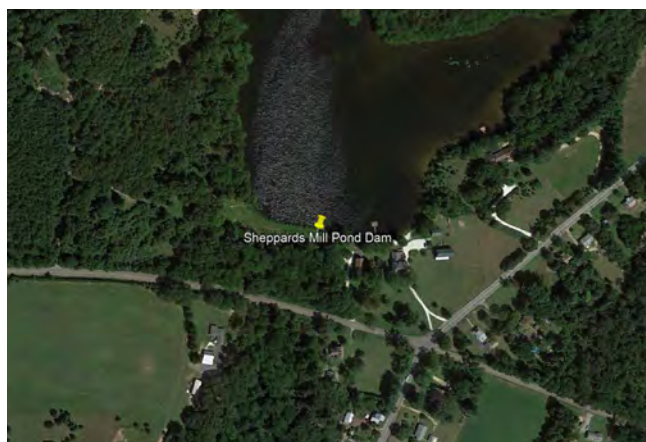
Sheppards Mill Pond Dam. Credit: Google Earth.

SHEPPARDS MILL POND DAM (Mill Creek Dam #1) is located along the Mill Creek tributary to the Cohansey. The original structure was constructed in 1885 and is currently owned by the New Jersey Division of Fish & Wildlife. In 1978, river herring were confirmed at this dam and the later construction of a culvert allowed tidal fluctuations upstream of the site as well as some movement of diadromous fish. However, a recent storm breached the culvert, which was replaced with a structure that currently restricts fish passage and tidal flow.

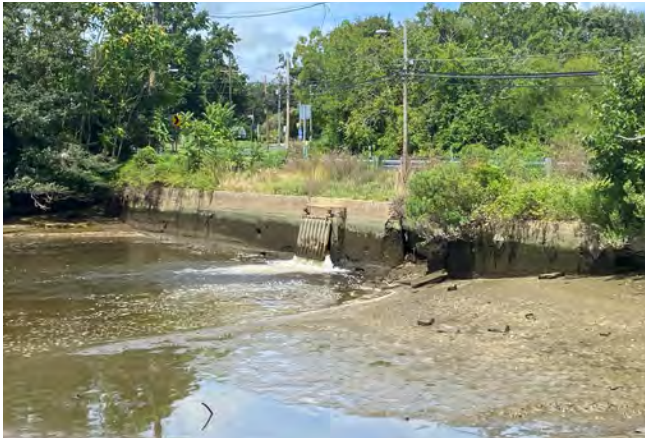
Clarks Pond Dam #1. Credit: Lyndon DeSalvo/TNC.

CLARKS POND DAM 1 (Clarks Pond Dam #1) is the first of three barriers on the Mill Creek tributary that passes through the Clarks Pond Fish and Wildlife Management Area. In 1978, river herring were confirmed at this site by Zich during his statewide anadromous fish inventory (Zich 1978). Currently, the downstream dam and pond closest to the Cohansey River is privately owned and does not provide any fish passage. The structure is integrated with Bridgeton Fairton Rd and prevents tidal influence upstream.
