Delaware River Basin

Restoration Roadmap

for American Shad, Alewife, and Blueback Herring

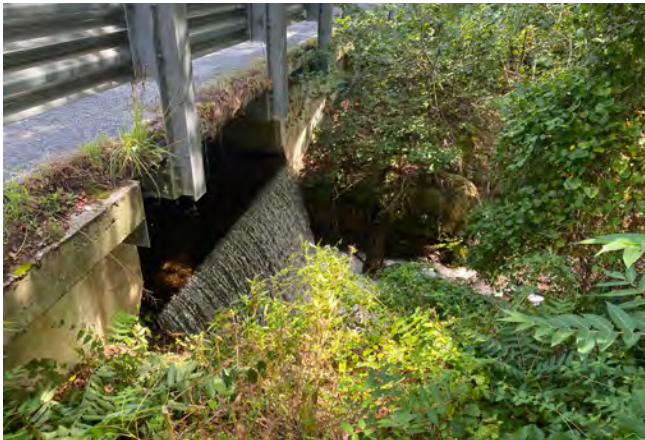
Clarks Pond Dam #2. Credit: Lyndon DeSalvo/TNC

CLARKS POND DAM 2 (Clarks Pond Dam #2) is owned by the New Jersey Division of Fish and Wildlife and is located within the Clarks Pond Fish and Wildlife Management Area. The dam is integrated into Clarks Pond Road and currently does not allow for fish passage.

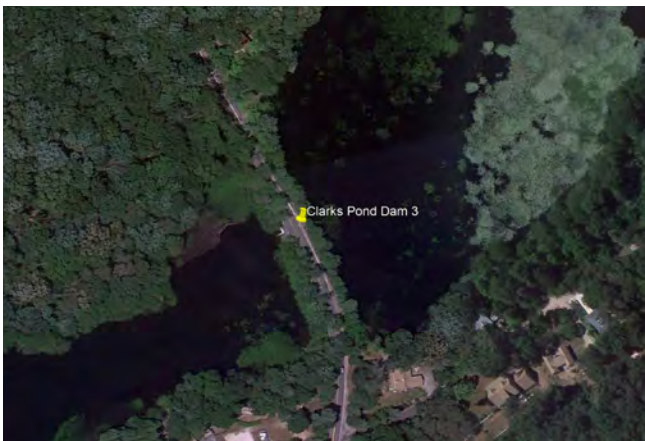
Clarks Pond Dam #3. Credit: Google Earth.

CLARKS POND DAM 3 (Clarks Pond Dam #3) is owned by the New Jersey Division of Fish and Wildlife and is located within the Clarks Pond Fish and Wildlife Management Area. The dam is integrated into Burlington Road and currently does not allow for fish passage.

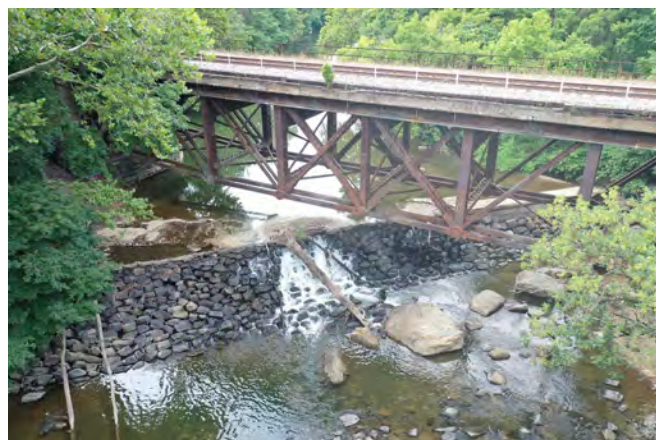
currently 12 dams on the Red Clay Creek, but many of these are already breached or owned by the State of Delaware, so opportunity for removal may be high. Dam #1 likely presents the biggest obstacle to removal given it is located immediately underneath a CSX railway bridge and therefore should be the principle focus during the feasibility study.

Red Clay Dam #1. Credit: Jason Fischel.

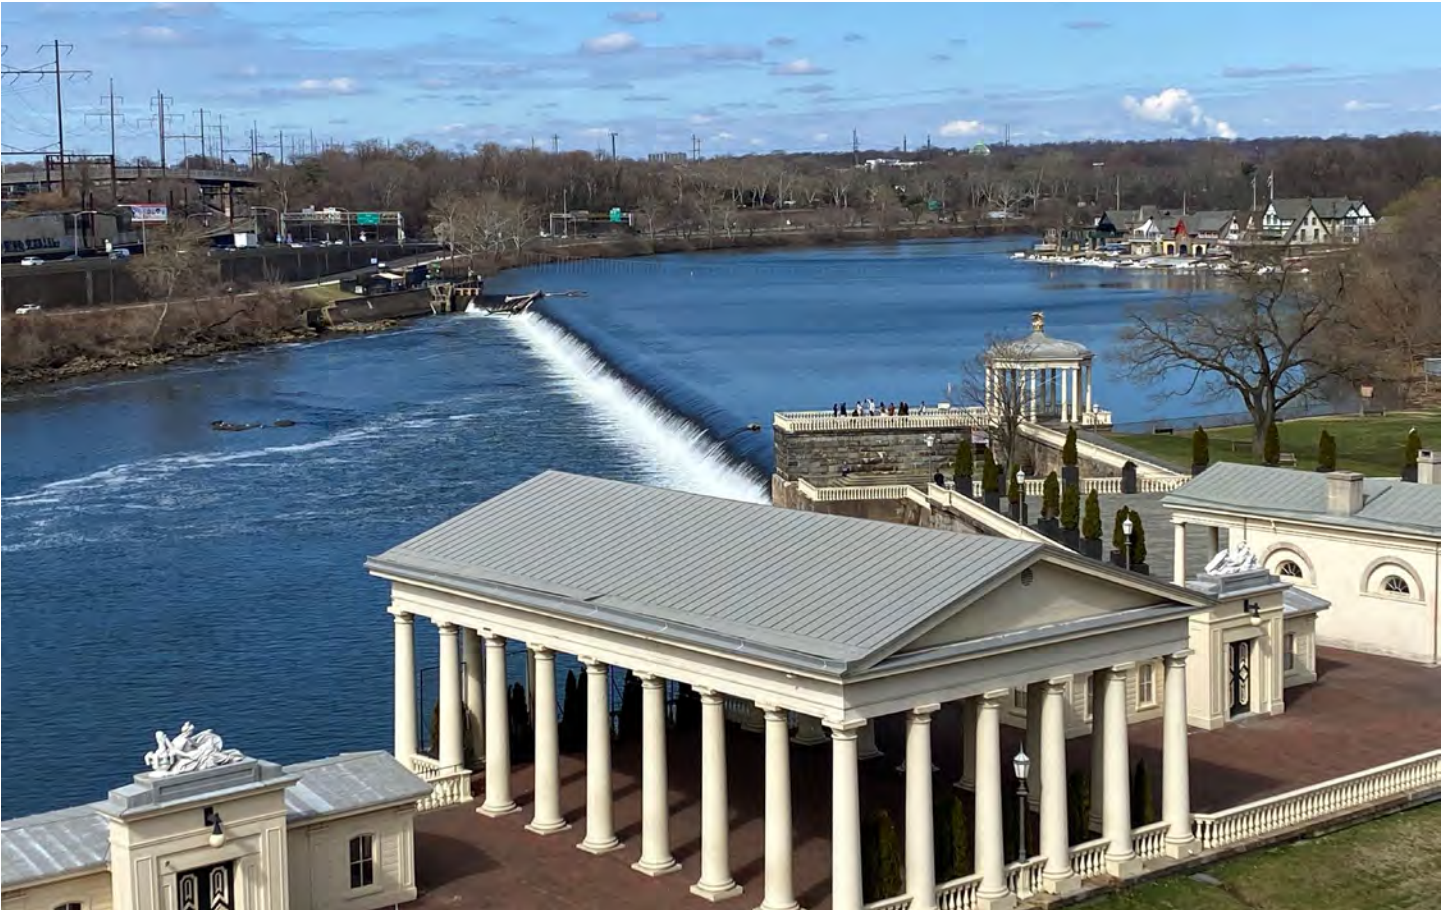
Fairmount Dam. Credit: Lyndon DeSalvo/TNC.

Key Uses	Provides impoundment for 2 drinking water intakes at Queen Lane and Belmont for PWD, dam prevents tidal fluctuation upstream and potential for saltwater intrusion.
CONSTRUCTION & CONDITION	
Year Completed	1820 (original), 1927
Barrier Type	Low-head dam
Material	Concrete
Height (ft)	31.5 (10.5' crest elevation)
Length (ft)	1,204
Capacity (ac-ft)	3,683
Condition	Satisfactory
Hazard Class (Last Inspection)	Significant (3/4/2019)
Adjacent Infrastructure	<i>Bridges</i> (10): Spring Garden St, MLK Jr. Dr, Girard Ave/US-13, Pennsylvania Railroad, Connecting Railway Bridge, Columbia Railroad Bridge/CSX, Strawberry Mansion Bridge, Philadelphia and Reading Railroad, Bridge at West Falls/CSX, Falls Rail Bridge/CSX, Twin Bridges/US-1, Falls Bridge, City Ave Bridge; <i>Utilities</i> : Numerous stormwater outfalls; <i>Other</i> : USGS gage (01474500)
Sediment	Sediment build-up in Schuylkill Rowing Basin spurred 2020 dredging project, but only 5% complete as of summer 2021. Plans to remove 60,000 cubic yards of sediment.

AQUATIC CONNECTIVITY & FISH PASSAGE	
Fish Passage	Vertical slot fishway
Diadromous Fish	American Shad, Alewife, Blueback Herring, Hickory Shad, American Eel, Sea Lamprey, Striped Bass, White Perch
Aquatic Federal T & E Species	None
Next Upstream Barrier	Flat Rock Dam (PA_PA00896)
Next Downstream Barrier	None
SITE CONSIDERATIONS	
<i>Recreation</i> - Rowing with Boathouse Row an iconic location for university boathouses. Dam is also part of city aesthetics and cultural history of Fairmount Park founding.

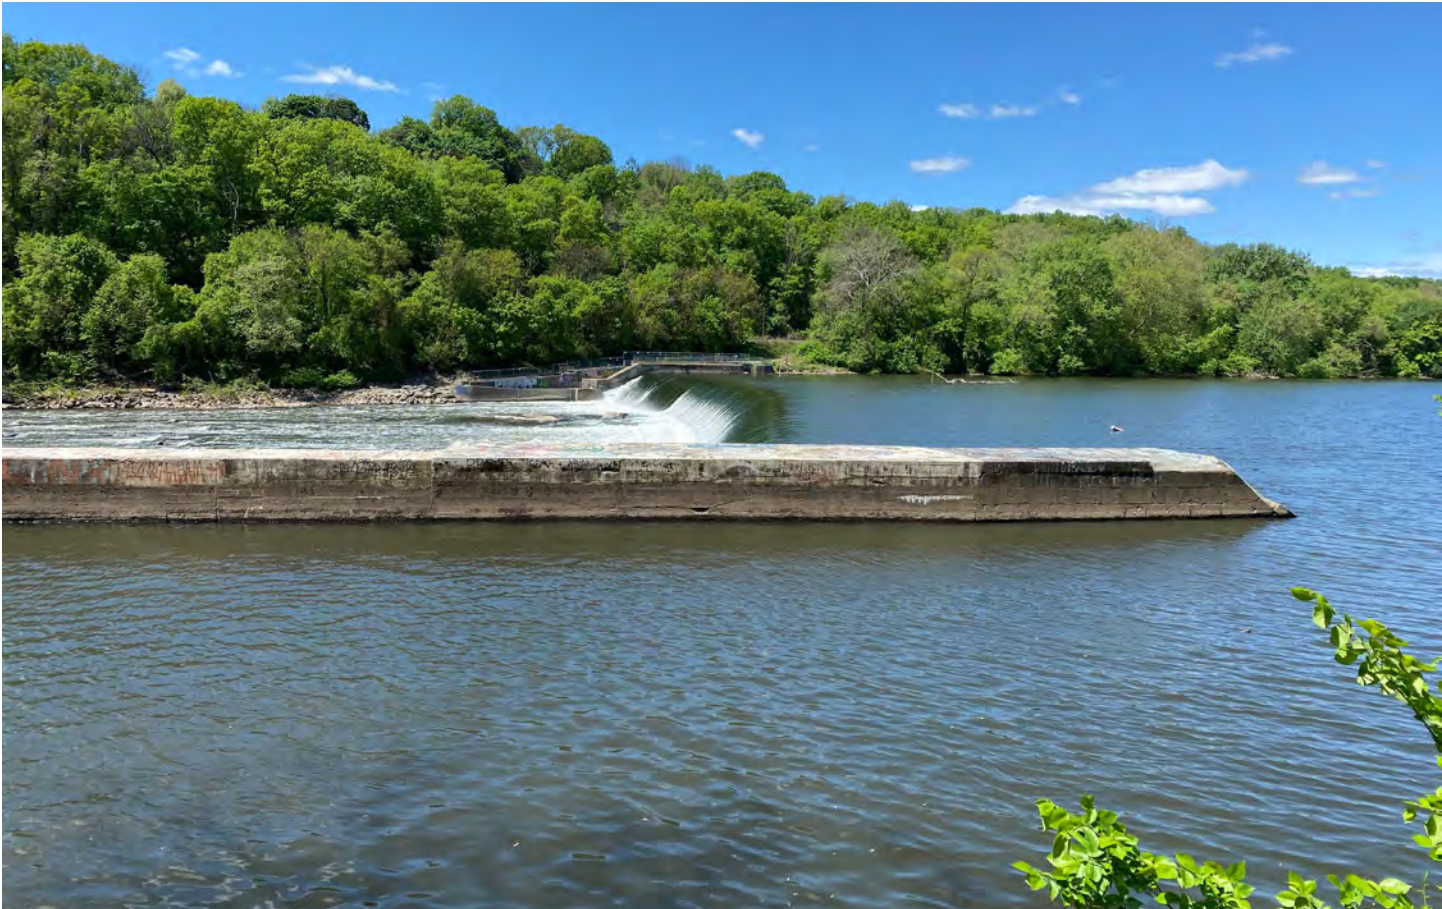
Flat Rock Dam. Credit: Lyndon DeSalvo/TNC.

Dam Name	Flat Rock Dam
Unique ID	PA_PA00896
LOCATION & HYDROGRAPHY	
Coordinates (Lat, Lon)	40.038333, -75.246667
Address (access)	Flat Rock Park, 122 River Rd, Gladwyne, PA 19035
Town	Philadelphia
County	Philadelphia
State	PA
River/Stream	Schuylkill River
River Mile	15.6
HUC-12	Plymouth Creek-Schuylkill River (020402031007)
Dam Drainage (sq mi)	1,809
CURRENT USE & OWNERSHIP	
Owner Name	PA DEP - Bureau of Abandoned Mine Reclamation (BAMR)
Public/Private	Public
Primary Purpose	Recreation
Relevant Neighboring Properties	PaperWorks Industries, Apex Apartments
Historic Designation	Dam feeds the Manayunk Canal and is the northern boundary of historic district. <ul style="list-style-type: none"> Manayunk Main Street Historic District (NRHP Ref # 83002274)
Key Uses	Upstream rowing in impoundment. Dam also waters Manayunk Canal.
CONSTRUCTION & CONDITION	
Year Completed	1818 (original); 1977
Barrier Type	Low-head dam
Material	Concrete

Height (ft)	21
Length (ft)	520
Capacity (ac-ft)	1,500
Condition	Fair
Hazard Class (Last Inspection)	Low (11/9/17)
Adjacent Infrastructure	<i>Bridges:</i> Fayette Street Bridge, Pearl Harbor Memorial Bridge/US-476, Upper Merion & Plymouth Rail Bridge; <i>Utilities:</i> Numerous stormwater outfalls; <i>Other:</i> Manayunk Canal, USGS Gage (01473800)
Sediment	Unknown
AQUATIC CONNECTIVITY & FISH PASSAGE	
Fish Passage	Vertical slot fishway
Diadromous Fish	American Shad, Alewife, Blueback Herring, Hickory Shad, American Eel, Sea Lamprey, Striped Bass, White Perch
Aquatic Federal T & E Species	None
Next Upstream Barrier	Norristown (Swede St) Dam (PA_46-001)
Next Downstream Barrier	Fairmount Dam (PA_51-002)
SITE CONSIDERATIONS	
<p><i>Canal</i> - Planned \$14-16 million investment in canal and lock restoration by PWD. <i>Recreation</i> - Basin formed by dam used for upstream rowing in Conshohocken. Campaign to build a boathouse at Flat Rock Park by some in Lower Merion, but significant opposition from nearby neighbors. <i>Energy</i> - Philadelphia Energy Authority has considered potential for hydropower in canal.</p>

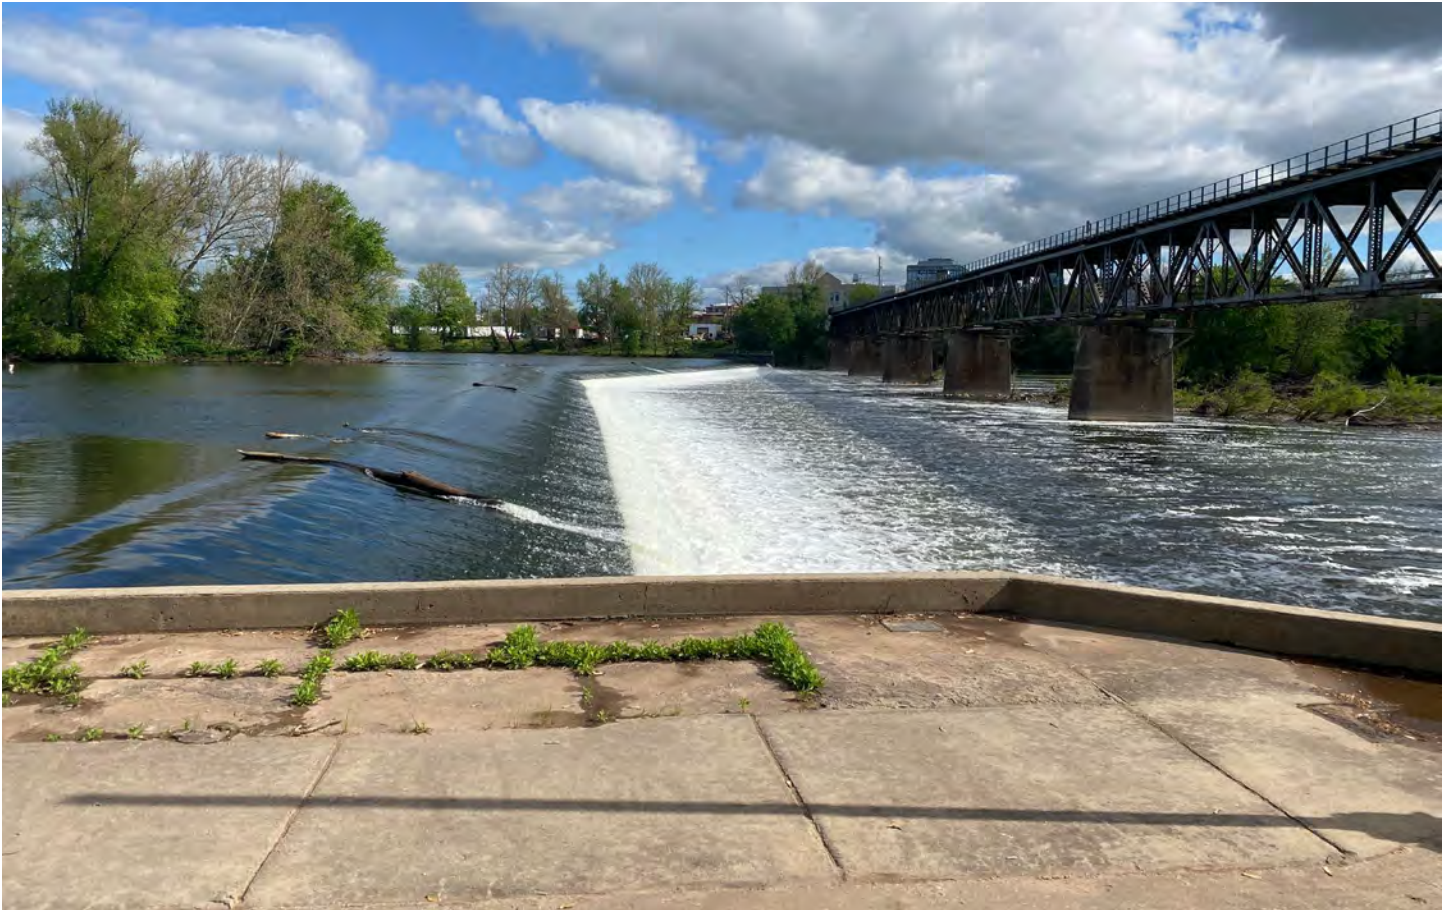
Norristown Dam. Credit: Lyndon DeSalvo/TNC.

Dam Name	Norristown (Swede Street) Dam
Unique ID	PA_46-001
LOCATION & HYDROGRAPHY	
Coordinates (Lat, Lon)	40.1104939, -75.3473831
Address (access)	Norristown Fish Passage, 300-318 Merion St, Bridgeport, PA 19405
Town	King of Prussia
County	Montgomery
State	PA
River/Stream	Schuylkill River
River Mile	24.2
HUC-12	Plymouth Creek-Schuylkill River (020402031007)
Dam Drainage (sq mi)	1,765
CURRENT USE & OWNERSHIP	
Owner Name	Montgomery County, Parks & Heritage Services
Public/Private	Public
Primary Purpose	Water Supply (public); Recreation
Relevant Neighboring Properties	Upper Merion Boat Club, Montgomery County – Barbadoes Island, SEPTA
Historic Designation	N/A
Key Uses	Rowing in impoundment.
CONSTRUCTION & CONDITION	
Year Completed	1836 (original); 1984 & 1994 (reconstructed sections)
Barrier Type	Low-head dam with a north and south section at slightly different angles that meet obliquely in the middle of the river

Material	Concrete and earthen
Height (ft)	12
Length (ft)	900
Capacity (ac-ft)	2,355
Condition	Satisfactory
Hazard Class (Last Inspection)	Low (6/6/2018)
Adjacent Infrastructure	<i>Bridges:</i> DeKalb Veterans Memorial Bridge/US 202, Bridgeport Bridge/SEPTA, Norfolk Southern Rail Bridge, Dannehower Bridge/US 202, CSX Stony Creek Branch Rail Bridge, Haws Avenue Bridge, Schuylkill River Crossing Complex/US 422, Sullivan’s Bridge/PA 363; <i>Utilities:</i> Pennsylvania American Water Intake and Treatment Plant; <i>Other:</i> USGS gage (01473500)
Sediment	Unknown
AQUATIC CONNECTIVITY & FISH PASSAGE	
Fish Passage	Denil fishway
Diadromous Fish	American Shad, Alewife, Blueback Herring, American Eel, Sea Lamprey
Aquatic Federal T & E Species	None
Next Upstream Barrier	Black Rock Dam (PA_46_027)
Next Downstream Barrier	Flat Rock Dam (PA_PA00896)
SITE CONSIDERATIONS	
<p><i>Water Supply</i> - Pennsylvania American Water intake located in impoundment. Norristown, PA sources drinking water from Schuylkill. <i>Fishway</i> - The shape and length of the dam create a problem for fish to find and utilize the fishway. <i>Recreation</i> - Upstream slack water is popular for water recreation – dragon boat racing and rowing. <i>Other</i> - Former coal-fired power plant on Barbadoes Island, immediately upstream of the dam</p>

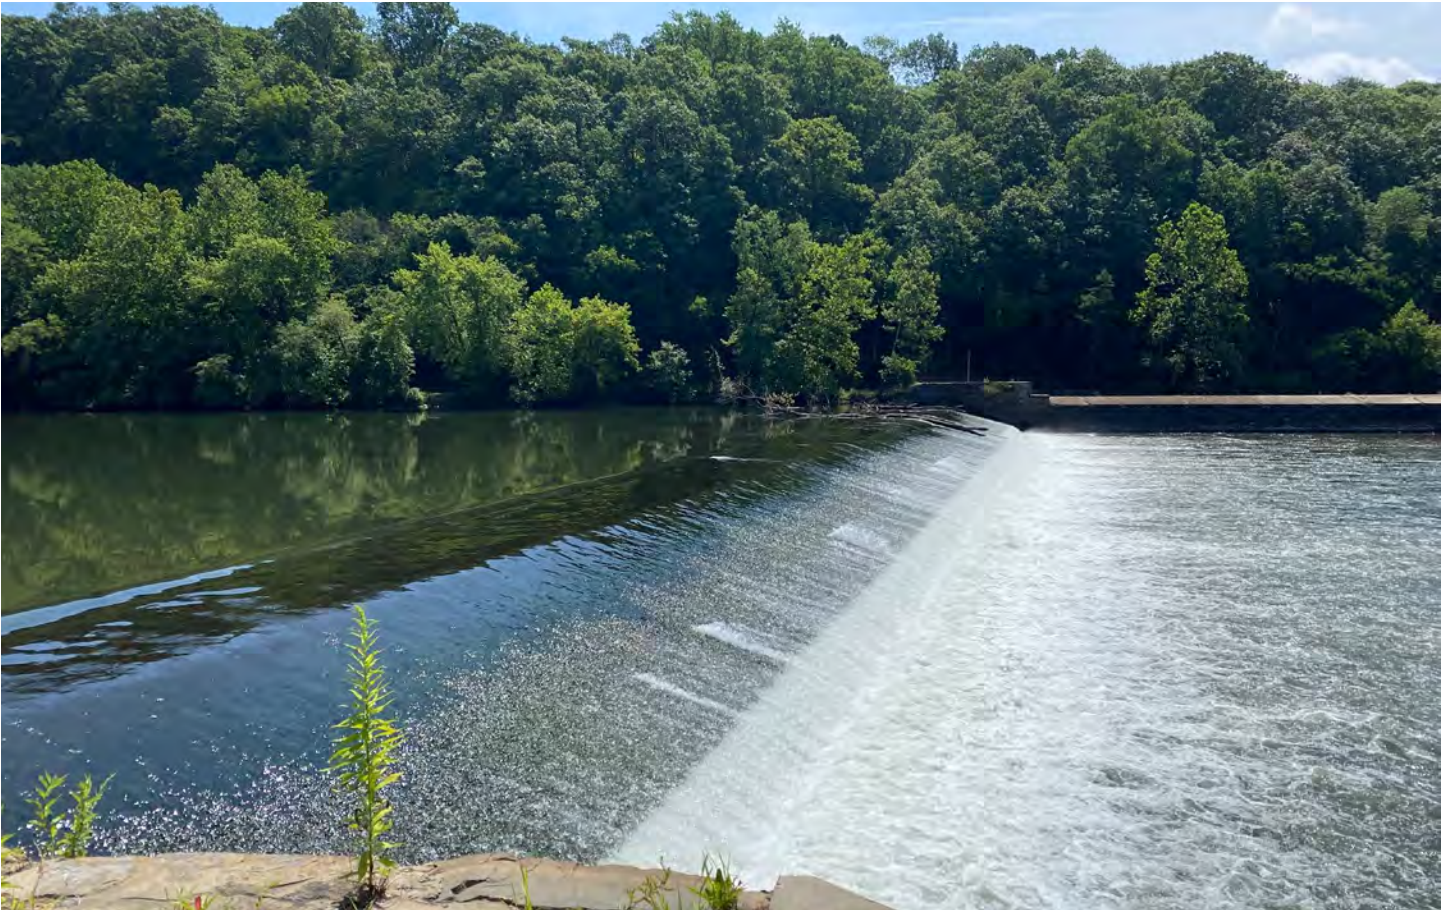
Black Rock Dam. Credit: Lyndon DeSalvo/TNC.

Key Uses	Provides water to canal. Public water supply intake in impoundment.
CONSTRUCTION & CONDITION	
Year Completed	1825 (original); 1840; 1960s
Barrier Type	Low head dam with timber crib
Material	Rock-filled timber crib with concrete cap
Height (ft)	11
Length (ft)	400
Capacity (ac-ft)	221
Condition	Satisfactory
Hazard Class (Last Inspection)	Low (7/27/2018)
Adjacent Infrastructure	<i>Bridges:</i> Black Rock Bridge/PA 113, Black Rock Tunnel Bridge, Cromby and Mingo Rail Bridge; <i>Utilities:</i> Phoenixville Boro Water Plant; <i>Other:</i> Schuylkill Canal and lock system
Sediment	Unknown
AQUATIC CONNECTIVITY & FISH PASSAGE	
Fish Passage	Denil fishway
Diadromous Fish	American Shad, Alewife, Blueback Herring, American Eel, Sea Lamprey
Aquatic Federal T & E Species	None
Next Upstream Barrier	New Kernsville Dam (PA_06-434)
Next Downstream Barrier	Norristown (Swede Street) Dam (PA_46-001)
SITE CONSIDERATIONS

Owner seems interested in possibility of transferring ownership or dam removal. Does not appear to want the upkeep and liability attached to the dam. <i>Risk & Safety</i> - A family of four in a boat was trapped and required rescue on the dam in 2017. <i>Water Supply</i> - Supplied water to former Cromby Generating Station, but likely no longer needed for water supply to new development proposed here. Phoenixville Boro Water Plant is located upstream of dam along impoundment with two intakes.

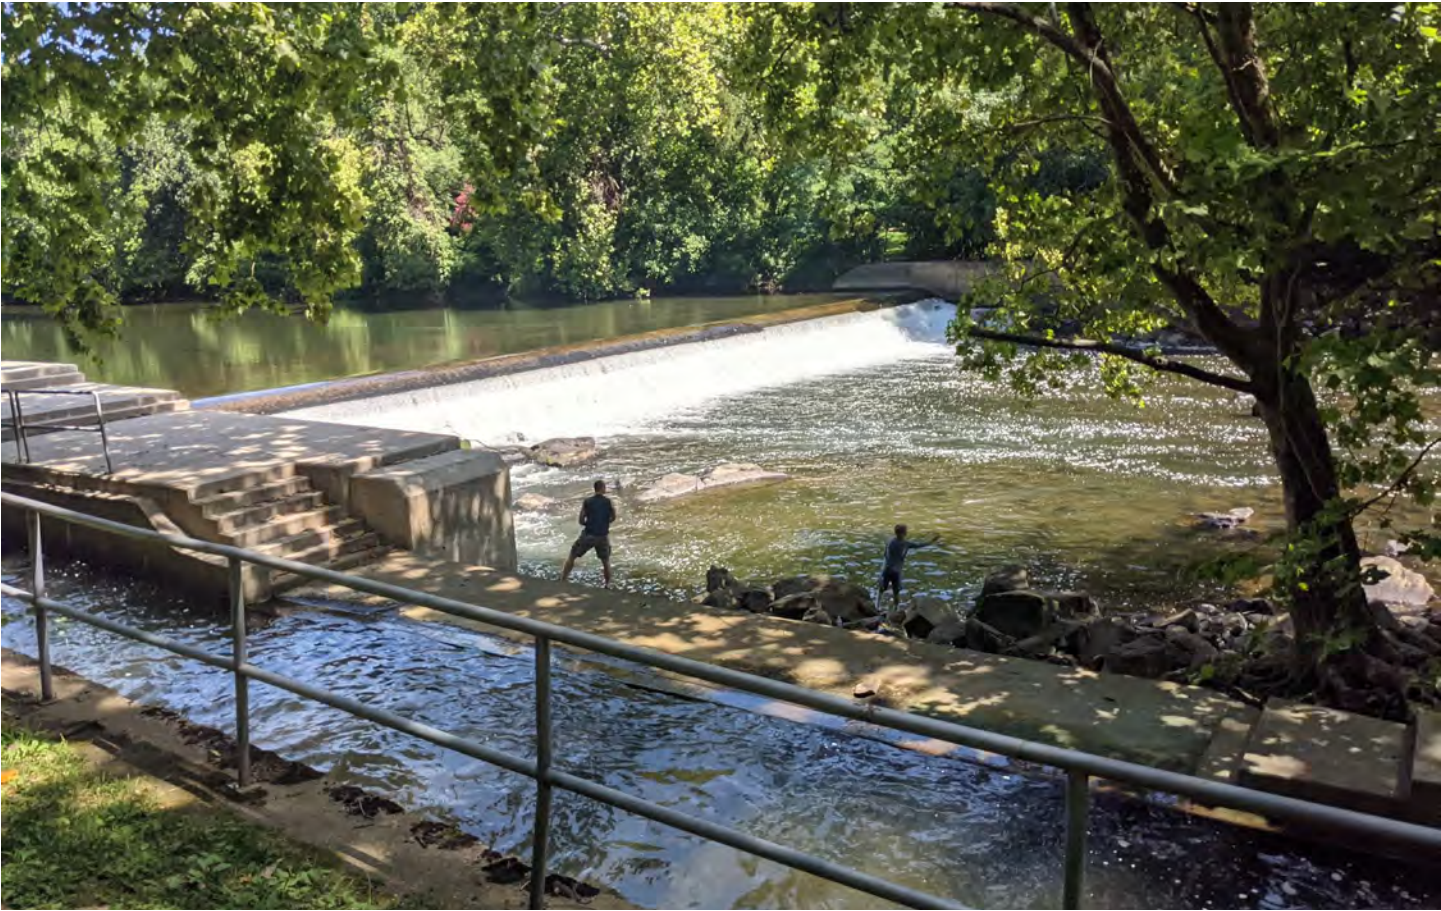
Broom Street Dam. Credit: Brandywine Shad 2020.

Dam Name	Broom Street Dam
Unique ID	DE_13
LOCATION & HYDROGRAPHY	
Coordinates (Lat, Lon)	39.758762, -75.555172
Address (access)	1704 N Park Dr, Wilmington, DE 19806
Town	Wilmington
County	New Castle
State	DE
River/Stream	Brandywine Creek
River Mile	2.9
HUC-12	Lower Brandywine Creek (020402050403)
Dam Drainage (sq mi)	321
CURRENT USE & OWNERSHIP	
Owner Name	City of Wilmington
Public/Private	Public
Primary Purpose	Water Supply
Relevant Neighboring Properties	Brandywine Park
Historic Designation	In historic district, but dam is not listed as historic. <ul style="list-style-type: none"> Brandywine Park and Kentmere Parkway (NRHP # 81000192) - Local
Key Uses	Supplies water for City of Wilmington intake.
CONSTRUCTION & CONDITION	
Year Completed	1762 (original)
Barrier Type	Mill dam
Material	Concrete
Height (ft)	7
Length (ft)	176
Capacity (ac-ft)	Unknown
Condition	Satisfactory
Hazard Class (Last Inspection)	N/A
Adjacent Infrastructure	<i>Bridges:</i> I-95/Rte 202 Bridge; <i>Other:</i> Mill race; <i>Utilities:</i> City of Wilmington water supply intake

Sediment	Estimated sediment accumulation between 9,800-23,300 cubic yards (DNREC-WATAR 2020).
AQUATIC CONNECTIVITY & FISH PASSAGE	
Fish Passage	None
Diadromous Fish	American Shad, Alewife, Blueback Herring, Hickory Shad, American Eel, Sea Lamprey, Striped Bass
Aquatic Federal T & E Species	None
Next Upstream Barrier	Dam #3 (O'Neill)
Next Downstream Barrier	N/A
SITE CONSIDERATIONS	
Dam has a mill race that is necessary intake for City of Wilmington water supply. There is a non-functioning fish ladder at the dam that was installed in the 1990s.

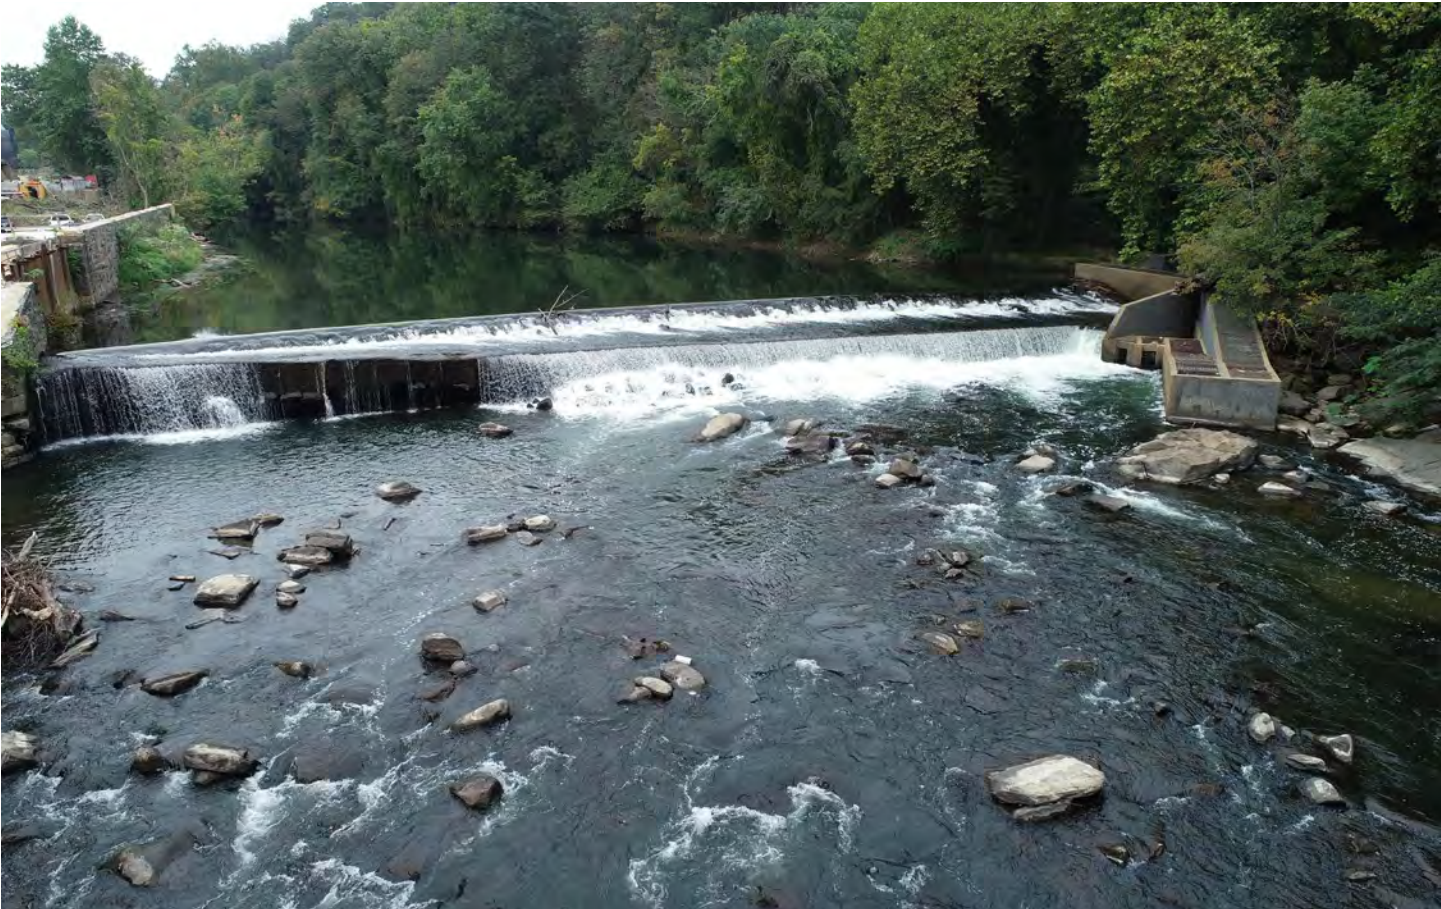
Alapocas Run Park Dam. Credit: Brandywine Shad 2020.

Dam Name	Alapocas Run Park Dam
Unique ID	DE_11
LOCATION & HYDROGRAPHY	
Coordinates (Lat, Lon)	39.768452, -75.559234
Address (access)	100-200 Mill Rd, Wilmington, DE 19806
Town	Wilmington
County	New Castle
State	DE
River/Stream	Brandywine Creek
River Mile	3.6
HUC-12	Lower Brandywine Creek (020402050403)
Dam Drainage (sq mi)	320
CURRENT USE & OWNERSHIP	
Owner Name	DNREC
Public/Private	Public
Primary Purpose	Water supply (historic)
Relevant Neighboring Properties	Alapocas Run Park, Bancroft Mills
Historic Designation	Dam is not historic but within historic district: <ul style="list-style-type: none"> Bancroft and Sons Cotton Mills (NRHP #84000439) - State
Key Uses	None
CONSTRUCTION & CONDITION	
Year Completed	1878
Barrier Type	Mill dam
Material	Concrete
Height (ft)	4
Length (ft)	150
Capacity (ac-ft)	Unknown
Condition	Poor. Center of dam is damaged with cavity.
Hazard Class (Last Inspection)	N/A
Adjacent Infrastructure	Bancroft Mills building

Sediment	Estimated sediment accumulation between 2,600-19,300 cubic yards (DNREC-WATAR 2020). Known former source of PCBs adjacent to Dam #4.
AQUATIC CONNECTIVITY & FISH PASSAGE	
Fish Passage	No
Diadromous Fish	American Shad, Alewife, Blueback Herring, Hickory Shad, American Eel, Sea Lamprey, Striped Bass
Aquatic Federal T & E Species	None
Next Upstream Barrier	Brandywine Falls Dam (DE_10)
Next Downstream Barrier	Dam #3/O'Neill (DE_12)
SITE CONSIDERATIONS	
Alapocas Run enters Brandywine River just downstream of the dam on the eastern side. Known former source of PCBs adjacent to Dam #4. There is a non-functioning fish ladder at the dam that was installed in the 1990s.

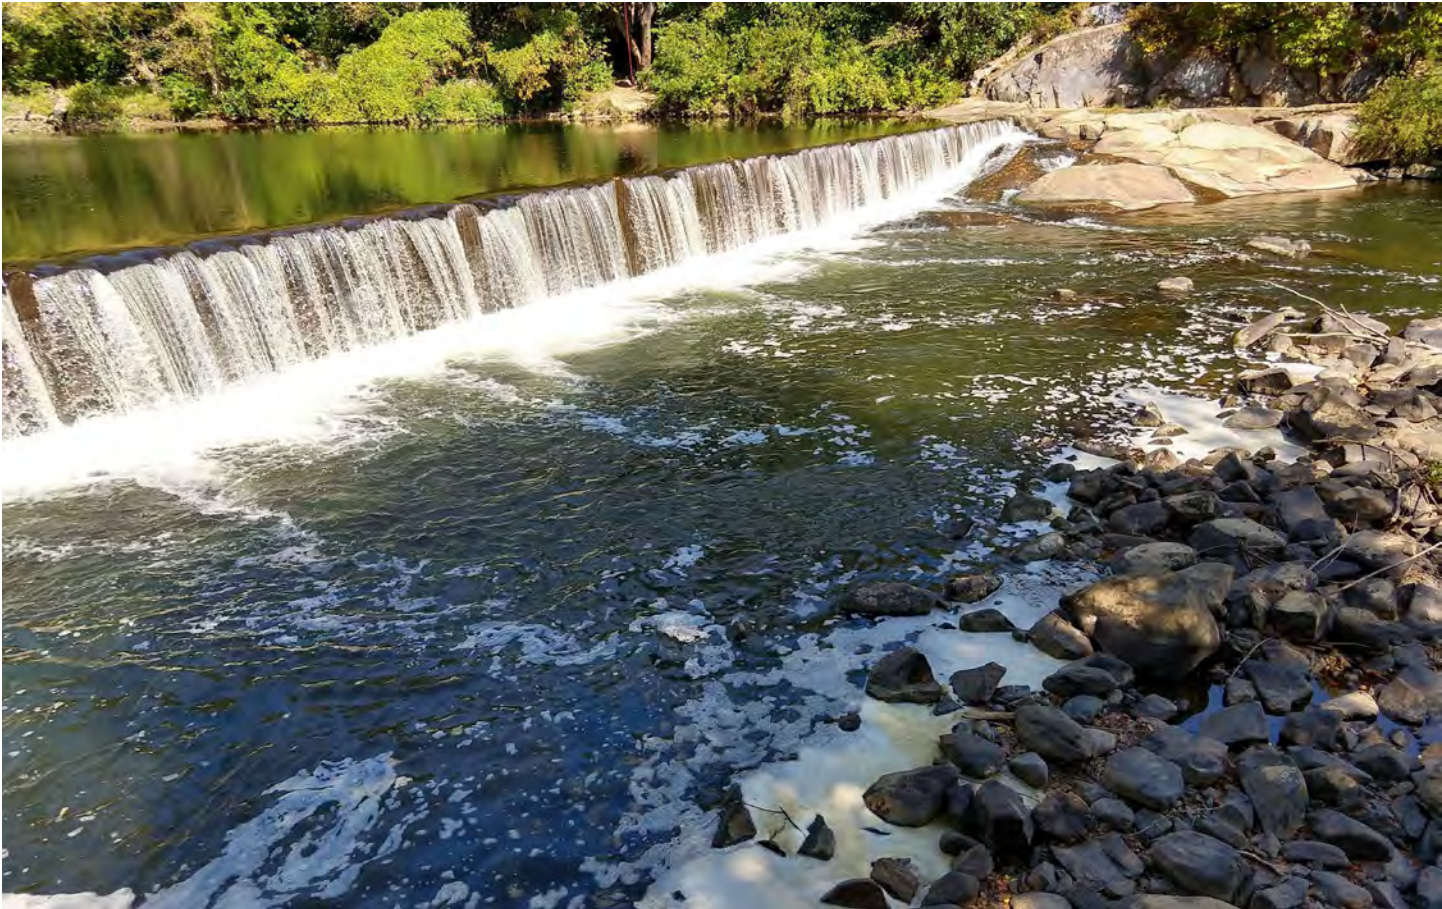
Brandywine Falls Dam. Credit: Brandywine Shad 2020.

Dam Name	Brandywine Falls Dam (aka Rockford Dam)
Unique ID	DE_10
LOCATION & HYDROGRAPHY	
Coordinates (Lat, Lon)	39.770509, -75.569233
Address (access)	35 Brandywine Falls Rd, Wilmington, DE 19806
Town	Wilmington
County	New Castle
State	DE
River/Stream	Brandywine Creek
River Mile	4.2
HUC-12	Lower Brandywine Creek (020402050403)
Dam Drainage (sq mi)	318
CURRENT USE & OWNERSHIP	
Owner Name	DNREC/Brandywine Falls Condo Association
Public/Private	Public/Private
Primary Purpose	Water supply (historic)
Relevant Neighboring Properties	Brandywine Falls Condo Association, Alapocas Run Park
Historic Designation	Dam is not historic but within historic district: <ul style="list-style-type: none"> Bancroft and Sons Cotton Mills (NRHP #84000439) - State
Key Uses	Waters mills race adjacent to private condos.
CONSTRUCTION & CONDITION	
Year Completed	c.1800 (original); 1878 (current)
Barrier Type	Mill dam
Material	Stone, concrete

Height (ft)	10
Length (ft)	200
Capacity (ac-ft)	Unknown
Condition	Good
Hazard Class (Last Inspection)	N/A
Adjacent Infrastructure	Mill race
Sediment	Estimated sediment accumulation up to 32,600 cubic yards (DNREC-WATAR 2020).
AQUATIC CONNECTIVITY & FISH PASSAGE	
Fish Passage	No
Diadromous Fish	American Shad, Alewife, Blueback Herring, Hickory Shad, American Eel, Sea Lamprey, Striped Bass
Aquatic Federal T & E Species	None
Next Upstream Barrier	DuPont Dam (DE_9)
Next Downstream Barrier	Alapocas Run Park Dam (DE_11)
SITE CONSIDERATIONS	
Access to the dam via the eastern side within the park will be challenging due to topography.

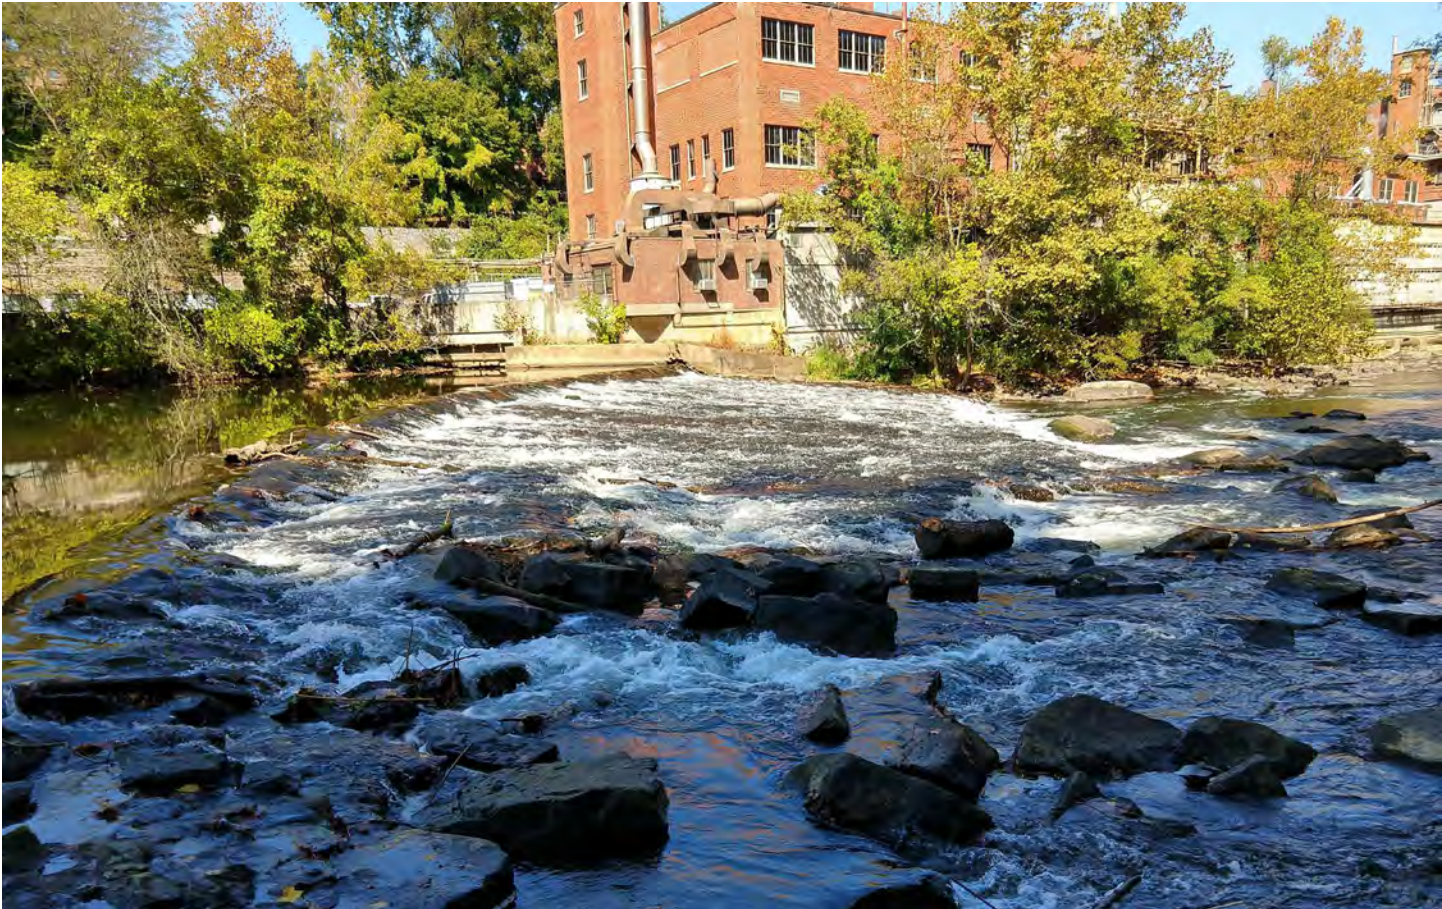
DuPont Dam. Credit: Brandywine Shad 2020.

Dam Name	DuPont Dam
Unique ID	DE_9
LOCATION & HYDROGRAPHY	
Coordinates (Lat, Lon)	39.769416, -75.573825
Address (access)	Dupont Experimental Station, Creek Rd, Wilmington, DE 19806
Town	Wilmington
County	New Castle
State	DE
River/Stream	Brandywine Creek
River Mile	4.5
HUC-12	Lower Brandywine Creek (020402050403)
Dam Drainage (sq mi)	318
CURRENT USE & OWNERSHIP	
Owner Name	DuPont Company
Public/Private	Private
Primary Purpose	Water supply (historic)
Relevant Neighboring Properties	Rockford Park, DuPont Experimental Station
Historic Designation	N/A
Key Uses	None
CONSTRUCTION & CONDITION	
Year Completed	1824
Barrier Type	Mill dam
Material	Stone, concrete
Height (ft)	6
Length (ft)	182
Capacity (ac-ft)	Unknown
Condition	Poor. Breached at multiple points.
Hazard Class (Last Inspection)	N/A
Adjacent Infrastructure	USGS gage (01481500)
Sediment	Estimated sediment accumulation between 1,200-16,600 cubic yards (DNREC-WATAR 2020).

AQUATIC CONNECTIVITY & FISH PASSAGE	
Fish Passage	No
Diadromous Fish	American Shad, Alewife, Blueback Herring, Hickory Shad, American Eel, Sea Lamprey, Striped Bass
Aquatic Federal T & E Species	None
Next Upstream Barrier	Breck's Mill/Walker's Mill Dam (DE_7)
Next Downstream Barrier	Brandywine Falls Dam (DE_10)
SITE CONSIDERATIONS

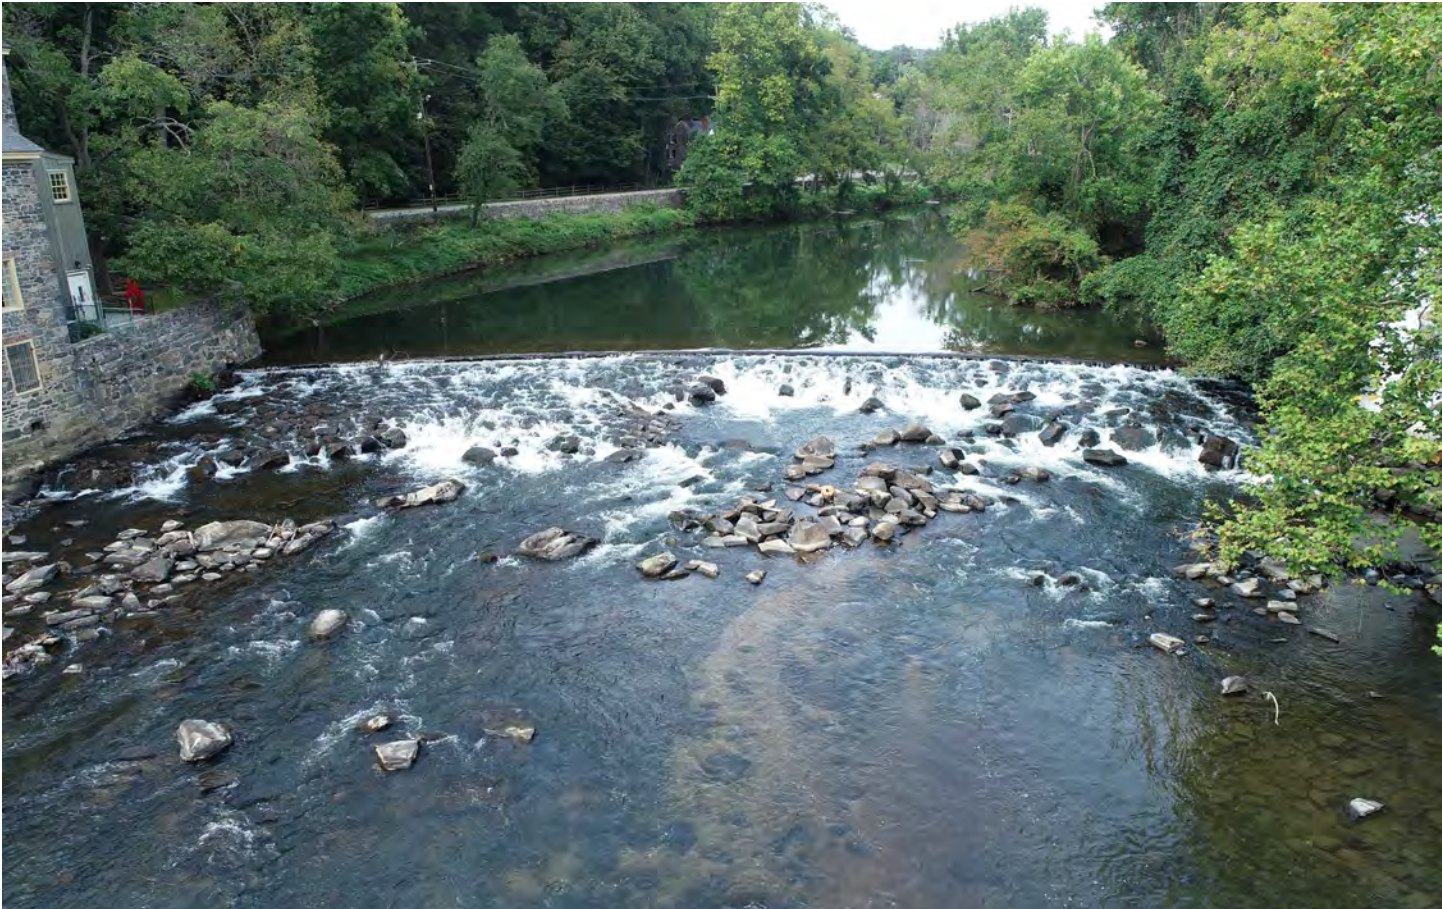
Breck's Mill/Walker's Mill Dam. Credit: Brandywine Shad 2020.

Dam Name	Breck's Mill/Walker's Mill Dam
Unique ID	DE_7
LOCATION & HYDROGRAPHY	
Coordinates (Lat, Lon)	39.770999, -75.579009
Address (access)	Breck's Mill, 1-99 Stone Block Row, Wilmington, DE 19807
Town	Wilmington
County	New Castle
State	DE
River/Stream	Brandywine Creek
River Mile	4.8
HUC-12	Lower Brandywine Creek (020402050403)
Dam Drainage (sq mi)	318
CURRENT USE & OWNERSHIP	
Owner Name	Hagley Museum / Walker's Mill Association, LLC
Public/Private	Private
Primary Purpose	Mill (historic)
Relevant Neighboring Properties	Hagley Museum, Breck's Mill, Walker's Mill
Historic Designation	Dam is considered historic and located within historic districts <ul style="list-style-type: none"> ▪ Brandywine Powder Mills District (NRHP #84000819) - State ▪ Breck's Mill Area - Henry Clay Village Historic District (NRHP #87000683) - State
Key Uses	Waters two mill races. Historic dam part of Hagley Museum.
CONSTRUCTION & CONDITION

Year Completed	1815 (original)
Barrier Type	Mill dam
Material	Stone, concrete
Height (ft)	6
Length (ft)	156
Capacity (ac-ft)	Unknown
Condition	Satisfactory
Hazard Class (Last Inspection)	N/A
Adjacent Infrastructure	<i>Buildings:</i> Breck's Mill, Walker's Mill buildings; <i>Other:</i> USGS gage (01481500)
Sediment	Estimated sediment accumulation between 3,000-52,200 cubic yards (DNREC-WATAR 2020).
AQUATIC CONNECTIVITY & FISH PASSAGE	
Fish Passage	No
Diadromous Fish	American Shad, Alewife, Blueback Herring, Hickory Shad, American Eel, Sea Lamprey, Striped Bass
Aquatic Federal T & E Species	None
Next Upstream Barrier	Lower Hagley Dam (DE_6)
Next Downstream Barrier	DuPont Dam (DE_9)
SITE CONSIDERATIONS	
Adjacent historic mill buildings and two mill races.

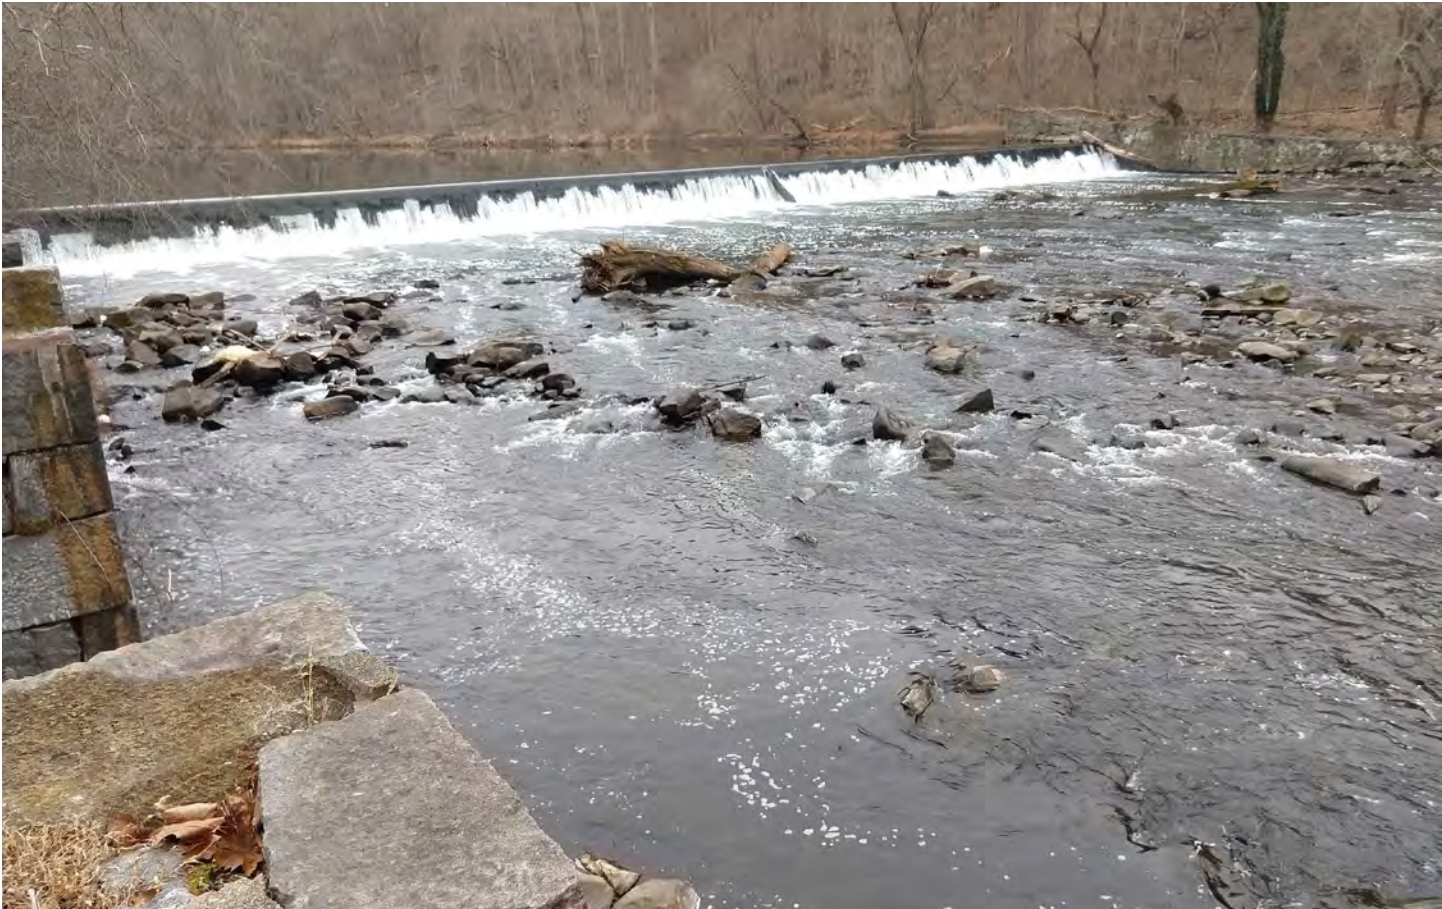
Lower Hagley Dam. Credit: Brandywine Shad 2020.

Dam Name	Lower Hagley Dam
Unique ID	DE_6
LOCATION & HYDROGRAPHY	
Coordinates (Lat, Lon)	39.776453, -75.575306
Address (access)	Hagley Museum, 200 Hagley Creek Rd, Wilmington, DE 19807
Town	Wilmington
County	New Castle
State	DE
River/Stream	Brandywine Creek
River Mile	5.2
HUC-12	Lower Brandywine Creek (020402050403)
Dam Drainage (sq mi)	317
CURRENT USE & OWNERSHIP	
Owner Name	Hagley Museum
Public/Private	Private
Primary Purpose	Mill (historic)
Relevant Neighboring Properties	Hagley Museum
Historic Designation	Dam is historic and part of National Historic Landmark Area <ul style="list-style-type: none"> ▪ Eleutherian Mills Historic District (NRHP #66000259)
Key Uses	Waters historic mill race on Hagley Museum property.
CONSTRUCTION & CONDITION	
Year Completed	1802
Barrier Type	Mill dam
Material	Stone, concrete
Height (ft)	8
Length (ft)	215
Capacity (ac-ft)	Unknown
Condition	Satisfactory
Hazard Class (Last Inspection)	N/A

Adjacent Infrastructure	Mill race
Sediment	Estimated sediment accumulation between 8,300-28,500 cubic yards (DNREC-WATAR 2020).
AQUATIC CONNECTIVITY & FISH PASSAGE	
Fish Passage	No
Diadromous Fish	American Shad, Alewife, Blueback Herring, Hickory Shad, American Eel, Sea Lamprey, Striped Bass
Aquatic Federal T & E Species	None
Next Upstream Barrier	Upper Hagley Dam (DE_emadd02)
Next Downstream Barrier	Breck's Mill/Walker's Mill Dam (DE_7)
SITE CONSIDERATIONS	
The dam is located within a National Historic Landmark Area.

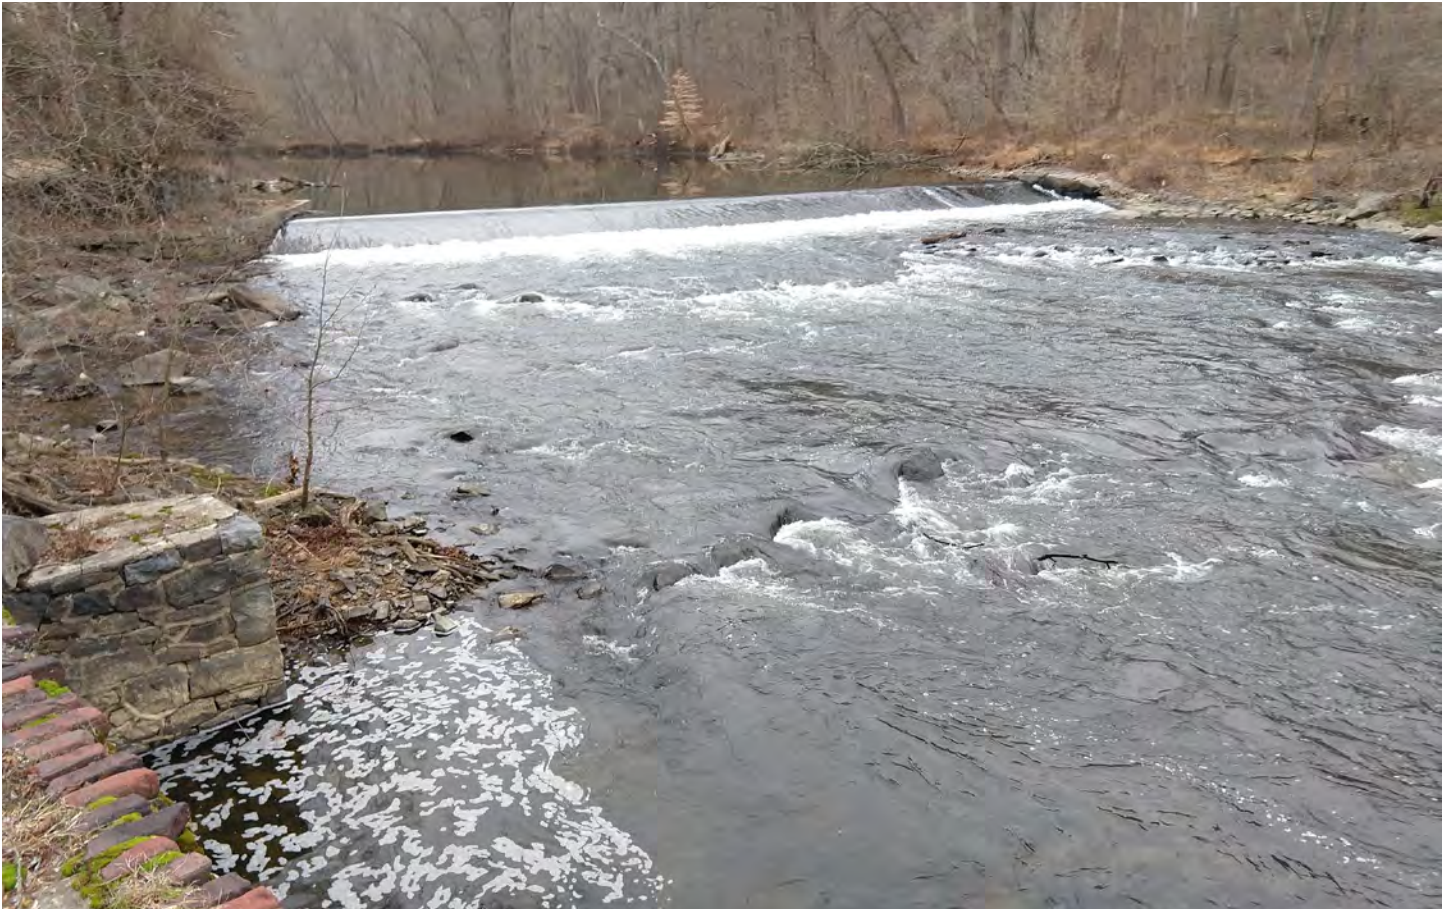
Eleutherian Dam. Credit: Brandywine Shad 2020.

Dam Name	Eleutherian Dam
Unique ID	DE_5
LOCATION & HYDROGRAPHY	
Coordinates (Lat, Lon)	39.785739, -75.577591
Address (access)	Hagley Library, 298 Buck Rd, Wilmington, DE 19807
Town	Wilmington
County	New Castle
State	DE
River/Stream	Brandywine Creek
River Mile	6.2
HUC-12	Lower Brandywine Creek (020402050403)
Dam Drainage (sq mi)	315
CURRENT USE & OWNERSHIP	
Owner Name	Hagley Museum
Public/Private	Private
Primary Purpose	Mill (historic)
Relevant Neighboring Properties	Hagley Museum
Historic Designation	Dam is historic and part of National Historic Landmark Area <ul style="list-style-type: none"> Eleutherian Mills Historic District (NRHP #66000259)
Key Uses	Waters historic mill race on Hagley Museum property.
CONSTRUCTION & CONDITION	
Year Completed	1802 (original); 2009 (current)
Barrier Type	Mill dam
Material	Timber, stone
Height (ft)	3
Length (ft)	126
Capacity (ac-ft)	Unknown
Condition	Excellent. Recently rebuilt.

Hazard Class (Last Inspection)	N/A
Adjacent Infrastructure	Mill race, channel
Sediment	Estimated sediment accumulation between 1,600-7,100 cubic yards (DNREC-WATAR 2020).
AQUATIC CONNECTIVITY & FISH PASSAGE	
Fish Passage	No
Diadromous Fish	American Shad, Alewife, Blueback Herring, Hickory Shad, American Eel, Sea Lamprey, Striped Bass
Aquatic Federal T & E Species	None
Next Upstream Barrier	Brandywine Creek Dam (DE_101)
Next Downstream Barrier	Upper Hagley Dam (DE_emadd02)
SITE CONSIDERATIONS	
The dam was rebuilt in 2009 at a cost of \$1 million using historic methods and building materials. The dam is located within a National Historic Landmark Area.

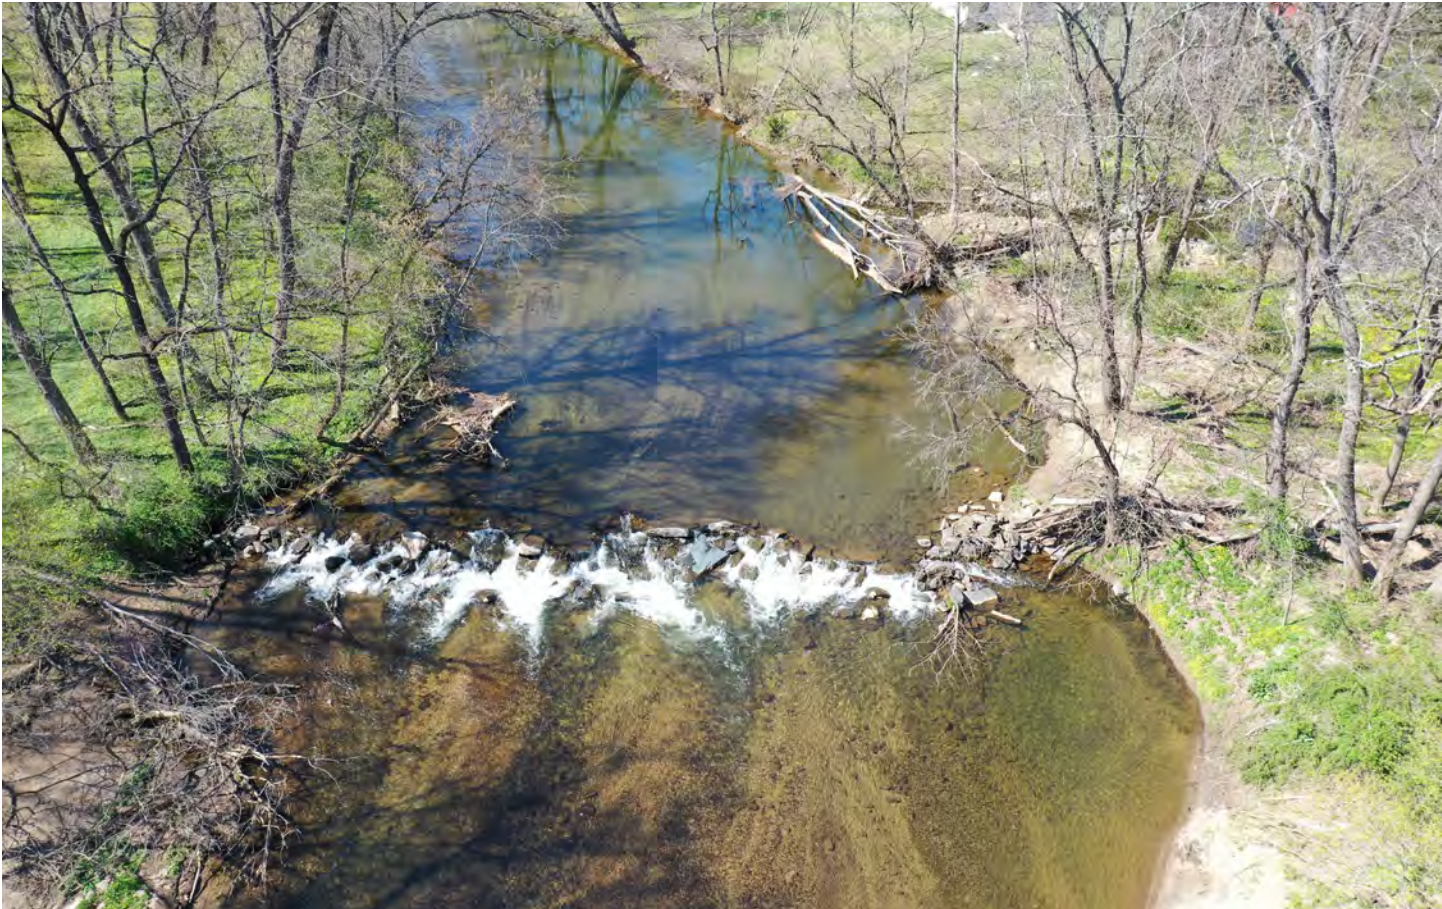
Red Mill Dam. Credit: Jason Fischel.

Dam Name	Red Mill Dam
Unique ID	DE_23
LOCATION & HYDROGRAPHY	
Coordinates (Lat, Lon)	39.689287, -75.709745
Address (access)	A2Z Paintball, Red Mill Rd, Newark, DE 19711
Town	Newark
County	New Castle
State	DE
River/Stream	White Clay Creek
River Mile	6.7
HUC-12	Upper White Clay Creek (020402050306)
Dam Drainage (sq mi)	75
CURRENT USE & OWNERSHIP	
Owner Name	Mac Shar Enterprises
Public/Private	Private
Primary Purpose	Mill (historic)
Relevant Neighboring Properties	Windy Mill (New Castle County), A2Z Paintball, Red Mill Farm
Historic Designation	Dam feeds mill race relevant to adjacent historic site. <ul style="list-style-type: none"> England House and Mill (NRHP Ref #72001597) - State
Key Uses	None
CONSTRUCTION & CONDITION	
Year Completed	1730s (original)
Barrier Type	Mill dam
Material	Rockfill
Height (ft)	3
Length (ft)	140
Capacity (ac-ft)	Unknown
Condition	Poor. The dam is failing at several points leading to downstream bank erosion and areas of upstream sediment deposition.

Hazard Class (Last Inspection)	N/A
Adjacent Infrastructure	<i>Utilities:</i> New Castle County sewer lines downstream of dam
Sediment	2010 study noted sediment deposition upstream of Red Mill Dam.
AQUATIC CONNECTIVITY & FISH PASSAGE	
Fish Passage	No
Diadromous Fish	American Shad, Alewife, Blueback Herring, Hickory Shad, American Eel, Sea Lamprey
Aquatic Federal T & E Species	Bog Turtle, <i>Glyptemys muhlenbergii</i>
Next Upstream Barrier	Karpinski Park Dam (DE_emadd05)
Next Downstream Barrier	None
SITE CONSIDERATIONS	
Sediment accumulation is an issue in the lower section of White Clay Creek. Stroud and USGS are currently completing studies to better understand the sources of sediment.
