Delaware River Basin

Restoration Roadmap

for American Shad, Alewife, and Blueback Herring

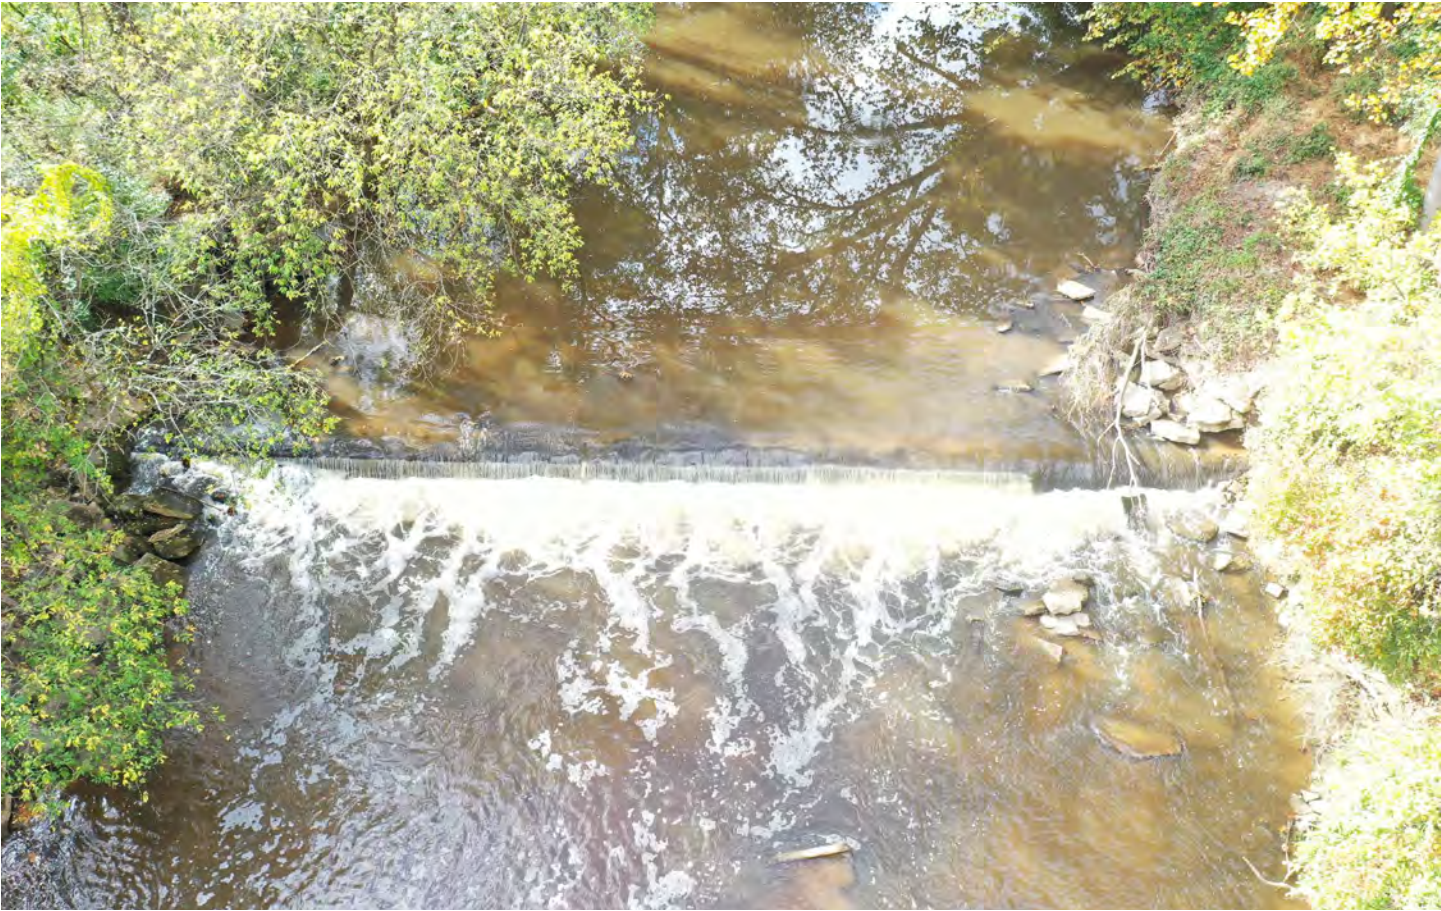
Karpinski Park Dam. Credit: Jason Fischel.

Dam Name	Karpinski Park Dam
Unique ID	DE_emadd05
LOCATION & HYDROGRAPHY	
Coordinates (Lat, Lon)	39.68991, -75.737637
Address (access)	Karpinski Park, Newark, DE 19711
Town	Newark
County	New Castle
State	DE
River/Stream	White Clay Creek
River Mile	9.5
HUC-12	Upper White Clay Creek (020402050306)
Dam Drainage (sq mi)	70
CURRENT USE & OWNERSHIP	
Owner Name	City of Newark
Public/Private	Public
Primary Purpose	Sewer main
Relevant Neighboring Properties	Karpinski Park (City of Newark)
Historic Designation	N/A
Key Uses	Barrier formed by sewer main.
CONSTRUCTION & CONDITION	
Year Completed	Unknown
Barrier Type	Sewer Main
Material	Concrete
Height (ft)	4
Length (ft)	75
Capacity (ac-ft)	Unknown
Condition	Concrete-encased sewer main that has eroded on the downstream side.
Hazard Class (Last Inspection)	N/A
Adjacent Infrastructure	<i>Utilities:</i> City of Newark sewer main
Sediment	Unknown
AQUATIC CONNECTIVITY & FISH PASSAGE	
Fish Passage	No

Diadromous Fish	American Shad, Alewife, Blueback Herring, Hickory Shad, American Eel, Sea Lamprey
Aquatic Federal T & E Species	Bog Turtle, <i>Glyptemys muhlenbergii</i>
Next Upstream Barrier	Paper Mill Dam (DE_22)
Next Downstream Barrier	Red Mill Dam (DE_23)
SITE CONSIDERATIONS	
Adjacent site was formerly used as a landfill/dump site, so will need to be considered during any removal/reconstruction.

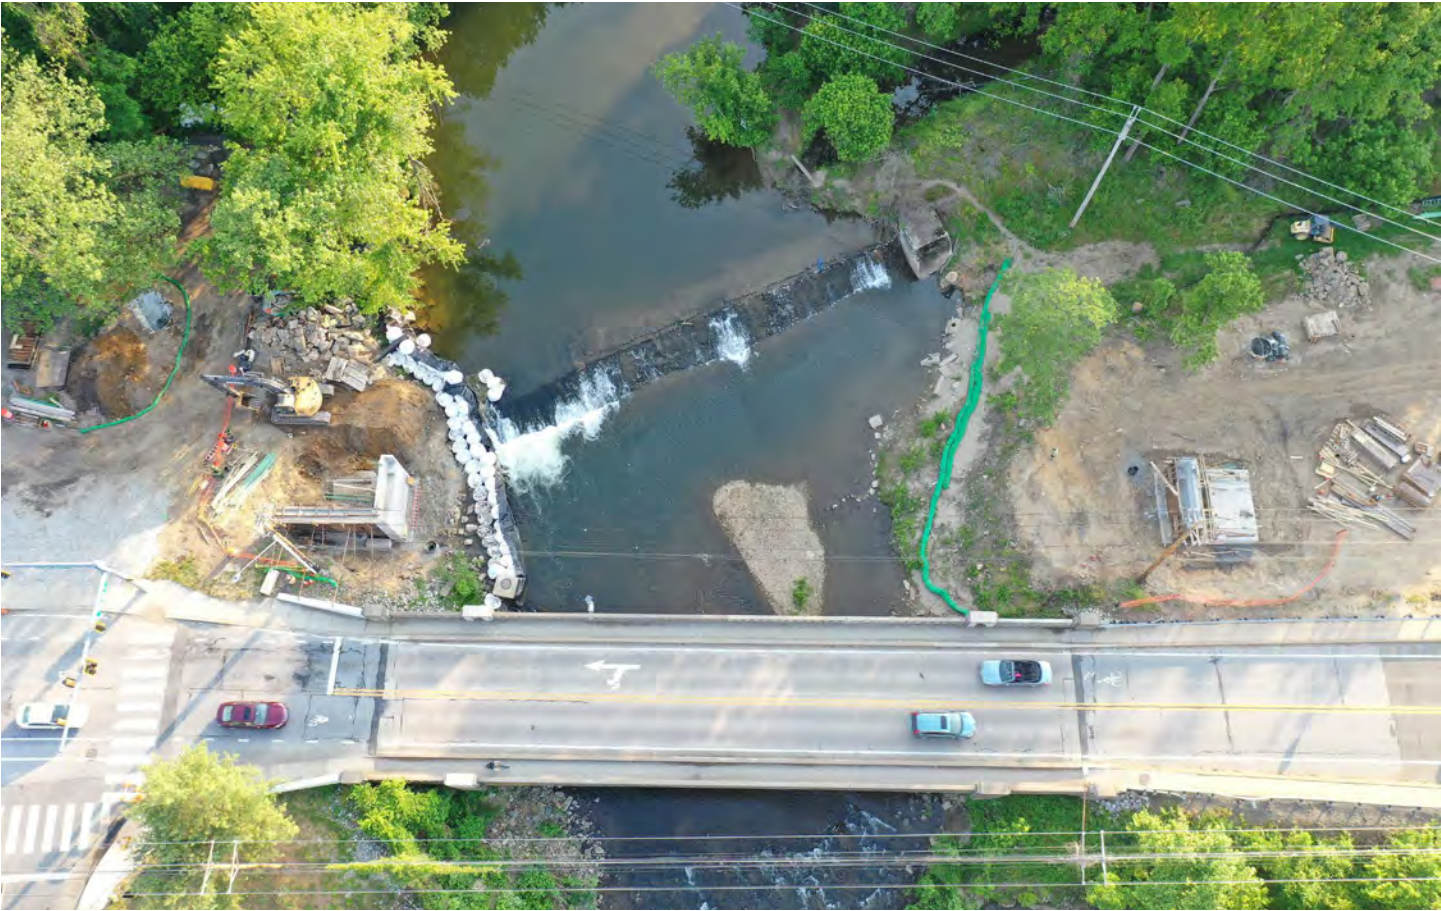
Dam Name	Paper Mill Dam
Unique ID	DE_22
LOCATION & HYDROGRAPHY	
Coordinates (Lat, Lon)	39.689463, -75.749031
Address (access)	Curtis Mill Park, 299 Paper Mill Rd #287, Newark, DE 19711
Town	Newark
County	New Castle
State	DE
River/Stream	White Clay Creek
River Mile	10.1
HUC-12	Upper White Clay Creek (020402050306)
Dam Drainage (sq mi)	69
CURRENT USE & OWNERSHIP	
Owner Name	City of Newark
Public/Private	Public
Primary Purpose	Mill (historic)
Relevant Neighboring Properties	Curtis Mill Park (City of Newark); electrical substation
Historic Designation	Dam is not historic. Paper Mill Road Bridge (immediately downstream of dam) is eligible for listing in the NRHP.
Key Uses	Pools water for USGS gage.
CONSTRUCTION & CONDITION	
Year Completed	1845
Barrier Type	Mill dam (historic)
Material	Concrete
Height (ft)	6
Length (ft)	160
Capacity (ac-ft)	Unknown
Condition	Poor. Breached at multiple points.
Hazard Class (Last Inspection)	N/A

Adjacent Infrastructure	<i>Utilities:</i> USGS Gage (01478650); <i>Other:</i> City of Newark sewer line crosses downstream at multiple point.
Sediment	Little sediment built up behind dam.
AQUATIC CONNECTIVITY & FISH PASSAGE	
Fish Passage	No
Diadromous Fish	American Shad, Alewife, Blueback Herring, Hickory Shad, American Eel
Aquatic Federal T & E Species	Bog Turtle, <i>Glyptemys muhlenbergii</i>
Next Upstream Barrier	Newark Intake Dam (DE_emadd06)
Next Downstream Barrier	Karpinski Park Dam (DE_emadd05)
SITE CONSIDERATIONS	
<p><i>Utilities</i> - Dam used as weir for USGS gage to ensure City is meeting minimum flow requirements as TCS Suez had first rights of withdrawal. USGS will re-gage and is not concerned with dam removal. Sewer crossing just downstream of dam may continue to pool water here. Bedrock is exposed so scouring is not a concern.</p>

Paper Mill Dam. Credit: Jason Fischel.

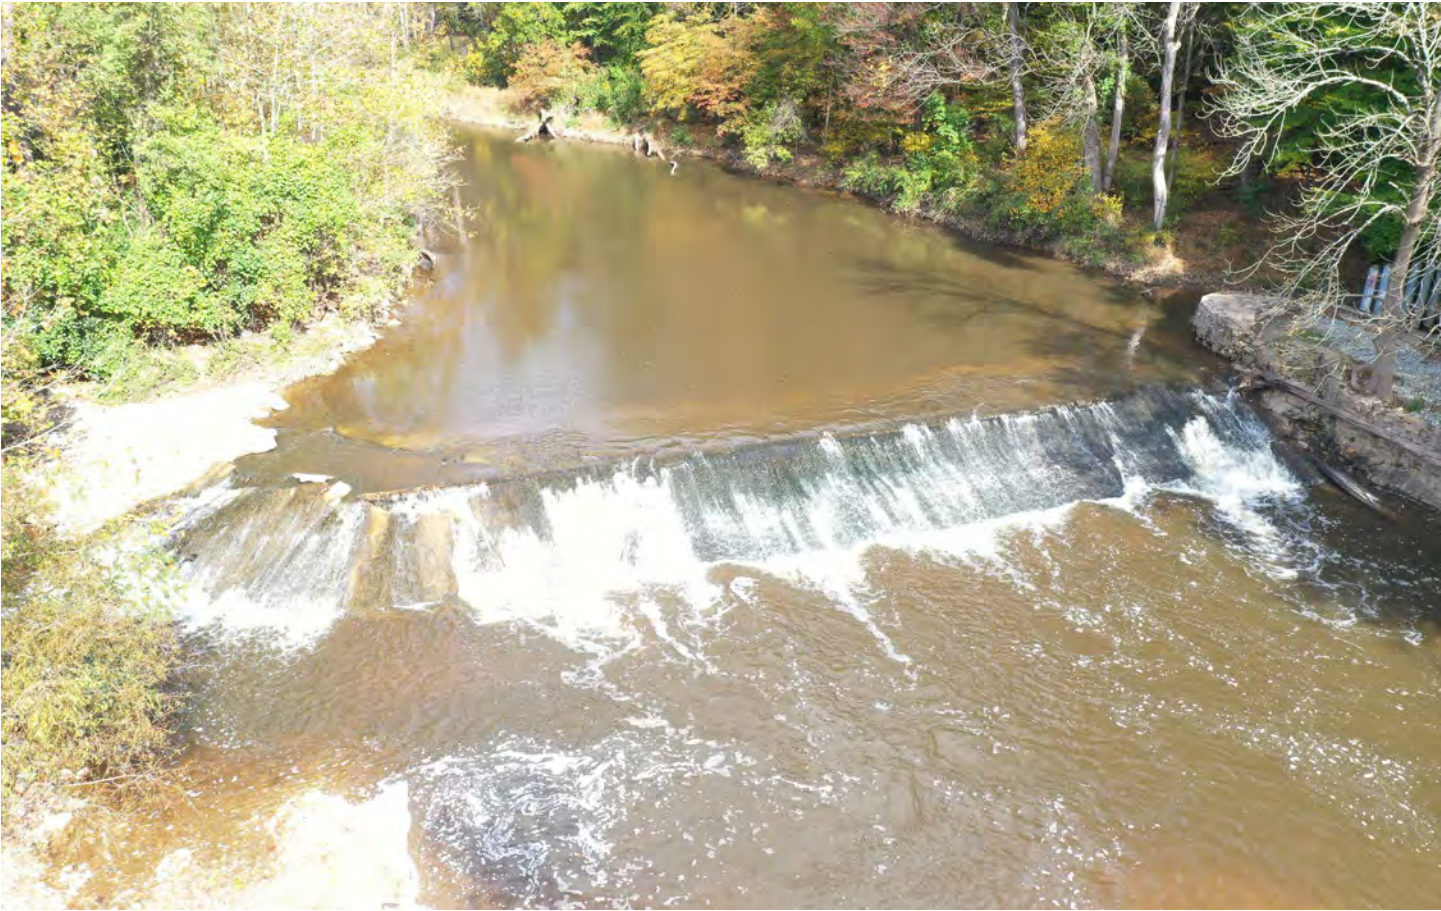
Dam Name	Newark Intake Dam
Unique ID	DE_emadd06
LOCATION & HYDROGRAPHY	
Coordinates (Lat, Lon)	39.698909, -75.752429
Address (access)	White Clay Creek State Park, 997-1099 Creek Rd, Newark, DE 19711
Town	Newark
County	New Castle
State	DE
River/Stream	White Clay Creek
River Mile	11.1
HUC-12	Upper White Clay Creek (020402050306)
Dam Drainage (sq mi)	67.5
CURRENT USE & OWNERSHIP	
Owner Name	City of Newark
Public/Private	Public
Primary Purpose	Water Supply
Relevant Neighboring Properties	Curtis Water Treatment Plant, Newark Reservoir, White Clay Creek State Park
Historic Designation	N/A
Key Uses	Supplies mill race for half of Newark's drinking water supply.
CONSTRUCTION & CONDITION	
Year Completed	1789 (original)
Barrier Type	Mill dam
Material	Concrete
Height (ft)	10
Length (ft)	150
Capacity (ac-ft)	Unknown
Condition	Poor. Deterioration evident.
Hazard Class (Last Inspection)	N/A
Adjacent Infrastructure	Mill race
Sediment	Unknown

AQUATIC CONNECTIVITY & FISH PASSAGE	
Fish Passage	No
Diadromous Fish	American Shad, Alewife, Blueback Herring, Hickory Shad, American Eel, Sea Lamprey
Aquatic Federal T & E Species	Bog Turtle, <i>Glyptemys muhlenbergii</i>
Next Upstream Barrier	Creek Road Dam (DE_emadd07)
Next Downstream Barrier	Paper Mill Dam (DE_22)
SITE CONSIDERATIONS	
<p><i>Water supply</i> - City of Newark relies on this dam and associated mill race for half of its water supply. Th City is open to the idea of dam removal and possibly sourcing using a wellfield. <i>Risk & Safety</i> - University of Delaware student died at dam during flood event.</p>

Newark Intake Dam. Credit: Jason Fischel.

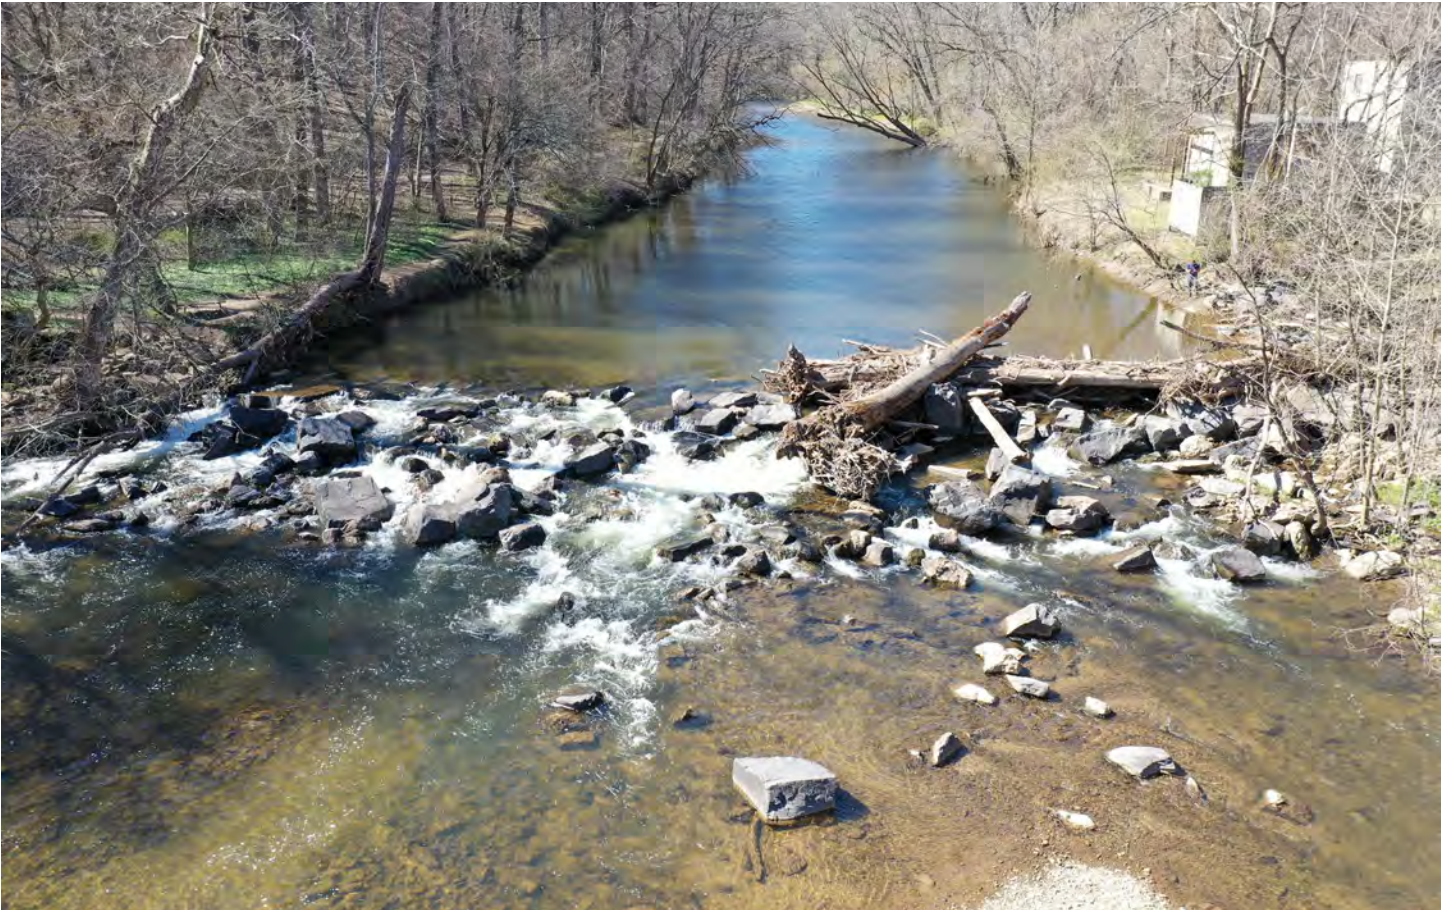
Dam Name	Deerfield Dam
Unique ID	DE_emadd08
LOCATION & HYDROGRAPHY	
Coordinates (Lat, Lon)	39.718626, -75.761231
Address (access)	White Clay Creek State Park, Wedgewood Road, Newark, DE 19711
Town	Newark
County	New Castle
State	DE
River/Stream	White Clay Creek
River Mile	12.7
HUC-12	Upper White Clay Creek (020402050306)
Dam Drainage (sq mi)	65.5
CURRENT USE & OWNERSHIP	
Owner Name	DNREC
Public/Private	Public
Primary Purpose	Water Supply
Relevant Neighboring Properties	Deerfield Golf Club
Historic Designation	N/A
Key Uses	Supplies water for state-owned golf course.
CONSTRUCTION & CONDITION	
Year Completed	1955
Barrier Type	Rockfill
Material	Rockfill
Height (ft)	6
Length (ft)	125
Capacity (ac-ft)	Unknown
Condition	Poor. Breached in multiple locations. Large boulders were placed on top of dam since initial construction.
Hazard Class (Last Inspection)	N/A
Adjacent Infrastructure	Abandoned building.
Sediment	Sediment accumulation upstream of dam. Braiding below dam extends for 1,000 feet and is degrading habitat.

AQUATIC CONNECTIVITY & FISH PASSAGE	
Fish Passage	No
Diadromous Fish	American Shad, Alewife, Blueback Herring, Hickory Shad, American Eel, Sea Lamprey
Aquatic Federal T & E Species	Bog Turtle, <i>Glyptemys muhlenbergii</i>
Next Upstream Barrier	White Clay Creek Preserve Dam (PA_15-377)
Next Downstream Barrier	Creek Road Dam (DE_emadd07)
SITE CONSIDERATIONS	
Large boulders were placed on top of dam since initial construction and will likely be retained on site following planned removal due to their size. Immediately adjacent to the dam is an abandoned building owned by the State of Delaware and the Tri-Valley Trail.

Deerfield Dam. Credit: Jason Fischel.

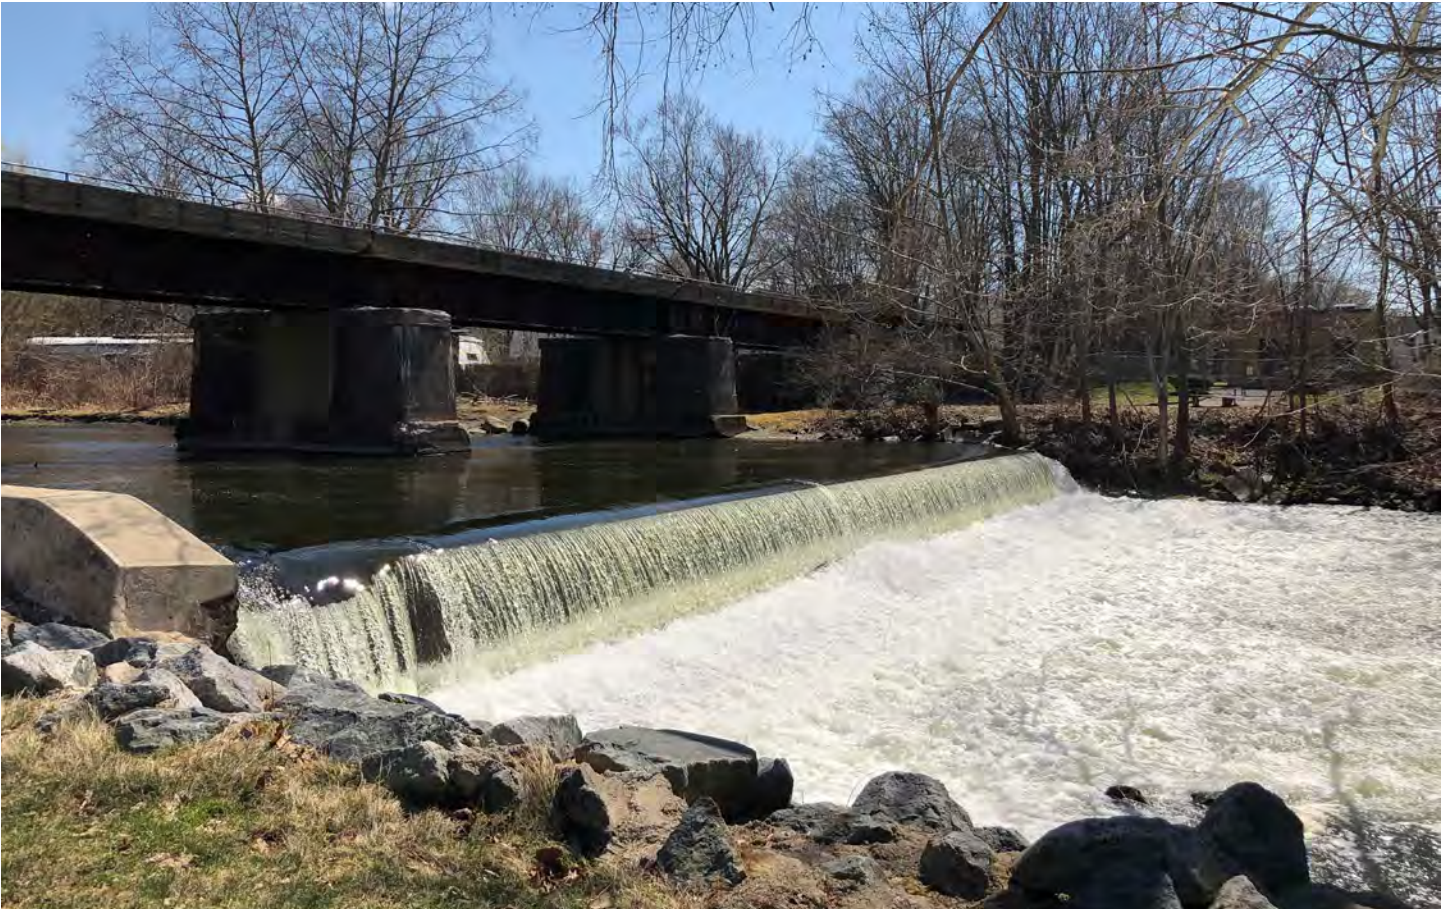
Dam Name	Lower E.R. Collins & Son Dam
Unique ID	NJ_24-28
LOCATION & HYDROGRAPHY	
Coordinates (Lat, Lon)	40.829395, -75.080830
Address (access)	213-99 Water St, Belvidere, NJ 07823
Town	Belvidere
County	Warren
State	NJ
River/Stream	Pequest River
River Mile	0.1
HUC-12	Lower Pequest River (020401050204)
Dam Drainage (sq mi)	158
CURRENT USE & OWNERSHIP	
Owner Name	NJDEP Division of Fish and Wildlife
Public/Private	Public
Primary Purpose	Mill (historic)
Relevant Neighboring Properties	NJDEP Belvidere Fishing Access Area
Historic Designation	Dam is near local historic district: <ul style="list-style-type: none"> Belvidere Historic District (NRHP Ref # 80002525) - Local
Key Uses	None
CONSTRUCTION & CONDITION	
Year Completed	c. 1800 (original)
Barrier Type	Low-head dam
Material	Timber
Height (ft)	7
Length (ft)	145
Capacity (ac-ft)	Unknown
Condition	Satisfactory
Hazard Class (Last Inspection)	N/A
Adjacent Infrastructure	<i>Bridges:</i> Norfolk Southern Rail Bridge, Greenwich-Market Street Bridge

Sediment	Unknown
AQUATIC CONNECTIVITY & FISH PASSAGE	
Fish Passage	No
Diadromous Fish	American Shad, Alewife, Blueback Herring, American Eel, Sea Lamprey
Aquatic Federal T & E Species	Dwarf Wedgemussel, <i>Alasmidonta heterodon</i>
Next Upstream Barrier	Upper E.R. Collins & Son Dam (NJ_24-29)
Next Downstream Barrier	N/A
SITE CONSIDERATIONS	
Given proximity to Norfolk Southern Rail Bridge, dam removal requires structural evaluation of the bridge.

Lower E. R. Collins & Son Dam. Credit: TNC.

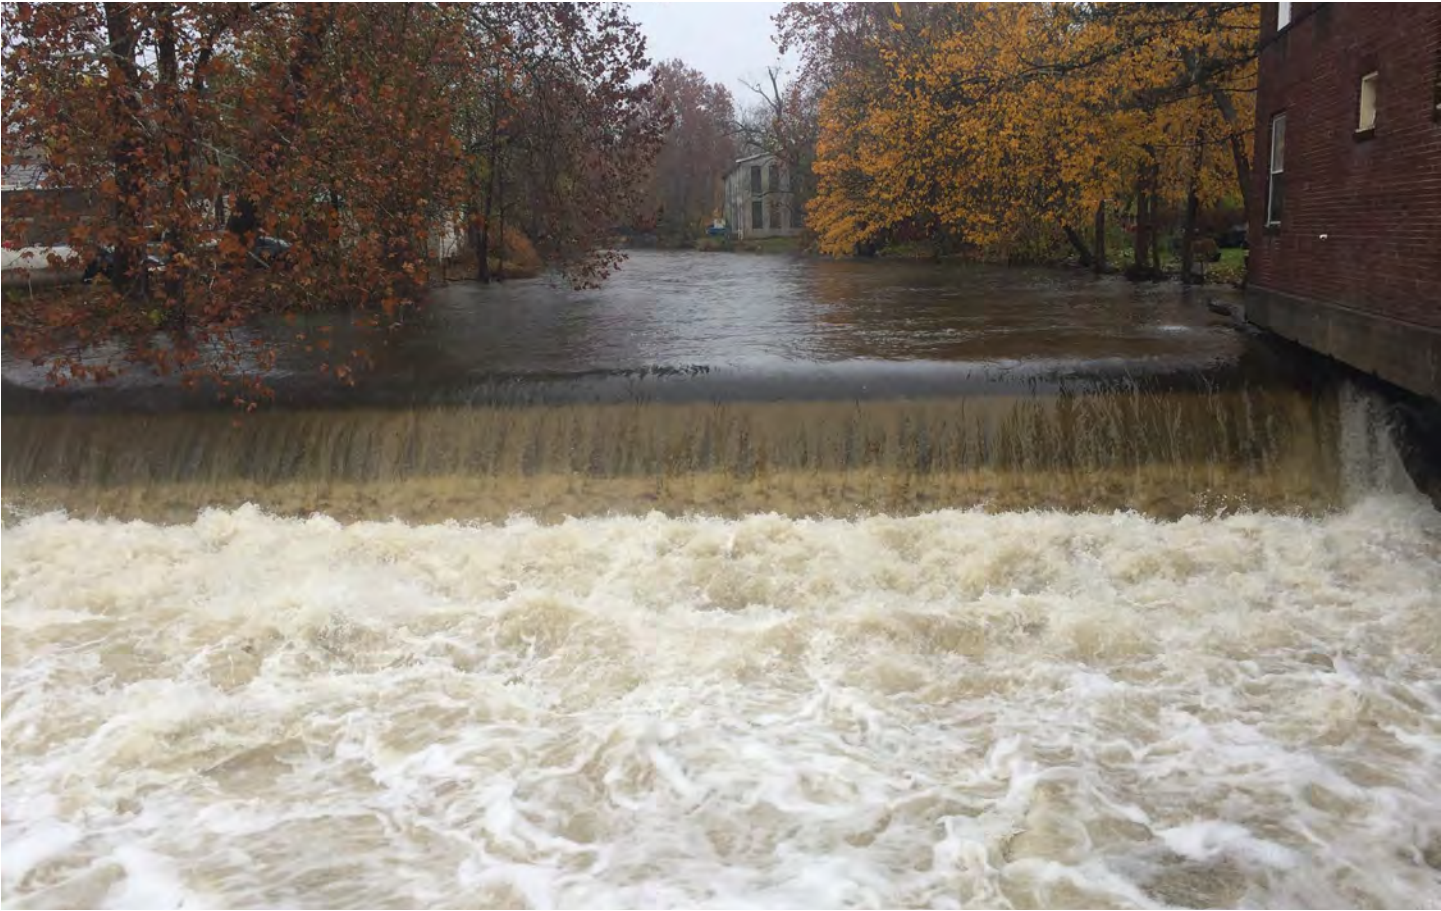
Dam Name	Upper E.R. Collins & Son Dam
Unique ID	NJ_24-29
LOCATION & HYDROGRAPHY	
Coordinates (Lat, Lon)	40.829478, -75.078264
Address (access)	S Water St, Belvidere, NJ 07823
Town	Belvidere
County	Warren
State	NJ
River/Stream	Pequest River
River Mile	0.2
HUC-12	Lower Pequest River (020401050204)
Dam Drainage (sq mi)	158
CURRENT USE & OWNERSHIP	
Owner Name	Private owner
Public/Private	Private
Primary Purpose	Hydroelectric (historic)
Relevant Neighboring Properties	2-10 Market St (2103_11_2); 3 Greenwich St (2103_11_38)
Historic Designation	Dam is located within the local historic district: <ul style="list-style-type: none"> Belvidere Historic District (NRHP Ref # 80002525) - Local
Key Uses	None
CONSTRUCTION & CONDITION	
Year Completed	c. 1800 (original)
Barrier Type	Mill dam, Ogee
Material	Concrete
Height (ft)	7
Length (ft)	85
Capacity (ac-ft)	Unknown
Condition	Satisfactory
Hazard Class (Last Inspection)	N/A
Adjacent Infrastructure	<i>Bridges:</i> Greenwich-Market Street Bridge, Hardwick-Prospect Street Bridge; <i>Other:</i> Two buildings associated with dam: 2-10 Market St, 3 Greenwich St

Sediment	Unknown
AQUATIC CONNECTIVITY & FISH PASSAGE	
Fish Passage	No
Diadromous Fish	American Shad, Alewife, Blueback Herring, American Eel, Sea Lamprey
Aquatic Federal T & E Species	Dwarf Wedgemussel, Alasmidonta heterodon
Next Upstream Barrier	Tranquility Mill Dam (NJ_21-15)
Next Downstream Barrier	Lower E.R. Collins & Son Dam (NJ_24-28)
SITE CONSIDERATIONS	
<p><i>Flooding</i> - Dam is exacerbating local flooding in the surrounding area and is a priority for removal by the dam owner and the Town. Given proximity to Greenwich-Market Street Bridge and abutment to two buildings, dam removal requires evaluation of structures.</p>

Upper E.R. Collins & Son Dam. Credit: TNC.

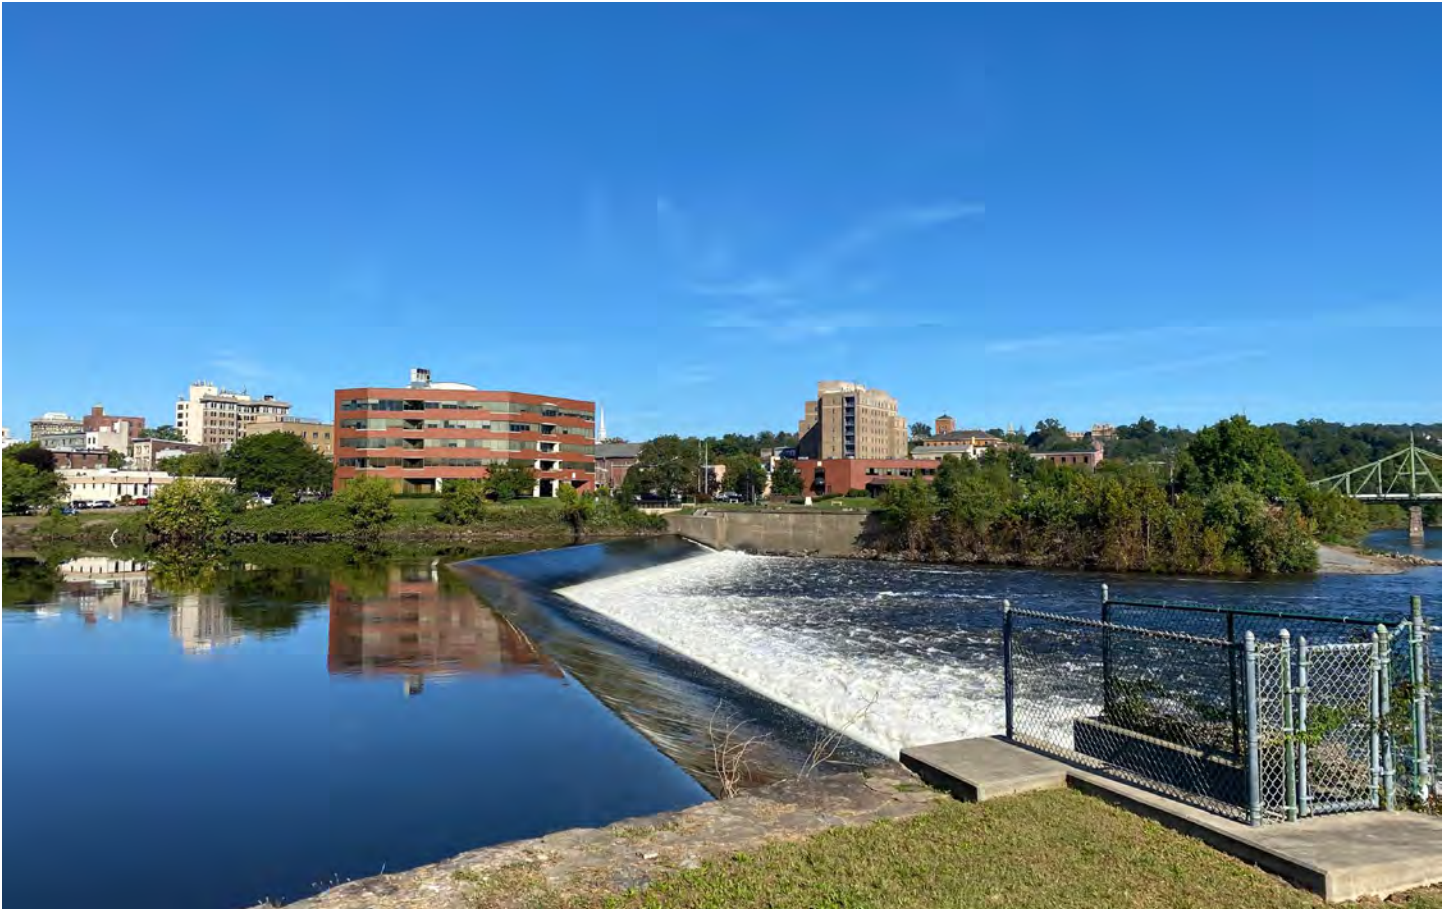
Key Uses	Waters Delaware Canal. Boating in upstream impoundment.
CONSTRUCTION & CONDITION	
Year Completed	1829 (original), 1968 (current)
Barrier Type	Stone
Material	Stone, Masonry, Timber Crib (core)
Height (ft)	30
Length (ft)	600
Capacity (ac-ft)	1,033
Condition	Satisfactory
Hazard Class (Last Inspection)	Low (11/12/20)
Adjacent Infrastructure	<i>Bridges:</i> Black River and Western Railroad Bridge No. 77 (Easton Viaduct over 3rd Street), Dr. George S. Smith Bridge (3rd Street / S.R. 611), Eastern and Northern EA - 77A Bridge (near 9th Street); <i>Utilities:</i> 2 main sewer lines (upstream, in-river), 42 stormwater outfalls; <i>Other:</i> Delaware Canal
Sediment	Sediment depth 1,500 feet upstream of the dam is approximately 5', with mostly sand and coarse gravel noted in 2012 analysis.
AQUATIC CONNECTIVITY & FISH PASSAGE	
Fish Passage	Vertical slot fishway
Diadromous Fish	American Shad, Alewife, Blueback Herring, American Eel, Sea Lamprey, Striped Bass

Aquatic Federal T & E Species	None
Next Upstream Barrier	Chain Dam (PA_48-013)
Next Downstream Barrier	N/A
SITE CONSIDERATIONS	
<p><i>Recreation, Cultural</i> - Previous efforts at dam removal met significant opposition due to canal linkage, recreation, and city aesthetics. Tropical Storm Ida in September 2021 caused an estimated \$5-8M in damages to the Delaware Canal. Delaware Canal 21 is currently launching a financial study to determine how to finance necessary improvements.</p>

Easton Dam. Credit: Lyndon DeSalvo/TNC.

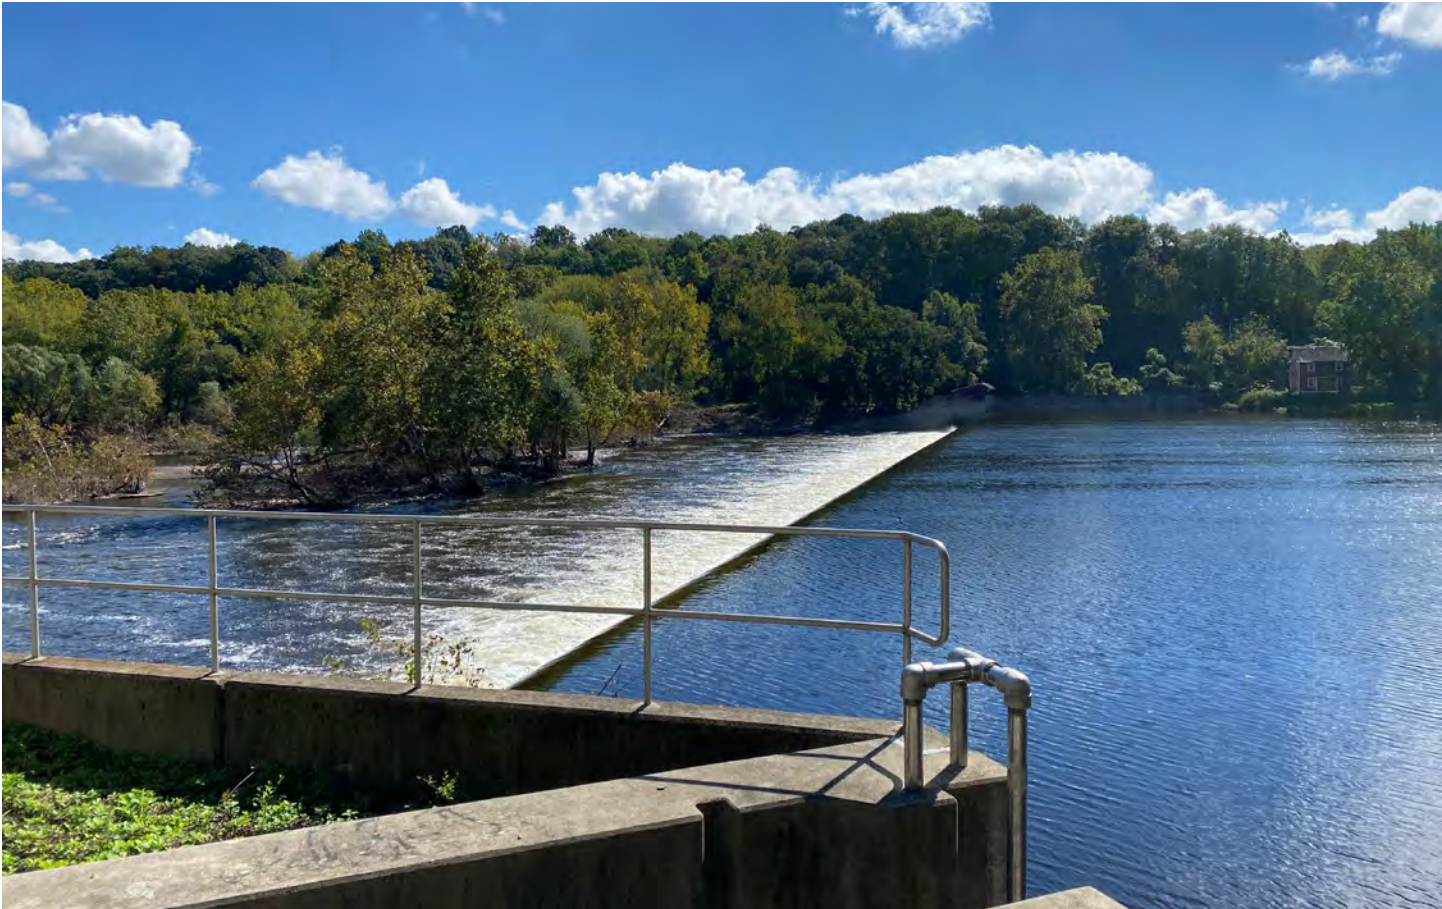
Key Uses	Boating in impoundment. Waters Lehigh Canal.
CONSTRUCTION & CONDITION	
Year Completed	1820s (original); 1974 (current)
Barrier Type	Ogee, Stone
Material	Stone, Concrete
Height (ft)	20
Length (ft)	700
Capacity (ac-ft)	1,197
Condition	Satisfactory
Hazard Class (Last Inspection)	Low (11/12/20)
Adjacent Infrastructure	<i>Bridges:</i> Glendon Hill Road Bridge, Glendon-Wilson Bridge (25th Street / S.R. 2012), Gene Hartzell Memorial Bridge (S.R. 33); <i>Utilities:</i> 12 stormwater outfalls; <i>Other:</i> Lehigh Canal, USGS gage (01454700 Lehigh River at Glendon, PA)
Sediment	Bed of Eurasian milfoil at upstream side of fish ladder.
AQUATIC CONNECTIVITY & FISH PASSAGE	
Fish Passage	Vertical slot fishway
Diadromous Fish	American Shad, Alewife, Blueback Herring, American Eel, Sea Lamprey, Striped Bass
Aquatic Federal T & E Species	None
Next Upstream Barrier	Hamilton Street Dam (PA_39-009)
Next Downstream Barrier	Easton Dam (PA_48-012)

SITE CONSIDERATIONS	
<p><i>Recreation, Cultural</i> - Slack water feeds Lehigh Canal and necessary for mule-drawn boat rides by National Canal Museum. Bethlehem Boat Club interest in maintaining pool. <i>Energy</i> - Preliminary proposals and provisional license granted by FERC for low-impact hydropower on Lehigh Canal. <i>Risk & Safety</i> - In 2014, drowning of fisherman in contact. Concerns with safety.</p> <p>*While DEP is owner of dam, agency would require City of Easton approval prior to alteration or dam removal.</p>

Chain Dam. Credit: Lyndon DeSalvo/TNC.

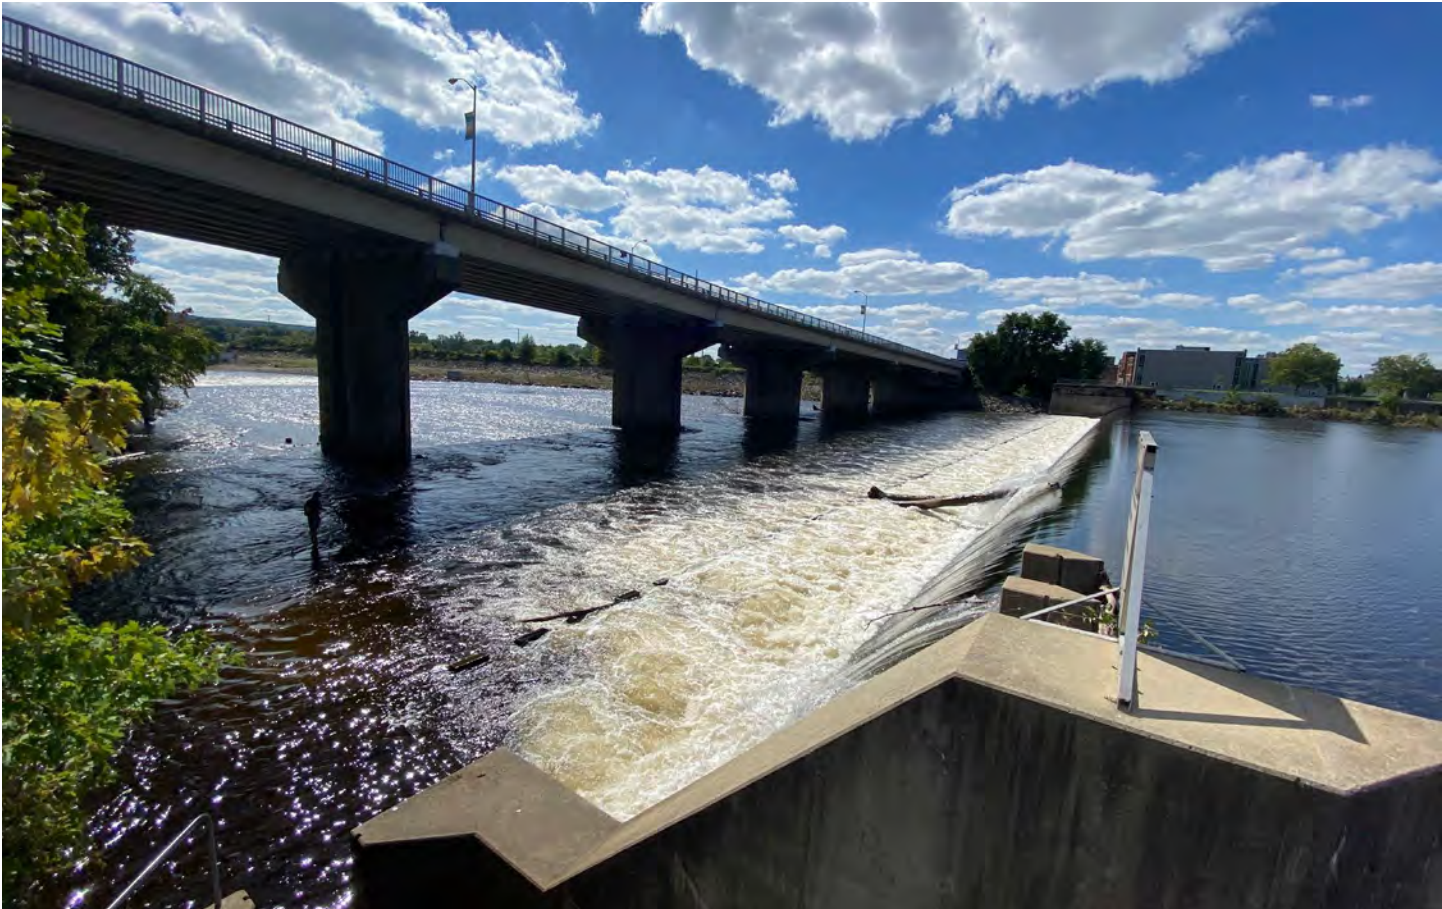
Barrier Type	Gravity
Material	Concrete
Height (ft)	14
Length (ft)	490
Capacity (ac-ft)	50
Condition	Satisfactory
Hazard Class (Last Inspection)	Low (3/11/21)
Adjacent Infrastructure	<i>Bridges:</i> Hamilton Street Bridge, Union Blvd-Tilghman St Bridge, American Parkway Bridge, Lehigh Valley Thruway/Rt 22 Bridge; <i>Utilities:</i> Lehigh County Authority Drinking Water Intakes; Lehigh County Authority Wastewater Treatment Plant; PPL Substation; <i>Other:</i> Lehigh Canal
Sediment	Coal silt settled here following the flooding of the former Treichlers Dam located up-stream in 1981.
AQUATIC CONNECTIVITY & FISH PASSAGE	
Fish Passage	Vertical slot fishway (dewatered during 2021 visit)
Diadromous Fish	American Shad, Alewife, Blueback Herring, American Eel, Sea Lamprey, Striped Bass
Aquatic Federal T & E Species	None
Next Upstream Barrier	Cementon Dam (PA_39-060)
Next Downstream Barrier	Chain Dam (PA_48-013)
SITE CONSIDERATIONS

<p><i>Water supply</i> - Lehigh County Authority has main WWTP just downstream of dam and also uses Lehigh River as backup water supply (presumably with intakes in dam impoundment). <i>Cultural, Economic Development</i> - Large mixed-use development - "The Waterfront" - under construction along 26 acres of Lehigh River banks within dam impoundment. Slack water feeds Lehigh Canal. <i>Energy</i> - Preliminary proposals and provisional license granted by FERC for low-impact hydropower on Lehigh Canal. <i>Risk & Safety</i> - Some concerns about risk and safety, especially given inadequate maintenance.</p>

Hamilton Street Dam. Credit: Lyndon DeSalvo/TNC.

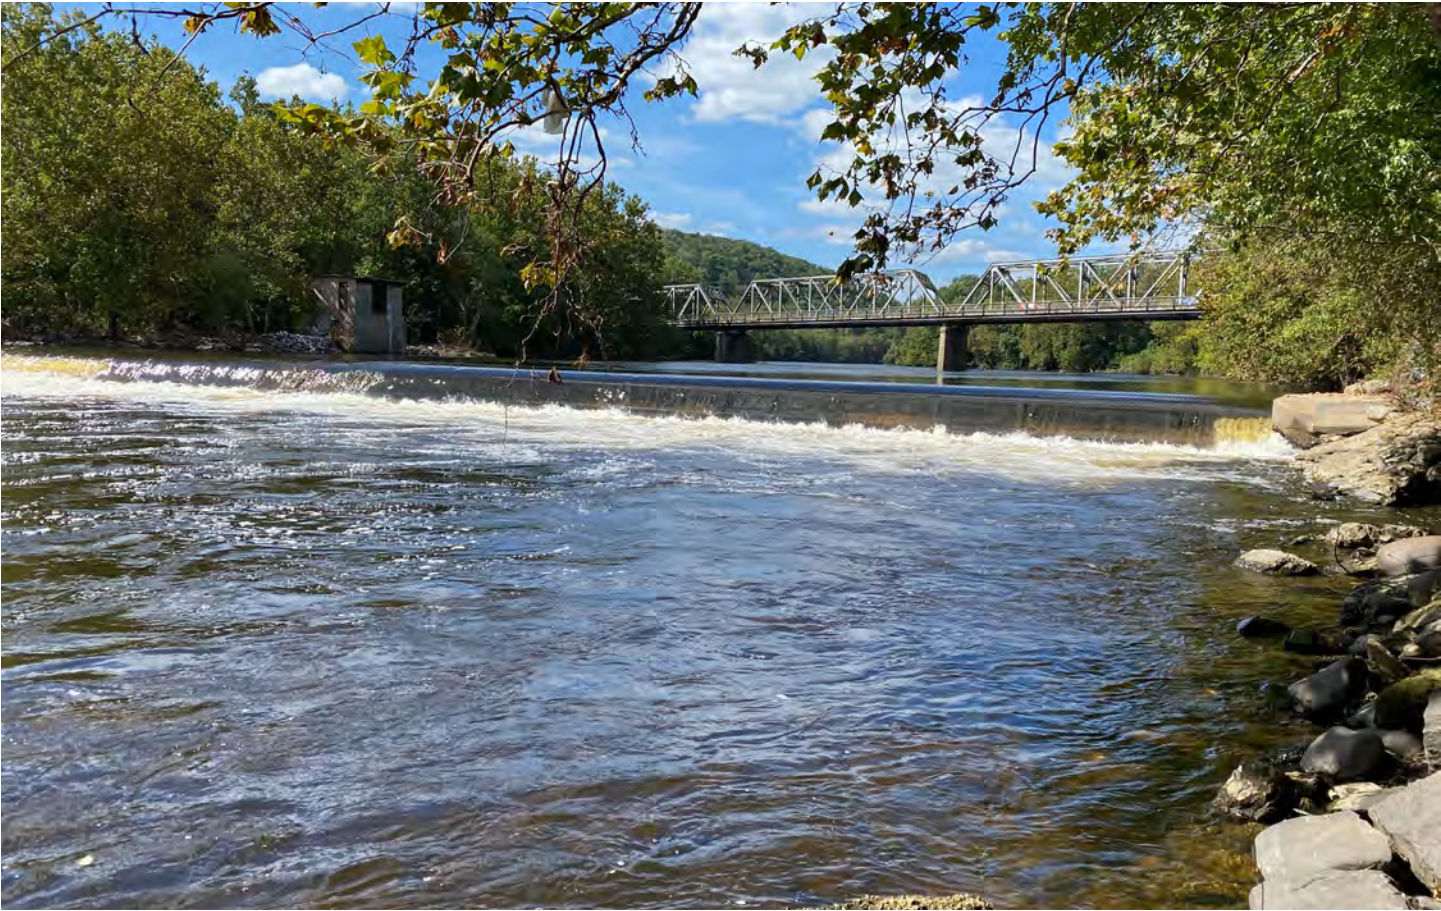
Dam Name	Northampton Dam (<i>aka Cementon Dam</i>)
Unique ID	PA_39-060
LOCATION & HYDROGRAPHY	
Coordinates (Lat, Lon)	40.689193, -75.502724
Address (access)	5101-5105 Main St, Whitehall, PA 18052
Town	Northampton
County	Lehigh
State	PA
River/Stream	Lehigh River
River Mile	23.9
HUC-12	Fireline Creek-Lehigh River (020401060804)
Dam Drainage (sq mi)	943
CURRENT USE & OWNERSHIP	
Owner Name	LaFarge Holcim Corporation
Public/Private	Private
Primary Purpose	Water supply
Relevant Neighboring Properties	LaFarge North American Cement Plant; Canal Street Park (Northampton Borough)
Historic Designation	N/A
Key Uses	Lafarge cement company uses this as water supply for daily operations
CONSTRUCTION & CONDITION	
Year Completed	1927
Barrier Type	Low-head dam
Material	Concrete
Height (ft)	8
Length (ft)	280
Capacity (ac-ft)	50
Condition	Satisfactory
Hazard Class (Last Inspection)	Low (1/23/20)
Adjacent Infrastructure	<i>Bridges:</i> Main St/PA-329 Bridge; <i>Utilities:</i> NBMA Water Treatment Plant

Sediment	Upriver abandoned mine drainage inputs mean that sediment behind dam likely contains metal pollution.
AQUATIC CONNECTIVITY & FISH PASSAGE	
Fish Passage	No
Diadromous Fish	American Shad, Alewife, Blueback Herring, American Eel, Sea Lamprey, Striped Bass
Aquatic Federal T & E Species	None
Next Upstream Barrier	Francis E. Walter Dam (PA_PA00008)
Next Downstream Barrier	Hamilton Street Dam (PA_39-009)
SITE CONSIDERATIONS	
<p><i>Water supply</i> - Northampton Borough Municipal Authority (NMBA) Water Treatment Plant has intake upstream of dam.</p> <p><i>Fish passage</i> - American Shad are present in tailrace of dam and Hokendauqua Creek pool located one mile downstream. American eels and sea lamprey not typically impeded by lack of fish passage at Northampton due to relatively high flows.</p>

Northampton Dam. Credit: Lyndon DeSalvo/TNC.

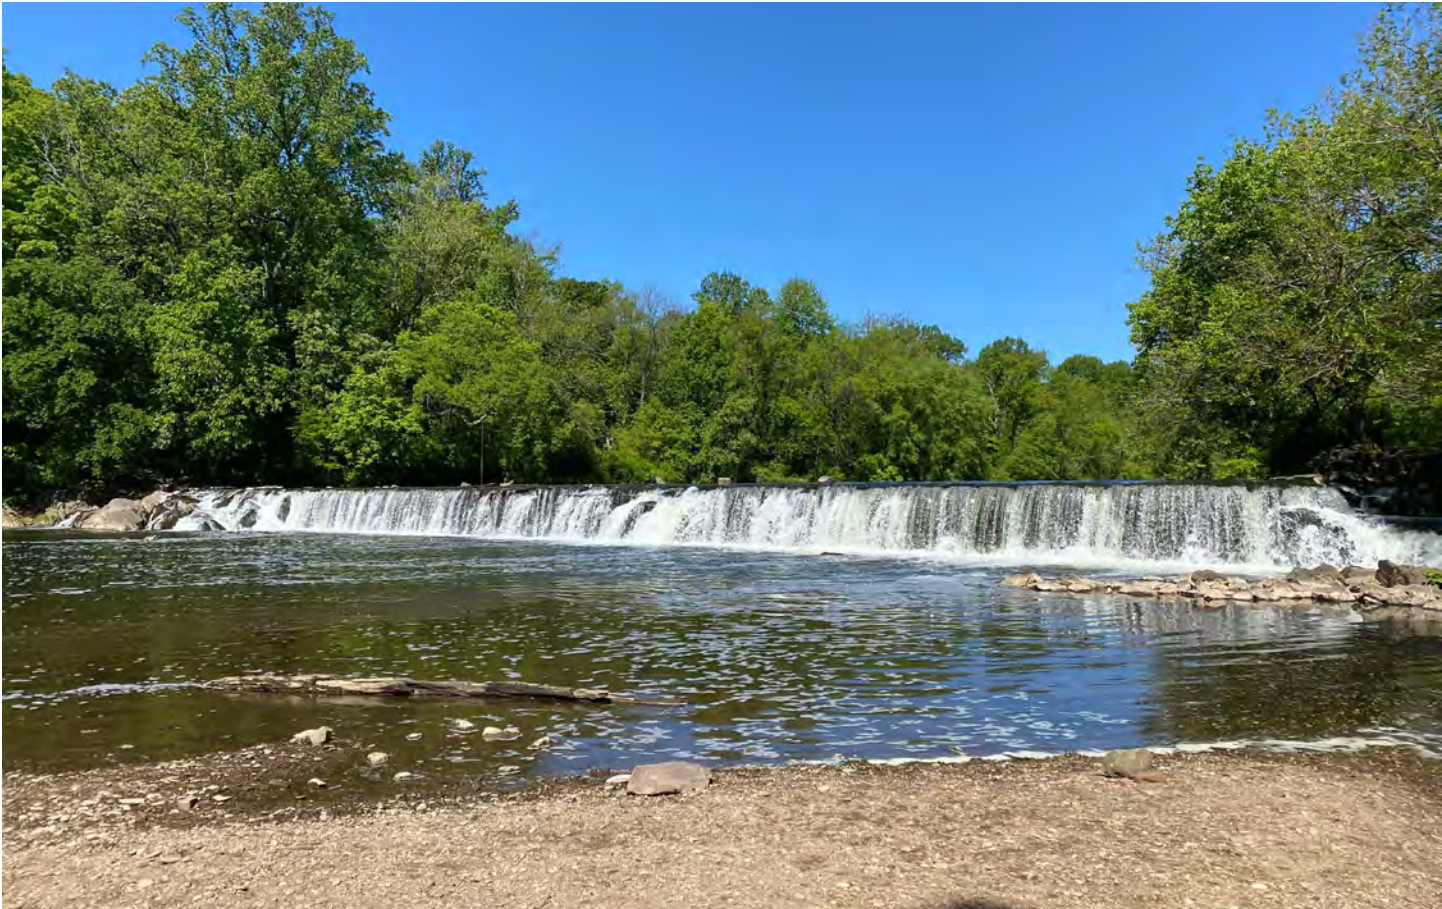
Dam Name	Hulmeville Park Dam
Unique ID	PA_09-084
LOCATION & HYDROGRAPHY	
Coordinates (Lat, Lon)	40.1432609, -74.916193
Address (access)	Neshaminy Shore Picnic Park, 13 Beaver St, Hulmeville, PA 19047
Town	Bensalem
County	Bucks
State	PA
River/Stream	Neshaminy Creek
River Mile	6.2
HUC-12	Core Creek-Neshaminy Creek (020402010303)
Dam Drainage (sq mi)	224
CURRENT USE & OWNERSHIP	
Owner Name	Neshaminy Shore Picnic Park / Bucks County
Public/Private	Private / Public
Primary Purpose	Recreation; Mill (historic)
Relevant Neighboring Properties	Juniper Village at Bucks County
Historic Designation	Dam is located near (but outside) historic district <ul style="list-style-type: none"> Hulmeville Historic District (NRHP Ref# 86001677) - Local
Key Uses	Boating in upstream impoundment.
CONSTRUCTION & CONDITION	
Year Completed	1720 (original);
Barrier Type	Run-of-river dam
Material	Rockfill
Height (ft)	12
Length (ft)	210
Capacity (ac-ft)	123

Condition	Fair
Hazard Class (Last Inspection)	Low (6/30/17)
Adjacent Infrastructure	<i>Bridges:</i> Route 513/Hulmeville Rd bridge, Route 1/Lincoln Highway bridge, Old Lincoln Highway bridge, SEPTA West Trenton Line Rail Bridge; <i>Other:</i> Old stone walls (possible canal or foundations from former mill buildings) located on north side near parking area.
Sediment	Unknown
AQUATIC CONNECTIVITY & FISH PASSAGE	
Fish Passage	No
Diadromous Fish	American shad, Alewife, Blueback Herring, American Eel, Striped Bass
Aquatic Federal T & E Species	None
Next Upstream Barrier	Neshaminy Falls Dam (PA_09-003)
Next Downstream Barrier	N/A
SITE CONSIDERATIONS	
<p><i>Recreation</i> - Dam provides slack water for recreational boating at Neshaminy Shores Picnic Park (listed as owner in USACE National Inventory of Dams); however, Bucks County owns streambank and surrounding parcels.</p>

Hulmeville Park Dam. Credit: Lyndon DeSalvo/TNC.

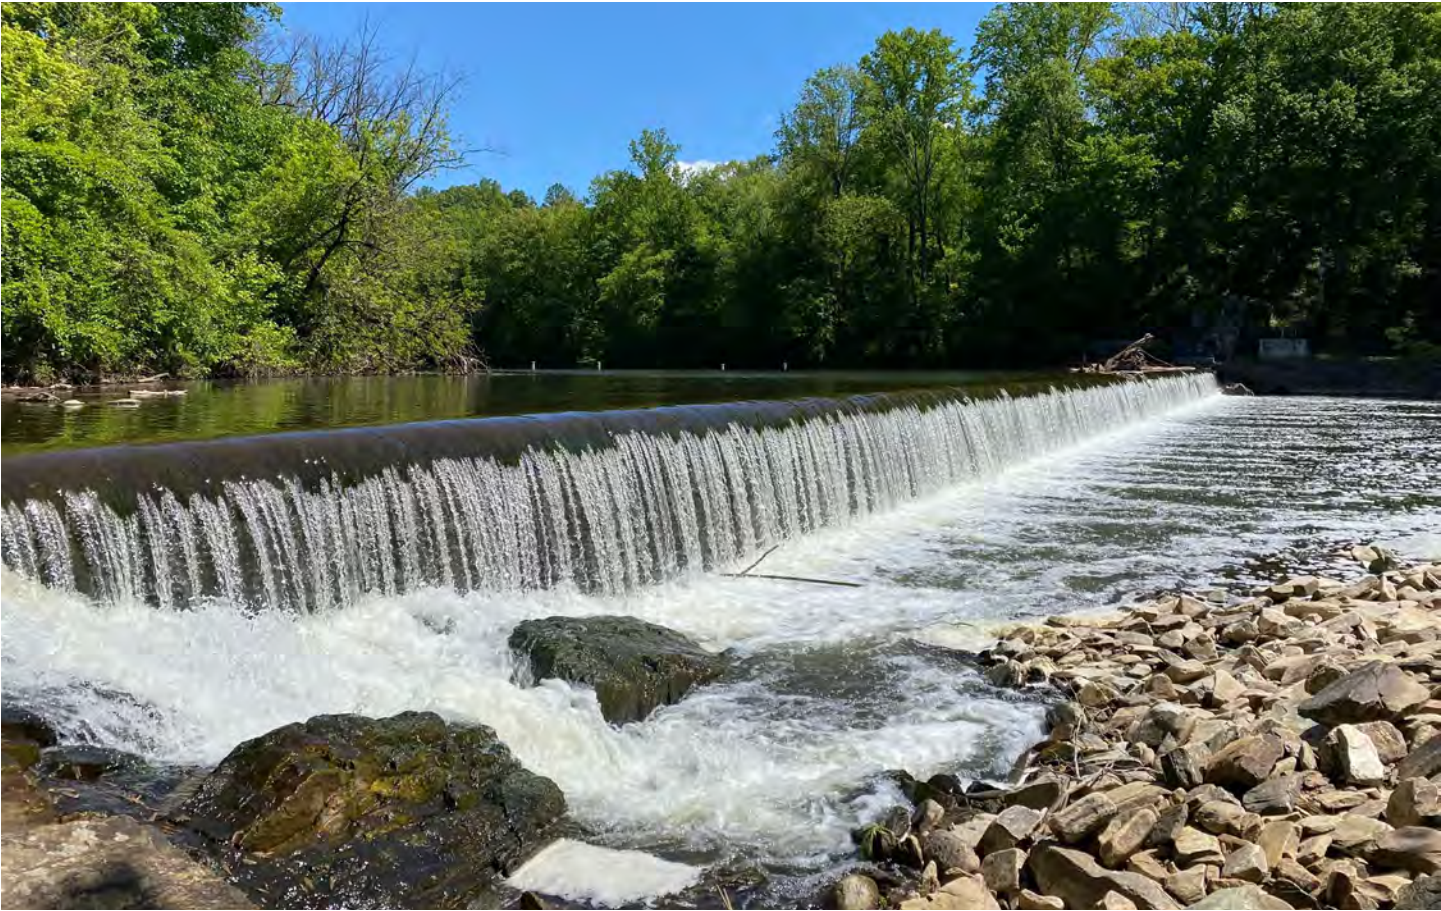
Dam Name	Neshaminy Falls Dam
Unique ID	PA_09-003
LOCATION & HYDROGRAPHY	
Coordinates (Lat, Lon)	40.150117, -74.956615
Address (access)	Neshaminy Falls Station, 4255 E Bristol Rd, Bensalem, PA 19020
Town	Langhorne
County	Bucks
State	PA
River/Stream	Neshaminy Creek
River Mile	9
HUC-12	Core Creek-Neshaminy Creek (020402010303)
Dam Drainage (sq mi)	211
CURRENT USE & OWNERSHIP	
Owner Name	Aqua Pennsylvania, Inc.
Public/Private	Private
Primary Purpose	Water Supply (public), Recreation
Relevant Neighboring Properties	N/A
Historic Designation	N/A
Key Uses	Aqua PA public water intake.
CONSTRUCTION & CONDITION	
Year Completed	1909
Barrier Type	Run-of-river dam
Material	Masonry
Height (ft)	14
Length (ft)	290
Capacity (ac-ft)	260
Condition	Satisfactory
Hazard Class (Last Inspection)	Low (6/30/2017)
Adjacent Infrastructure	<i>Bridges:</i> SEPTA West Trenton Rail Bridge, Brownsville Rd Bridge; <i>Utilities:</i> Aqua PA Water intake and transmission mains, Aqua PA Water Treatment Plant

Sediment	Unknown
AQUATIC CONNECTIVITY & FISH PASSAGE	
Fish Passage	No
Diadromous Fish	American Shad, Alewife, Blueback Herring, American Eel, Striped Bass
Aquatic Federal T & E Species	None
Next Upstream Barrier	Spring Garden Dam (PA_09-083)
Next Downstream Barrier	Hulmeville Dam (PA_09-084)
SITE CONSIDERATIONS	
Water supply - Water treatment plant underwent \$25 million upgrade from 2009-2013; has intake from dam.

Neshaminy Falls Dam. Credit: Lyndon DeSalvo/TNC.
