Delaware River Basin

Restoration Roadmap

for American Shad, Alewife, and Blueback Herring

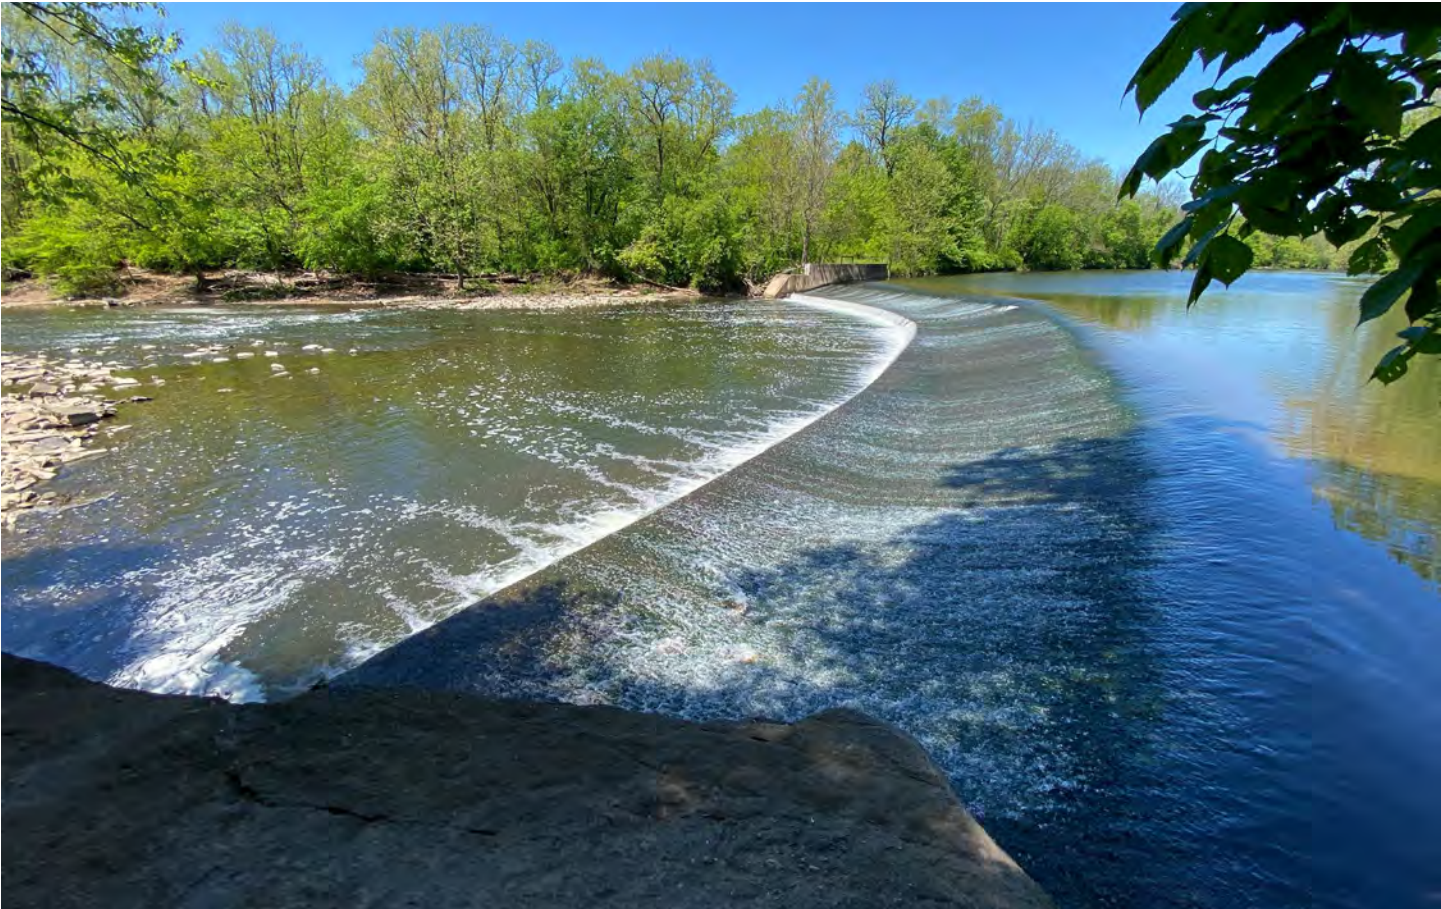
Dam Name	Spring Garden Dam
Unique ID	PA_09-083
LOCATION & HYDROGRAPHY	
Coordinates (Lat, Lon)	40.224714, -74.963755
Address (access)	Fisherman's Parking Lot - Tyler State Park, Northampton Township, PA 18940
Town	Newtown
County	Bucks
State	PA
River/Stream	Neshaminy Creek
River Mile	17.6
HUC-12	Mill Creek-Neshaminy Creek (020402010301)
Dam Drainage (sq mi)	165
CURRENT USE & OWNERSHIP	
Owner Name	PA DCNR
Public/Private	Public
Primary Purpose	Recreation
Relevant Neighboring Properties	Tyler State Park
Historic Designation	N/A
Key Uses	Boating in upstream impoundment.
CONSTRUCTION & CONDITION	
Year Completed	1920
Barrier Type	Run-of-river dam; arch shape
Material	Concrete
Height (ft)	9
Length (ft)	275
Capacity (ac-ft)	112
Condition	Satisfactory
Hazard Class (Last Inspection)	Low (6/18/2018)
Adjacent Infrastructure	Bridges: Route 322/Richboro Rd Bridge (Downstream), Main Park Rd/Dairy Hill Trail Bridge
Sediment	Unknown
AQUATIC CONNECTIVITY & FISH PASSAGE

Fish Passage	No
Diadromous Fish	American shad, Alewife, Blueback Herring, American Eel, Striped Bass
Aquatic Federal T & E Species	None
Next Upstream Barrier	Neshaminy Weir Dam (PA_09-167)
Next Downstream Barrier	Neshaminy Falls Dam (PA_09-003)
SITE CONSIDERATIONS	
Risk & Safety - PA DCNR considers the dam a liability and is seeking funds for removal.

Spring Garden Dam. Credit: Lyndon DeSalvo/TNC.

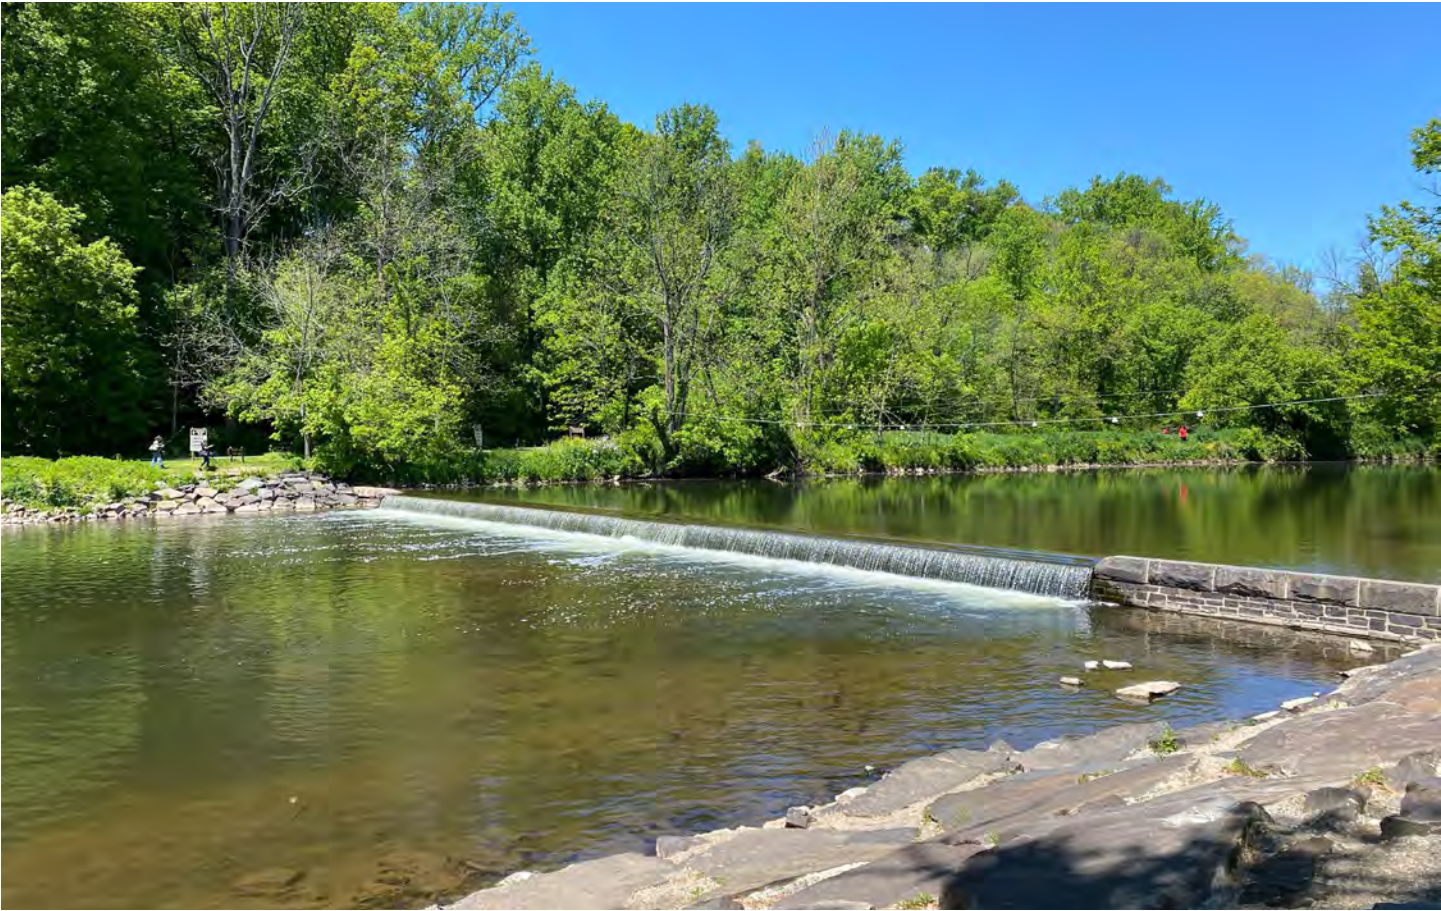
Neshaminy Weir Dam. Credit: Lyndon DeSalvo/TNC.

Dam Name	Neshaminy Weir Dam
Unique ID	PA_09-167
LOCATION & HYDROGRAPHY	
Coordinates (Lat, Lon)	40.233086, -74.974240
Address (access)	Tyler State Park – Boathouse Parking Lot, Newtown, PA 18940
Town	Newtown
County	Bucks
State	PA
River/Stream	Neshaminy Creek
River Mile	18.6
HUC-12	Mill Creek-Neshaminy Creek (020402010301)
Dam Drainage (sq mi)	164
CURRENT USE & OWNERSHIP	
Owner Name	PA DCNR
Public/Private	Public
Primary Purpose	Recreation
Relevant Neighboring Properties	Bucks County Community College
Historic Designation	N/A
Key Uses	Used for non-motorized boating.
CONSTRUCTION & CONDITION	
Year Completed	1980
Barrier Type	Run-of-river dam
Material	Stone
Height (ft)	2-3
Length (ft)	170
Capacity (ac-ft)	Unknown
Condition	Good
Hazard Class (Last Inspection)	Low (N/A)
Adjacent Infrastructure	<i>Bridges:</i> Main Park Rd/Dairy Hill Trail Bridge, Schofield Ford Covered Bridge
Sediment	Unknown
AQUATIC CONNECTIVITY & FISH PASSAGE

Fish Passage	No
Diadromous Fish	American Shad, Alewife, Blueback Herring, American eel, Striped Bass
Aquatic Federal T & E Species	None
Next Upstream Barrier	Reed Dam (PA_09-141)
Next Downstream Barrier	Spring Garden Dam (PA_09-083)
SITE CONSIDERATIONS	
<p><i>Recreation</i> - Boat launch just upstream of dam; road crossing/walkway (with AOP) just downstream of dam to access other areas of Tyler State Park.</p>

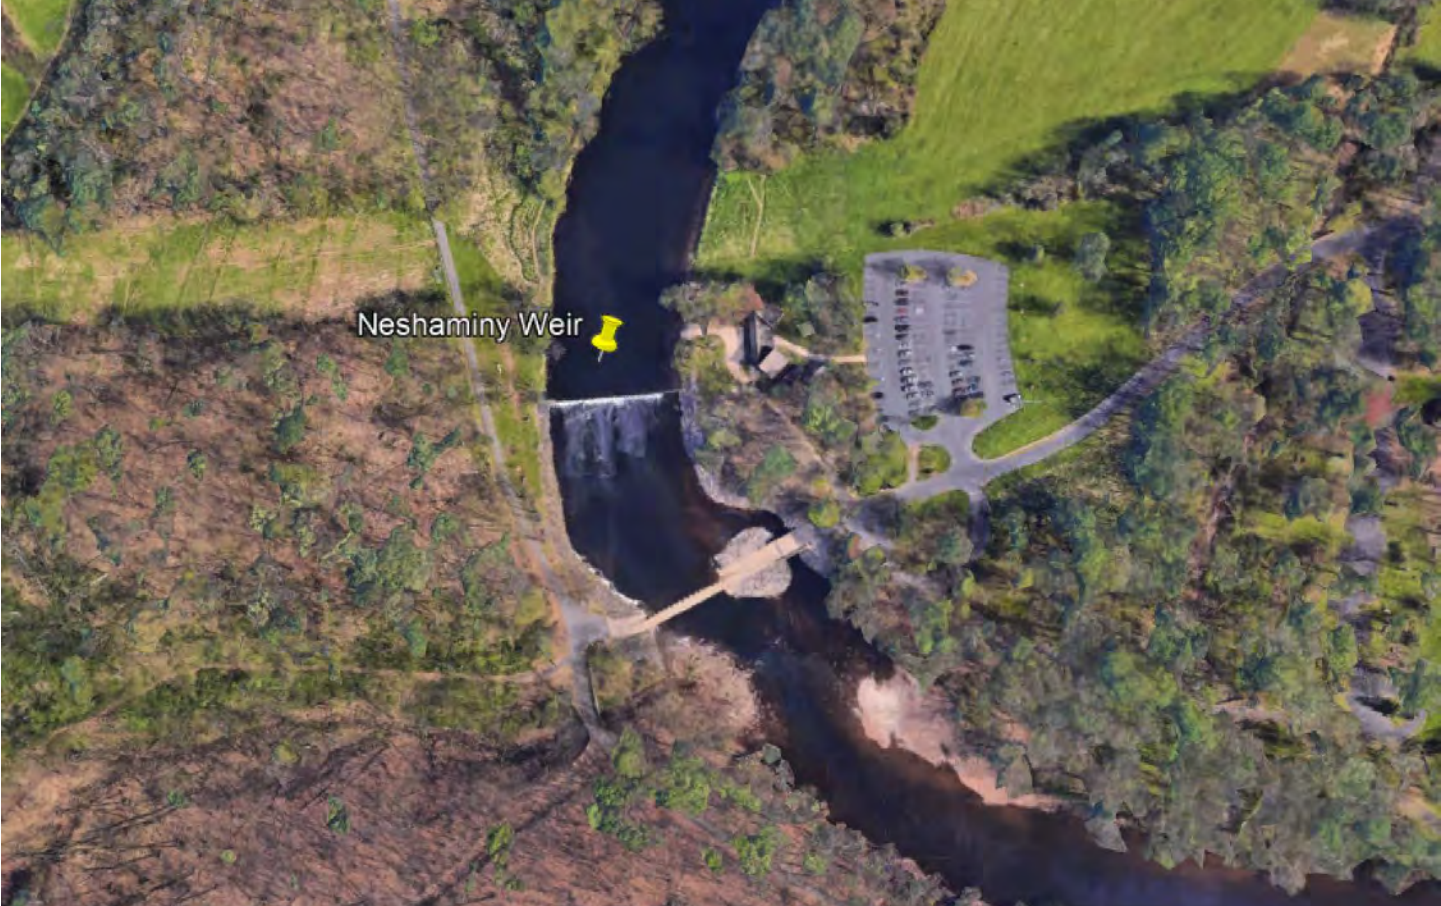
Neshaminy Weir Dam aerial. Credit: Google Earth.
