# 02

## Challenges Encountered

### Large-Scale Levee Setback Playbook

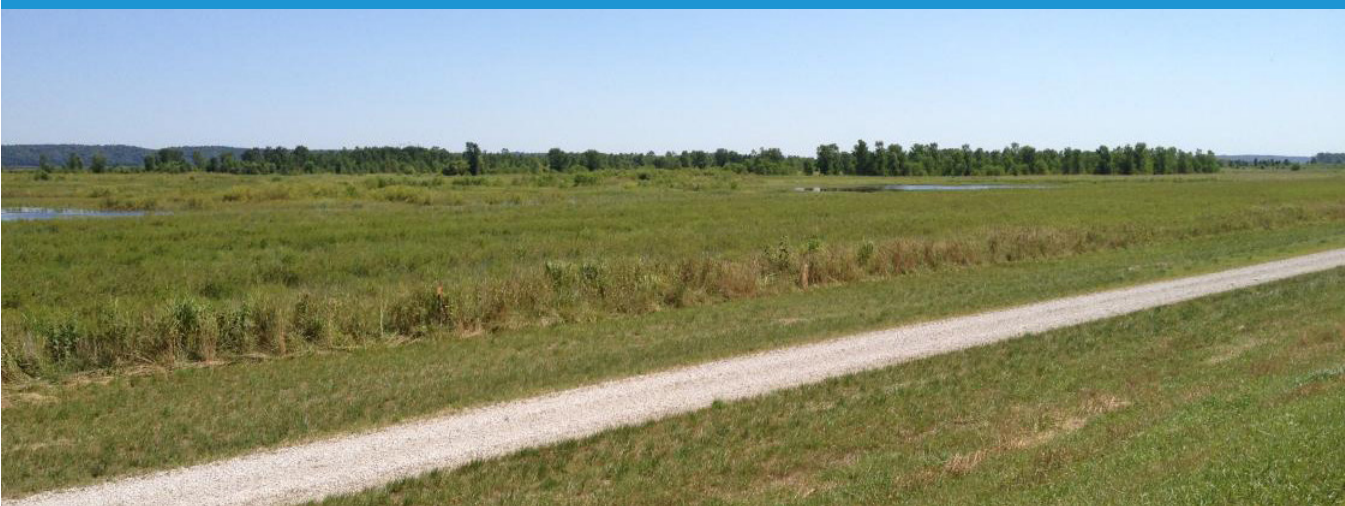
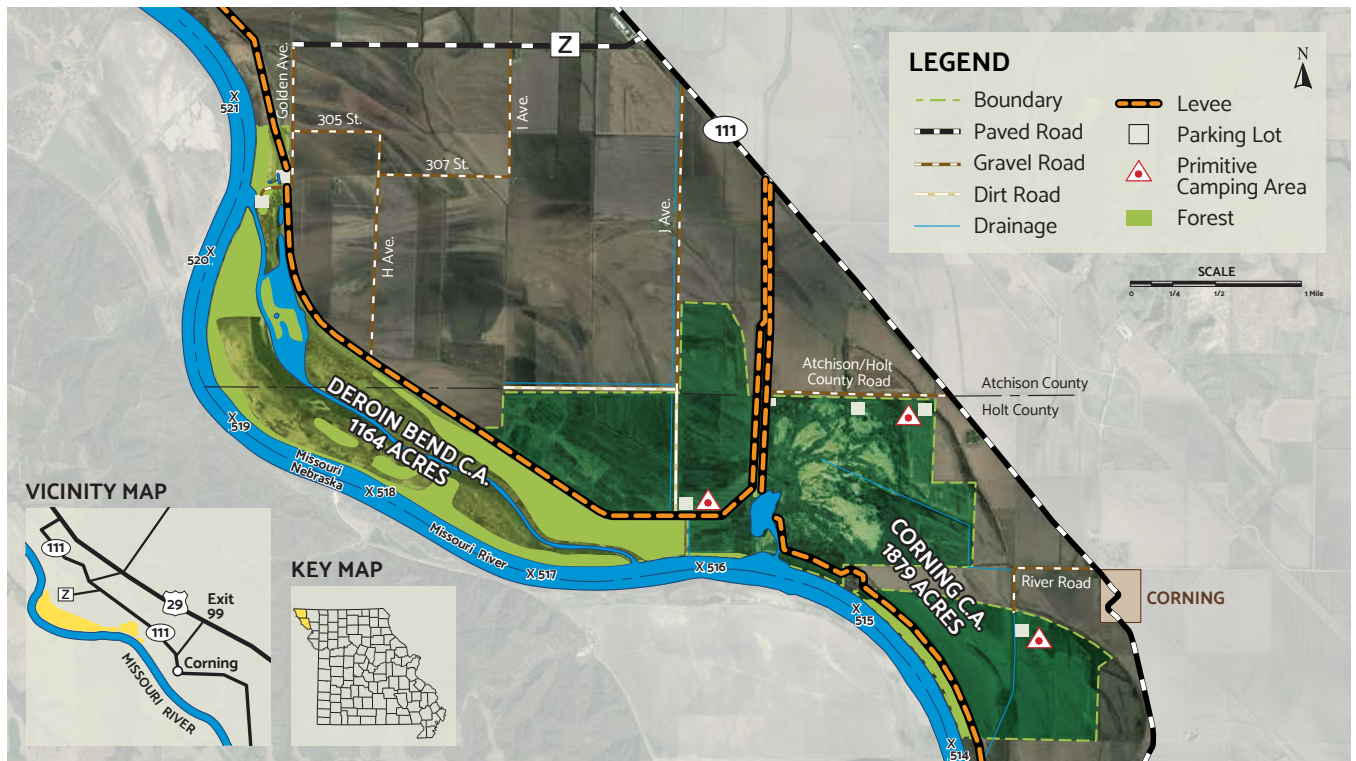
Figure 6: Deroin Bend and Corning Conservation Areas map before levee setback.

The Corning Conservation Area is an 1,880-acre mitigation project, designed to enhance fish and wildlife habitat along the Missouri River. The area is (1) owned in fee title by USACE- Kansas City District under the MRRP, (2) has an NRCS WRP easement on part of the property, and (3) has day-to-day management activities conducted by MDC under a land management partnership agreement. This area is managed for a variety of game and non-game species of fish and wildlife. All three agencies need to ensure close coordination when a construction or management action is being proposed.

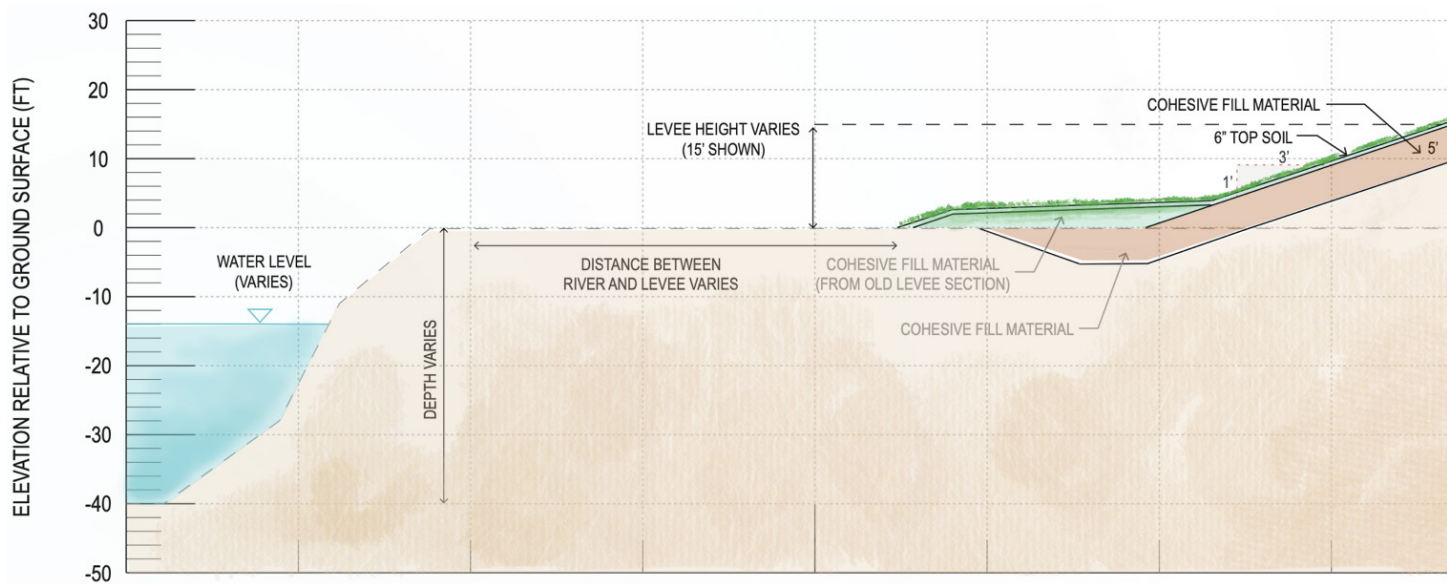
LEVEE SETBACK  
TYPICAL

Figure 8: USACE levee design template.

While USACE-Omaha District waited for floodwaters to recede, they utilized digital elevation models to create engineering design templates for the placement of the levee with its height, side slopes, and seepage berms so that quantities could be determined, expediting the final design of repair alternatives (Figure 8).

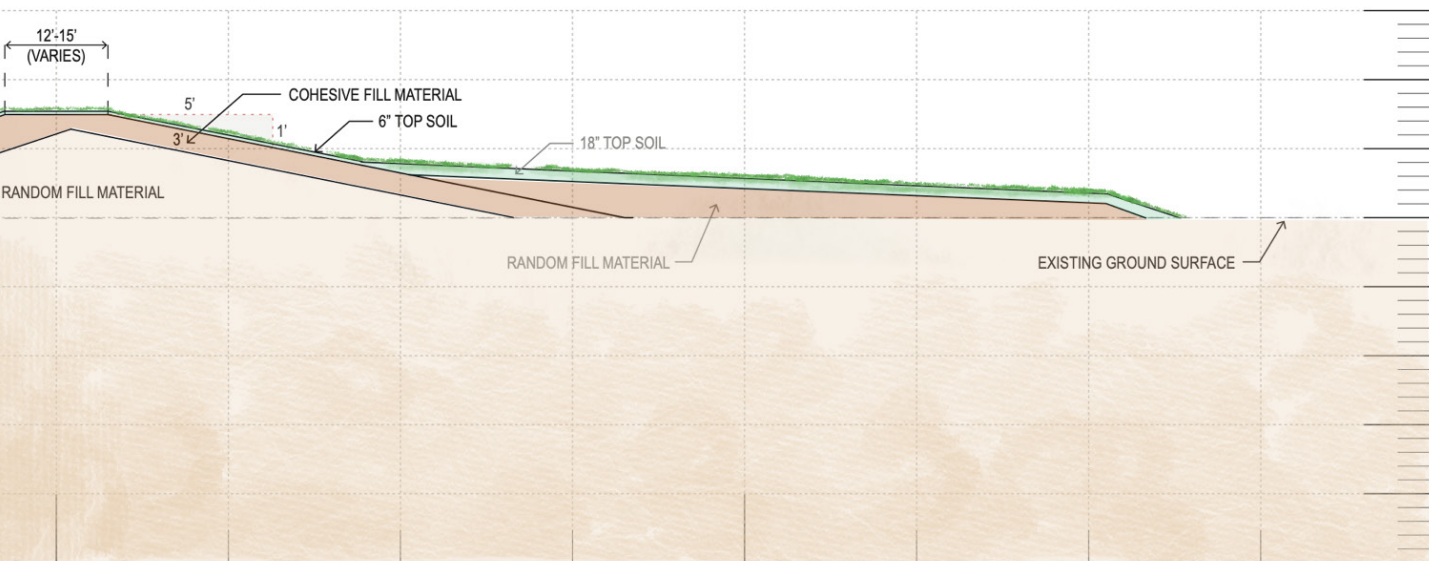
### CROSS SECTION REPAIR

USACE levee design plans

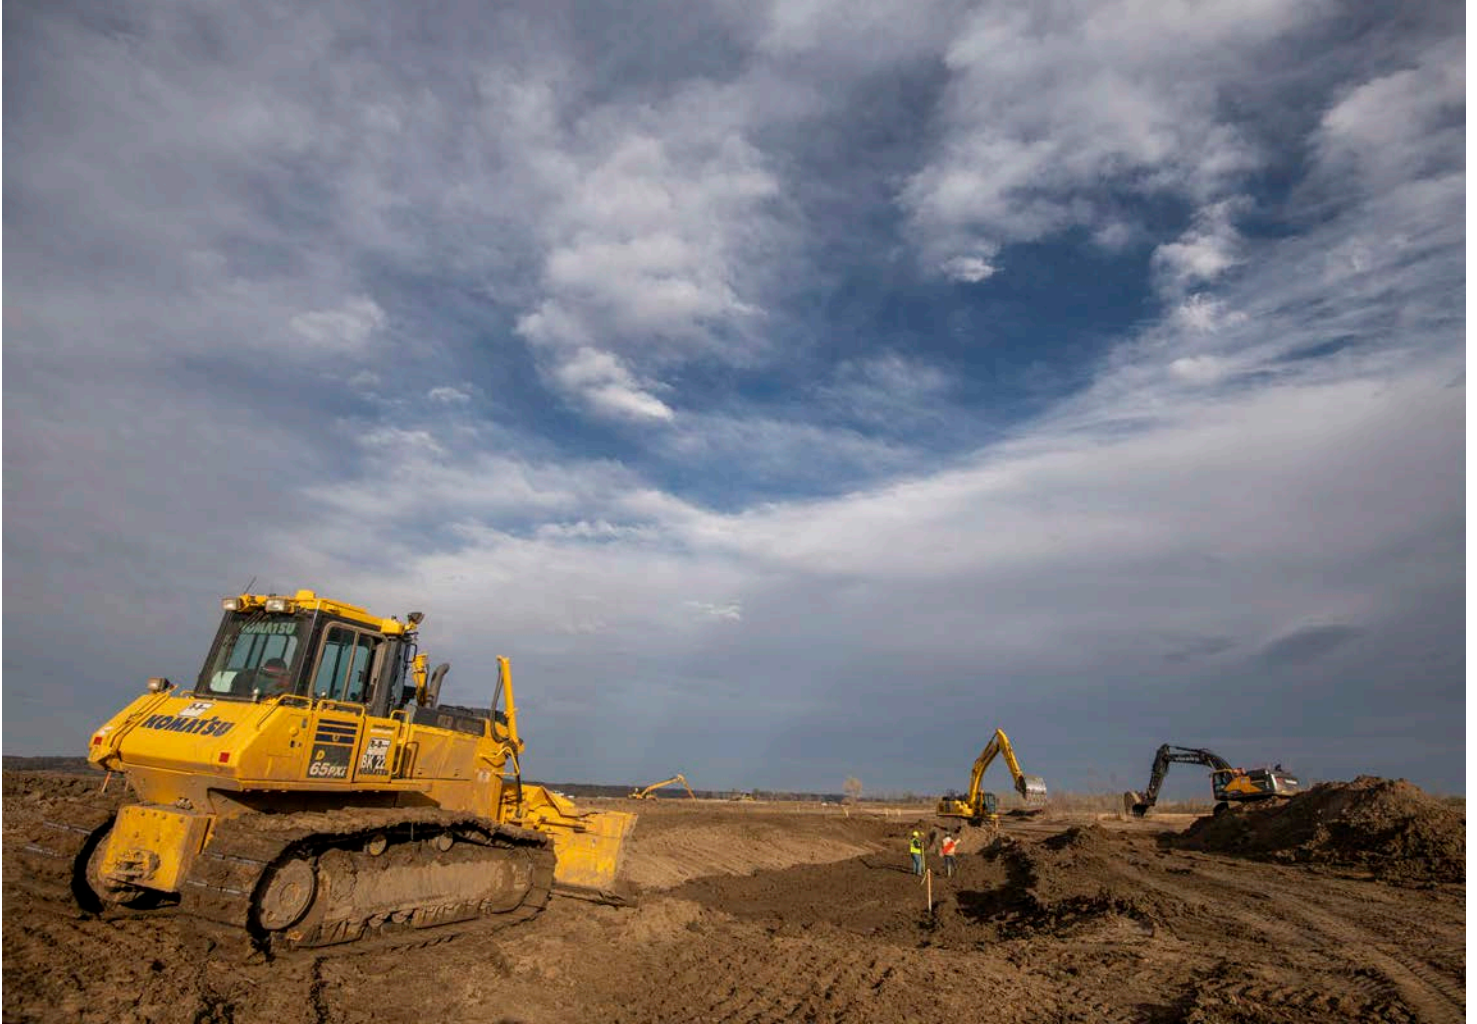
**Crews conduct excavation work on the L-536 setback project, October 2020.**

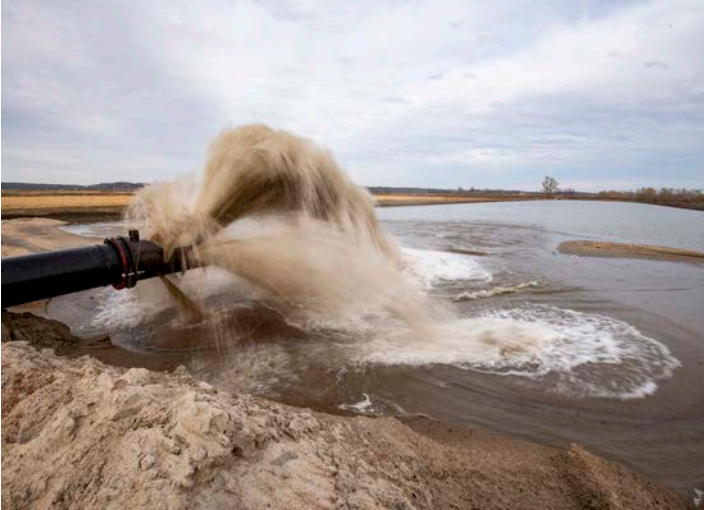
**Dredging work along the Missouri River, October 2020.**

When sand also became difficult to find, the USACE construction management team worked to implement a dredge operation, dredging sand from the Missouri River to construct a significant portion of the seepage berms.

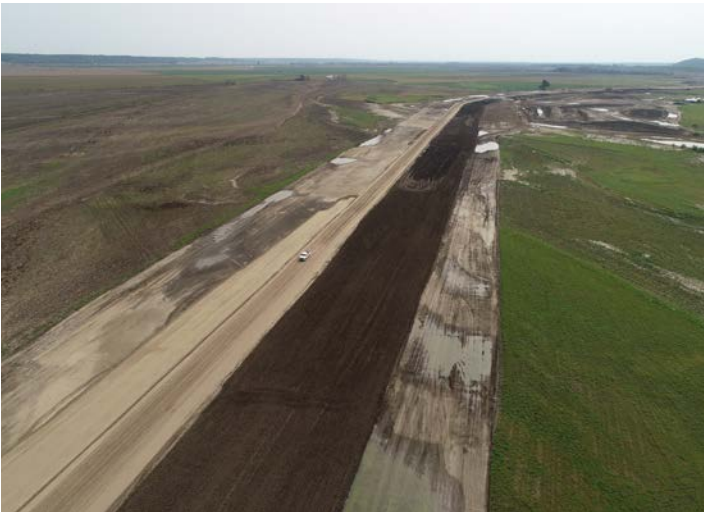
**Levee composition work at L-536, September 2020.**

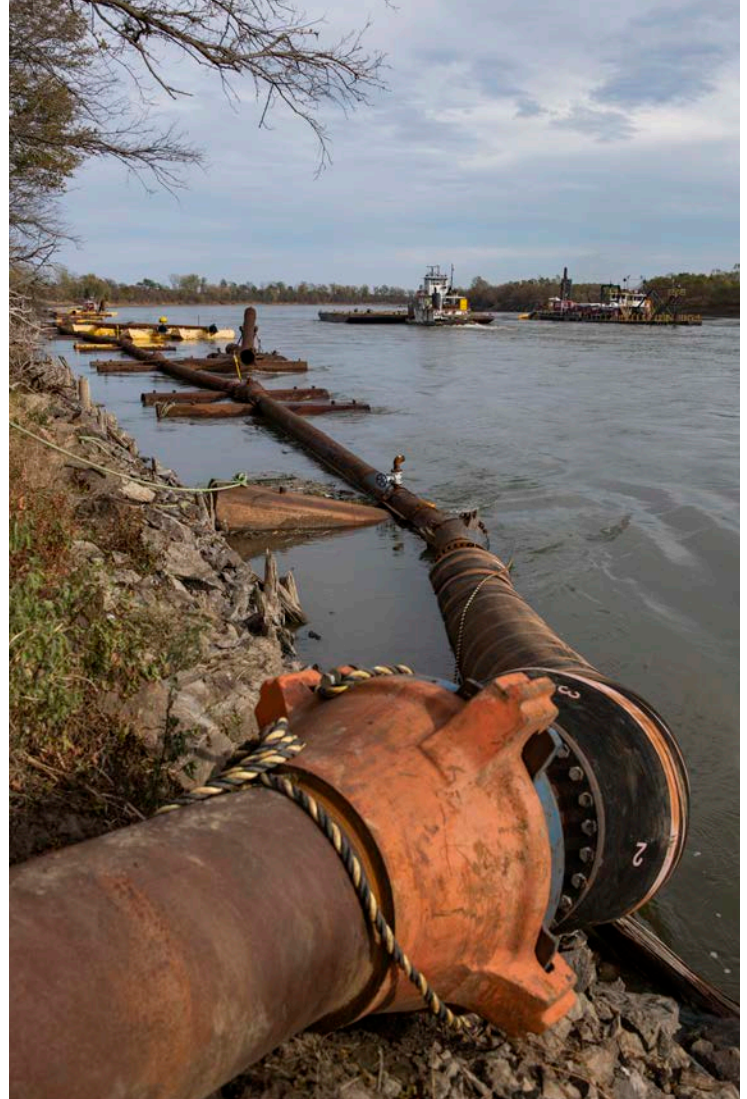
**Dredging work along the Missouri River, October 2020.**

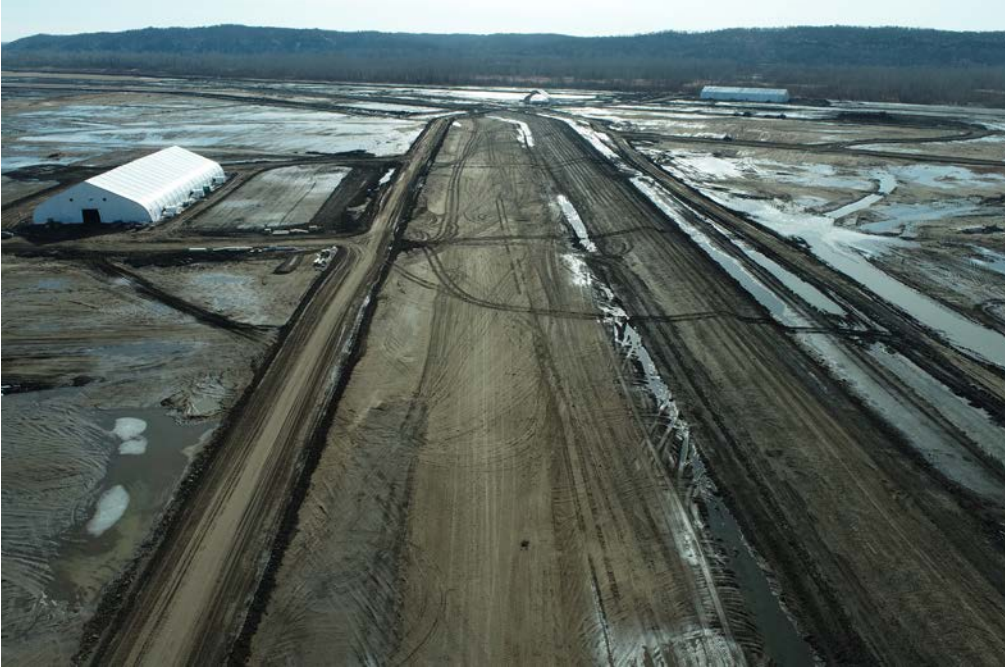
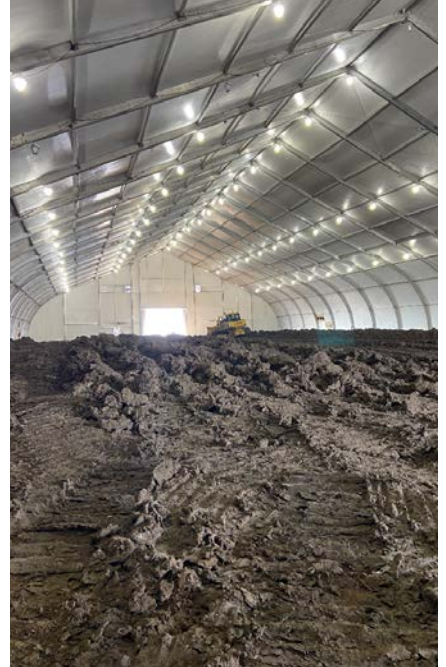
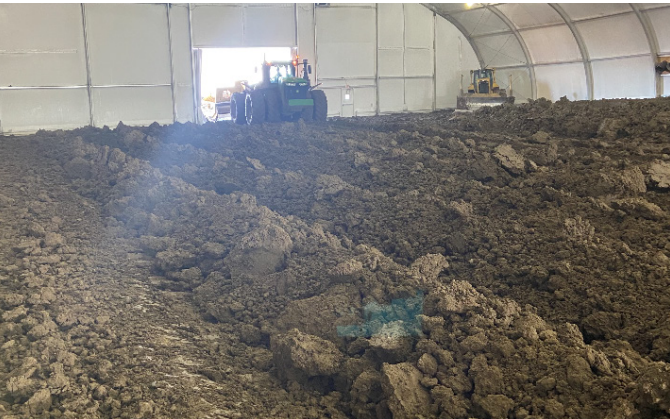
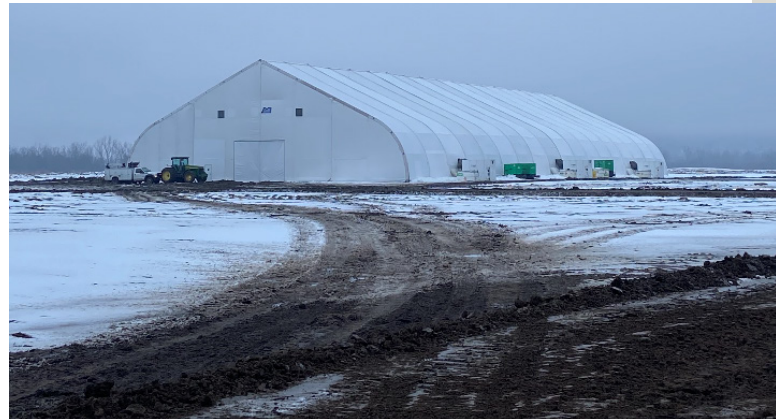
**Warming tents were used to thaw the project's clay material during the last quarter of construction, Winter 2021.**

A polar vortex in winter 2020/2021 brought extreme cold temperatures that dipped below -25 degrees Fahrenheit and threatened to halt construction efforts. The project team used huge heated winter tents to keep clay material thawed and to allow construction to keep progressing.
